**RECALL #** Starcraft18V-362 2018-352      **Date of Release : July 2018**  
 Jayco 18V-364 2018-351

**ACTION REQUIRED**

Replace the defective strap that secures each liquid propane (LP) tank.

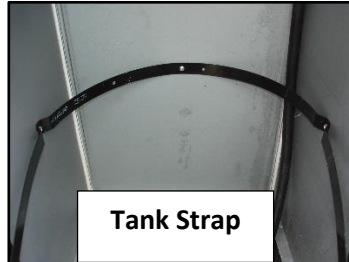
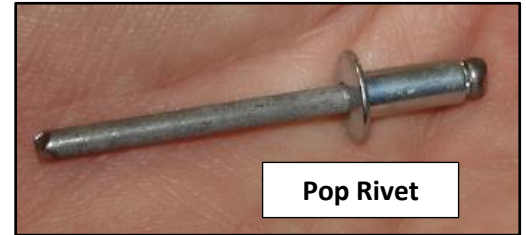
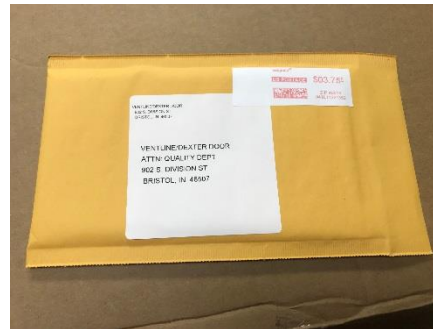
**STARCRAFT 18V-362 - 2 LP straps, 6 pop rivets** Envelope to return end of each defective straps to Dexter/Ventline  
**JAYCO 18V-364A – 1 LP strap, 3 pop rivets** & Envelope to return end of each defective strap to Dexter/Ventline  
**JAYCO 18V-364B – 2 LP straps, 6 pop rivets** - & Envelope to return end of each defective straps to Dexter/Ventline

- LP tank strap/s
- 3 Pop Rivets per strap
- 1 postage paid envelope addressed to Dexter

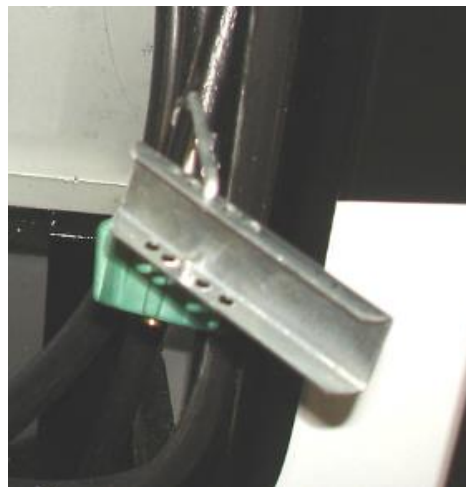
***PLEASE CUT OFF 2" FROM THE BUCKEL END OF EACH DEFECTIVE STRAP AND RETURN TO DEXTER IN THE ENVELOPE PROVIDED IN THE PARTS KIT.***

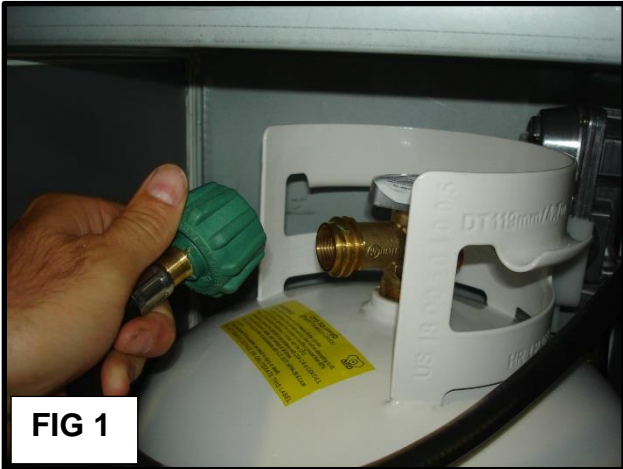
**Fig 1:** Turn off LP at tank. Disconnect the LP hose from the tank.  
Unfasten the tank strap/s, and remove the tank from the compartment.  
**Fig 2:** Replace each strap with a new one from the Recall Parts Kit.

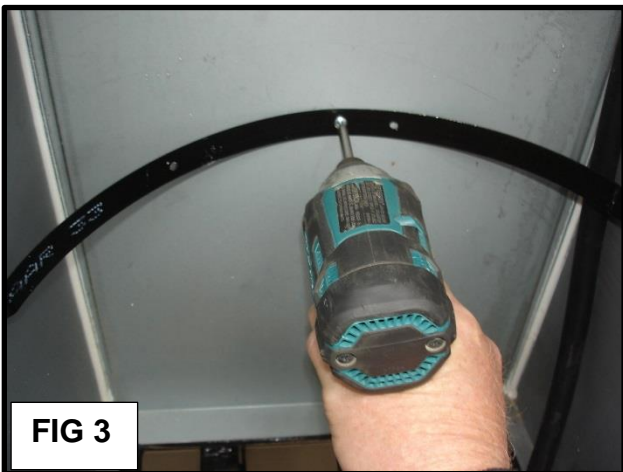
**Fig 3:** Remove 3 bolts securing the strap with the screw gun and square bit.  
Pull on the strap to keep tension on the bolts as you loosen them.  
The nuts will fall off the back side.

**DO NOT DISCARD DEFECTIVE STRAP/S BEFORE YOU CUT OFF THE 2" LENGTH TO RETURN**

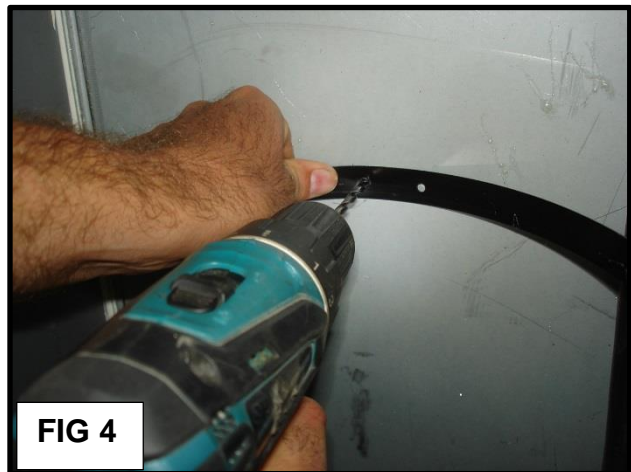
**Fig 4:** Use the 13/64 drill bit and drill the 3 screw holes larger for pop rivets.

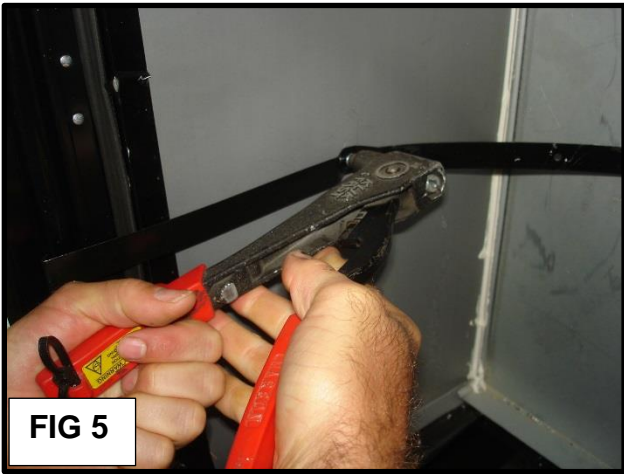
**Fig 5:** Install each new strap from the kit, with pop rivet gun and 3 rivets from the kit.

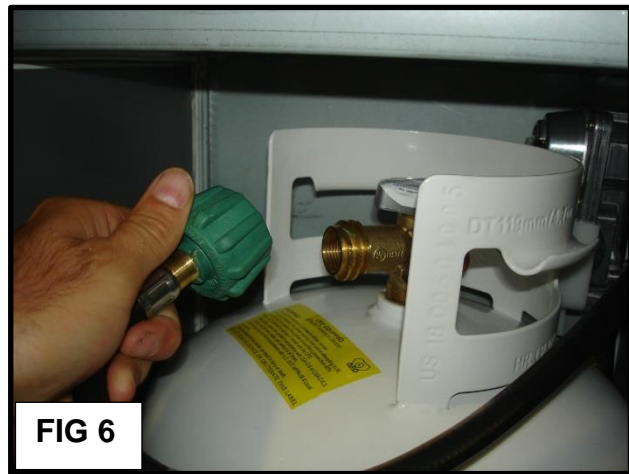
**Fig 6:** Replace the tank, attach the hose, and secure the strap around each tank.
