Subject: 18V-557 Crash Protection Plate Parts Supply

SI M13 02 18
Fuel Systems

UPDATE! RECALL CAMPAIGN 18V-557: INSTALL PROTECTION PLATE ON HIGH PRESSURE FUEL PUMP

Installing the Protection Plate to the High Pressure Fuel Pump (HPP)

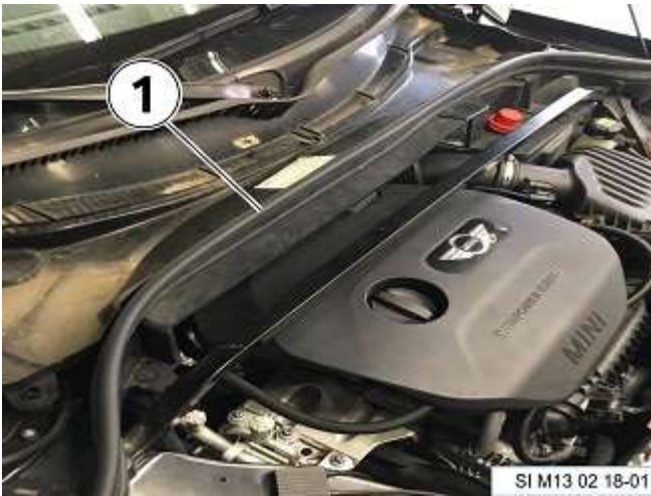
- Remove the rear engine to hood seal (1)

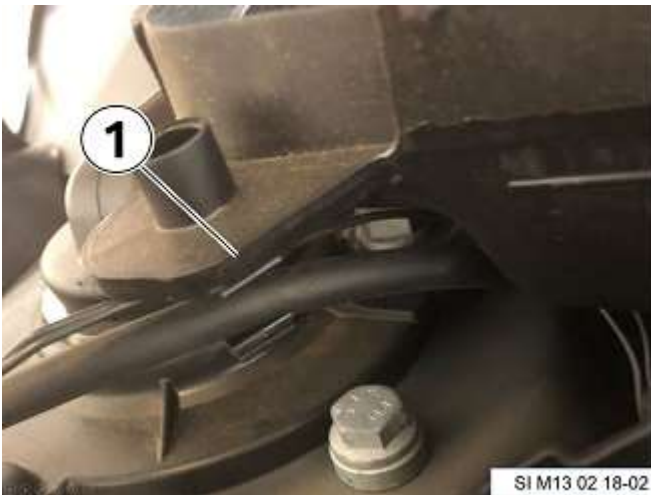
- Unlock the washer hose clip and remove the washer hose from the lower cowl cover (1).

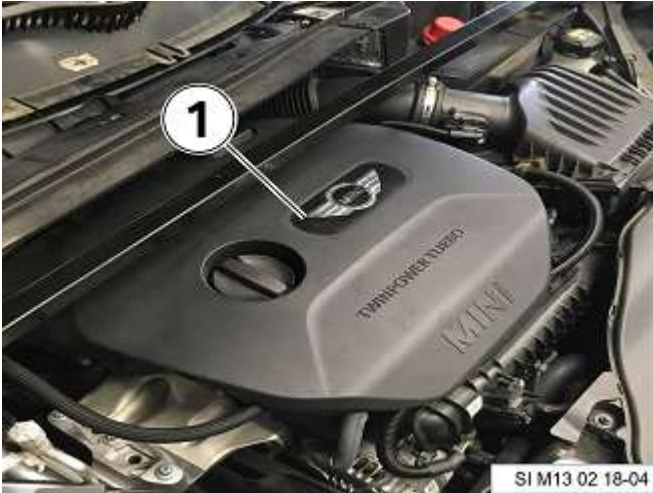
- Remove the engine acoustic cover (1)

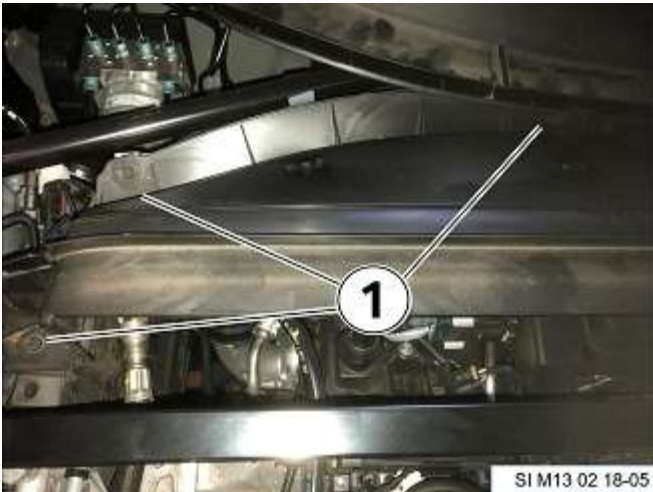
- Remove screws (1) for the upper bulkhead cover.

*Installation torque 3Nm

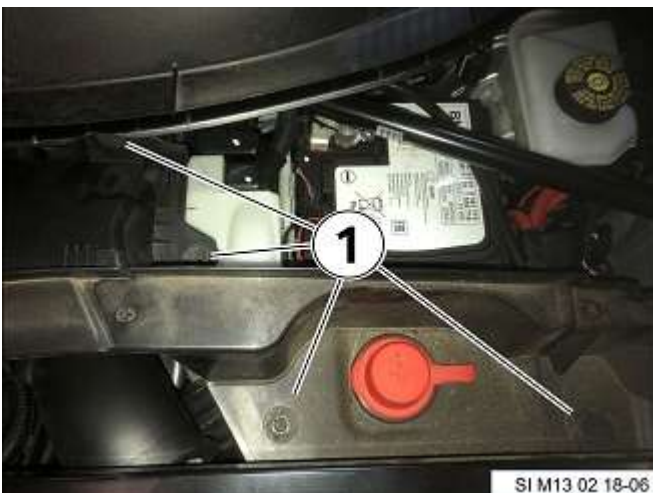
- Remove screws for the upper bulkhead cover and the cover for the B+ terminal (1).

*Installation torque 3Nm

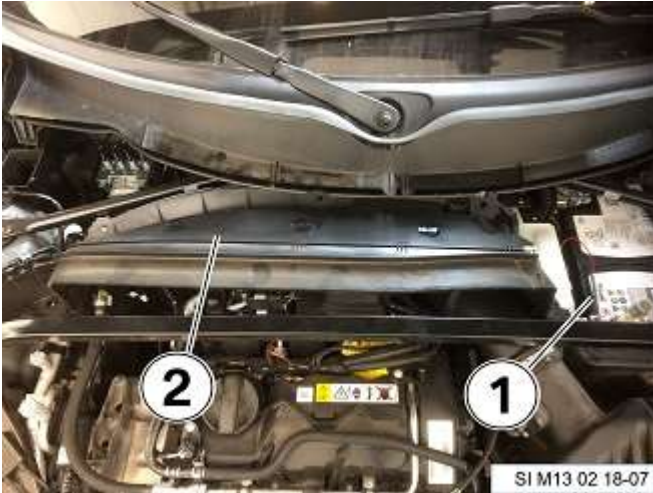
- Remove the B+ cover (1) and then remove the upper bulkhead cover (2).

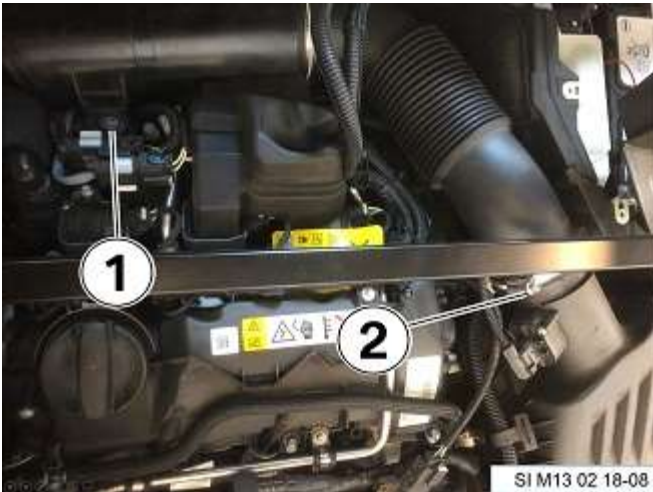
- Remove screw (1) and intake hose clamp (2) from the intake air pipe.

Tightening torque of screw = 5Nm

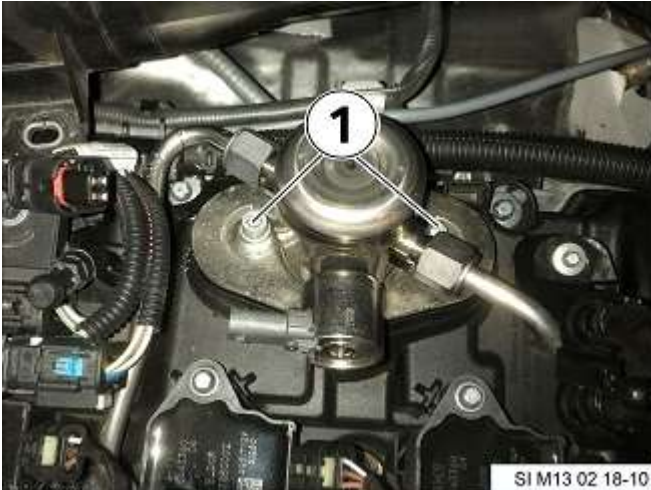
Warning

- The installation of the protection bracket requires the removal of both screws that hold down the high pressure pump. Constant pressure has to be applied to the body of the HPP to keep the pump properly set in the cylinder head!

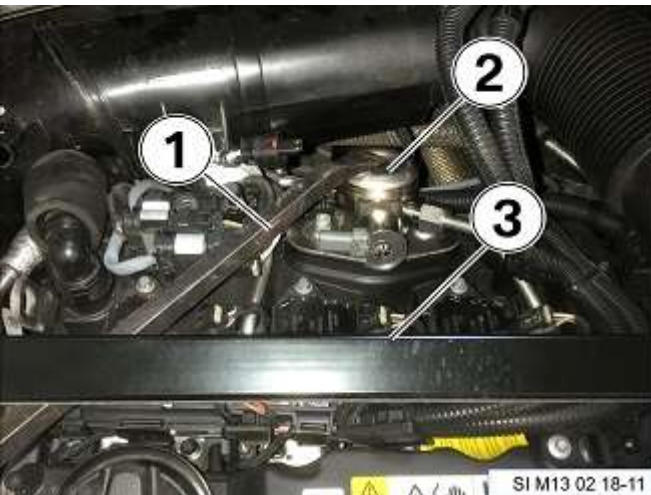
- Using an appropriate length pry bar (1), apply pressure to the top of the high pressure pump (2) using the strut brace (3) as a fulcrum.

***NOTE:** The high pressure pump cannot come out of the mounting flange in the cylinder head during this repair!

***NOTE:** Having an assistant hold pressure on the HPP during the next steps will make the procedure easier.

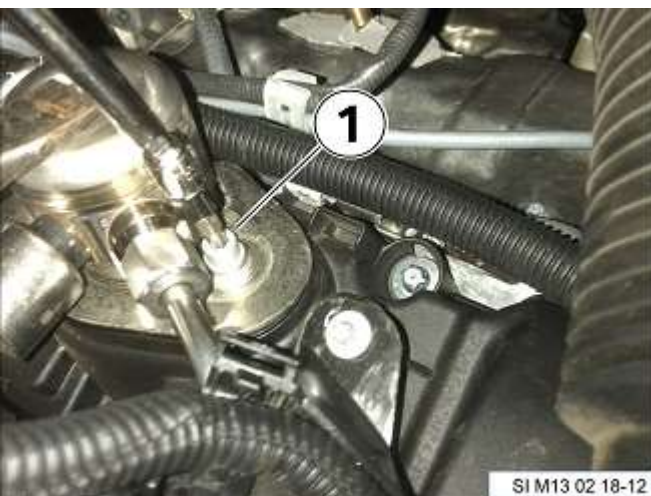
- Remove the left side screw for the high pressure pump (1).

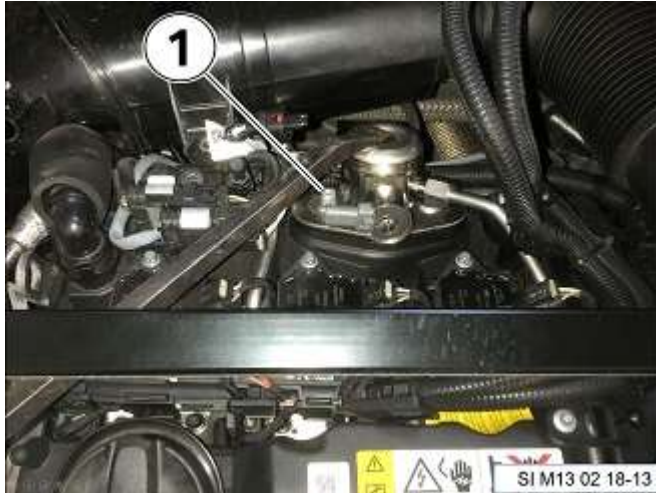
- Remove the right side screw for the high pressure pump (1).

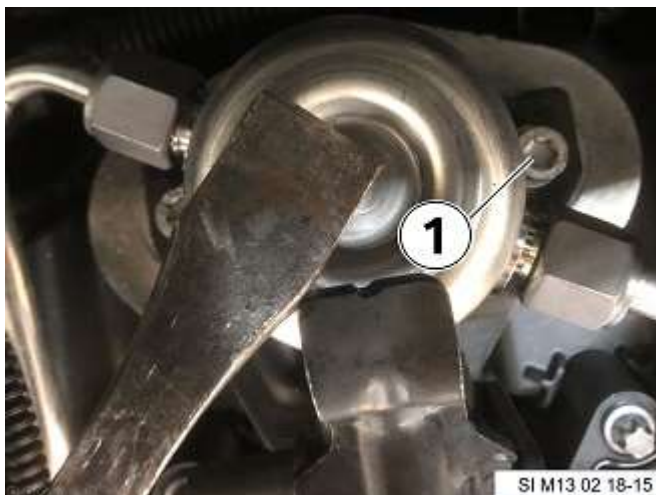
- Insert a new screw into the left side of the high pressure pump (1) and hand tighten. Then torque both screws to 12Nm.

Reinstall remaining components in reverse order.
