TO: Mercedes-Benz Dealer Principals, General Managers, Sales Managers, Service Managers, Parts Managers	FROM: Anthony Washington, Department Manager, Regulatory Mgmt & Campaigns Vans
RE: <b>Recall Campaign 2017030012 – Replace Driver’s-side Airbag, MY 15-17 906 Freightliner and Mercedes-Benz Sprinters</b>	DATE: March 13, 2019

<b>Campaign No. :</b>	<h2>Replace Takata Driver-side Airbag</h2>
<b>2017030012</b>	
<p>This Recall Campaign is being launched to replace the driver-side airbag on approximately <b>81,000</b> affected MY15 – MY17 Freightliner and Mercedes-Benz Sprinter vehicles that are flagged in VMI as of today. Work Instructions are attached and available in Star TekInfo. The recall is being launched in all Zones as defined by the National Highway Traffic Safety Administration. This recall was initiated early March 2019.</p>	
<b>Background</b>	
<b>What's the Concern</b>	The driver-side airbag is affected by this recall based on the defect decision of TK Holdings, Inc. ("Takata"). Under certain circumstances during a crash that necessitates frontal airbag deployment, the defect in the driver-side airbag inflator housing may cause the inflator to rupture. A driver-side inflat

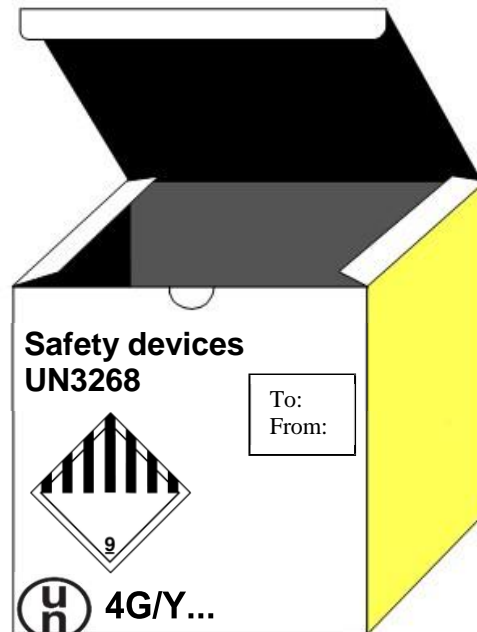
- A **Class 9 Miscellaneous** label must be clearly visible on one side of the box.

- The following words ("marking") must also be clearly visible on the same side of the box as the Class 9 label:  
**Safety devices**  
**UN3268** (font size must be  $\geq \frac{1}{2}$  inch)
- Affix "**To/From**" address label to same or adjacent packaging face as the hazardous markings/labels.
- The UN 4G code preprinted near the bottom edge of the box must also be clearly visible.

- **Note:** The Packing Group and the EX# are no longer required to be printed on the HAZMAT bill of lading.
- **Package example:**

- Carefully open received box and remove new airbag. Keep box intact & save all contents!
- Place used airbag into replacement UN specified 4G fiberboard box, re-using any packaging material (e.g., cardboard inserts) used for the new airbag. Package exactly as the new airbag was packaged.
- Use plastic adhesive tape 50 mm wide to secure the box closed. Do not obscure labels or text on the box with the tape.
- Ensure that the 4G fiberboard box is not ripped or damaged.

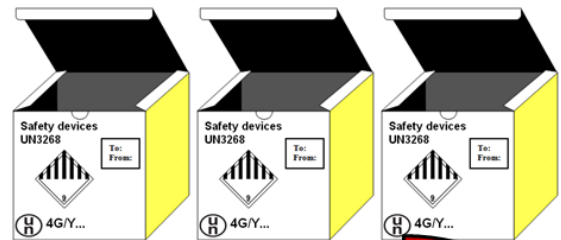
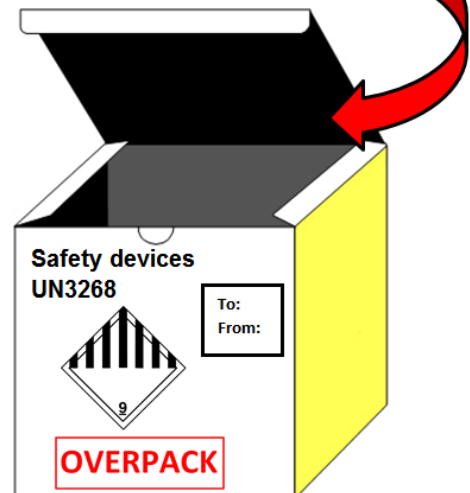
#### Package example:

- Package each airbag in a separate UN spec box prepared with the labels/markings described above.
- Place each individual airbag box inside a larger non-UN spec box to keep the shipment together.
- This larger box is called an "OVERPACK."
- The OVERPACK must have the identical markings and label as the boxes contained inside.

- The OVERPACK must have the "OVERPACK" statement on the same face as the hazard markings and labels.

- Carefully open received UN spec box and remove new airbag. Keep the box intact & save all contents!
- Place used airbag back into replacement airbag box, re-using any packaging material (e.g., cardboard inserts) used for the new airbag. Package as the new airbag was packaged.
- Use plastic adhesive packaging tape 50 mm wide to secure box closed. Do not obscure labels or text on box with tape.
