TO: Mercedes-Benz Dealer Principals, General Managers, Sales Managers, Service Managers, Parts Managers	FROM: Anthony Washington, Department Manager, Regulatory Mgmt & Campaigns Vans
RE: <b>Recall Campaign 2018110007</b> <b>Replace Front Passenger-side Airbag MY14 Freightliner and Mercedes-Benz Sprinters</b>	DATE: March 12, 2019

<b>Campaign No. :</b>	<b>Campaign Desc. :</b>	<b>Takata Recall Notification – Passenger-side Airbag</b>
<b>2018110007</b>	<b>NCV3TAKAGA</b>	
<p>This is to notify you of the upcoming <b>Recall Campaign</b> to replace the Passenger-side Airbag on approximately <b>24,074</b> MY14 Freightliner and Mercedes-Benz Sprinter vehicles. The recall campaign will be visible on the <a href="http://www.safercar.gov">www.safercar.gov</a> website and may generate questions from customers. All affected VINs are flagged as “OPEN” in VMI.</p>		
<b>Background</b>		
<b>Issue</b>	<p>The passenger-side airbag is affected by this recall based on the defect decision of TK Holdings, Inc. (“Takata”). Under certain circumstances during a crash that necessitates frontal airbag deployment, the defect in the passenger-side airbag inflator housing may cause the inflator to rupture. A pass

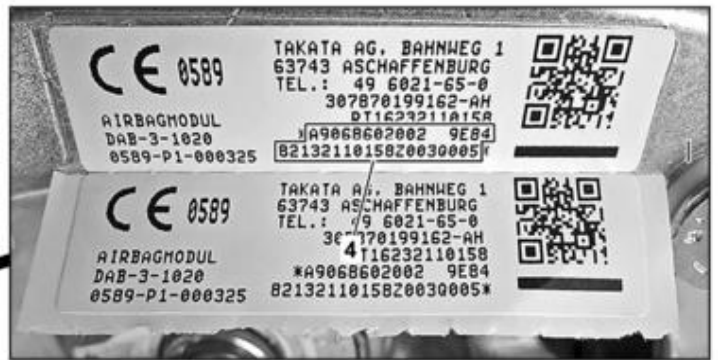
**Shown on driver airbag (1)**

1 Driver airbag

3 Adhesive label

4 Serial number

1 Document the serial number (4) of the removed driver airbag (1) or of the removed front passenger airbag (2) using "Mercedes-Benz Part Scan".

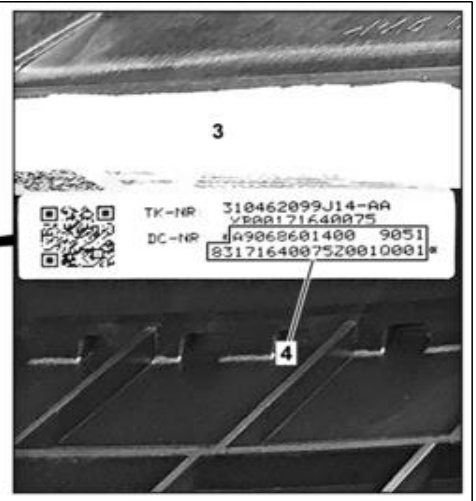
**Shown on front passenger airbag (2)**

2 Front passenger airbag

4 Serial number

3 Adhesive label

The serial number (4) consists of the following information:

- A-object number (e.g. A906860200005)
- Color number (e.g. 9051)
- Sequential number (e.g. 831716400752001)
- Q-status (e.g. Q001)

This information must be read off the adhesive label (3) and entered consecutively without spaces (e.g. A906860200005905183171640075001Q001) as the serial number (4).
