November 2020
FL815A-C
NHTSA #19V-370
Transport Canada #19-237
REVISED NOTICE

Subject: Air Tank Reservoir Capacity

Models Affected: Specific Model Year 2005-2019 Freightliner 108SD, 114SD, 122SD, Argosy, Business Class M2, Cascadia, Classic, Columbia, Coronado, FL80, and FLD120; Sterling Acterra, L-Line, and LT-Line; and Western Star 4700, 4900, and 6900 model vehicles manufactured January 8, 2004, through October 12, 2018.

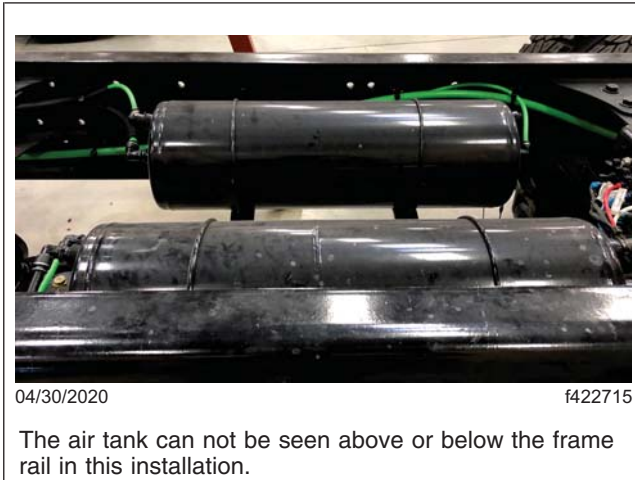
Fig. 1, In-Rail Air Tank, Top View

For examples of the different types of air tank installations, see [Fig. 1](#), [Fig. 2](#), [Fig. 3](#), [Fig. 4](#), and [Fig. 5](#).

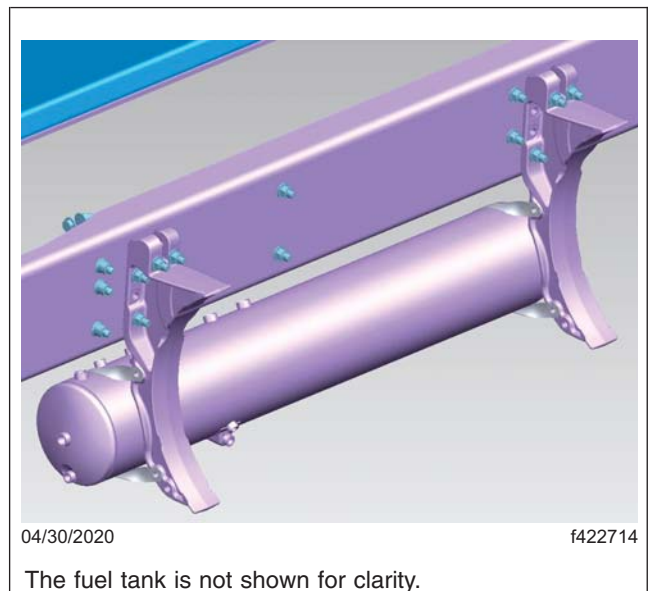
Fig. 4, Fuel Tank Mounted Air Tank

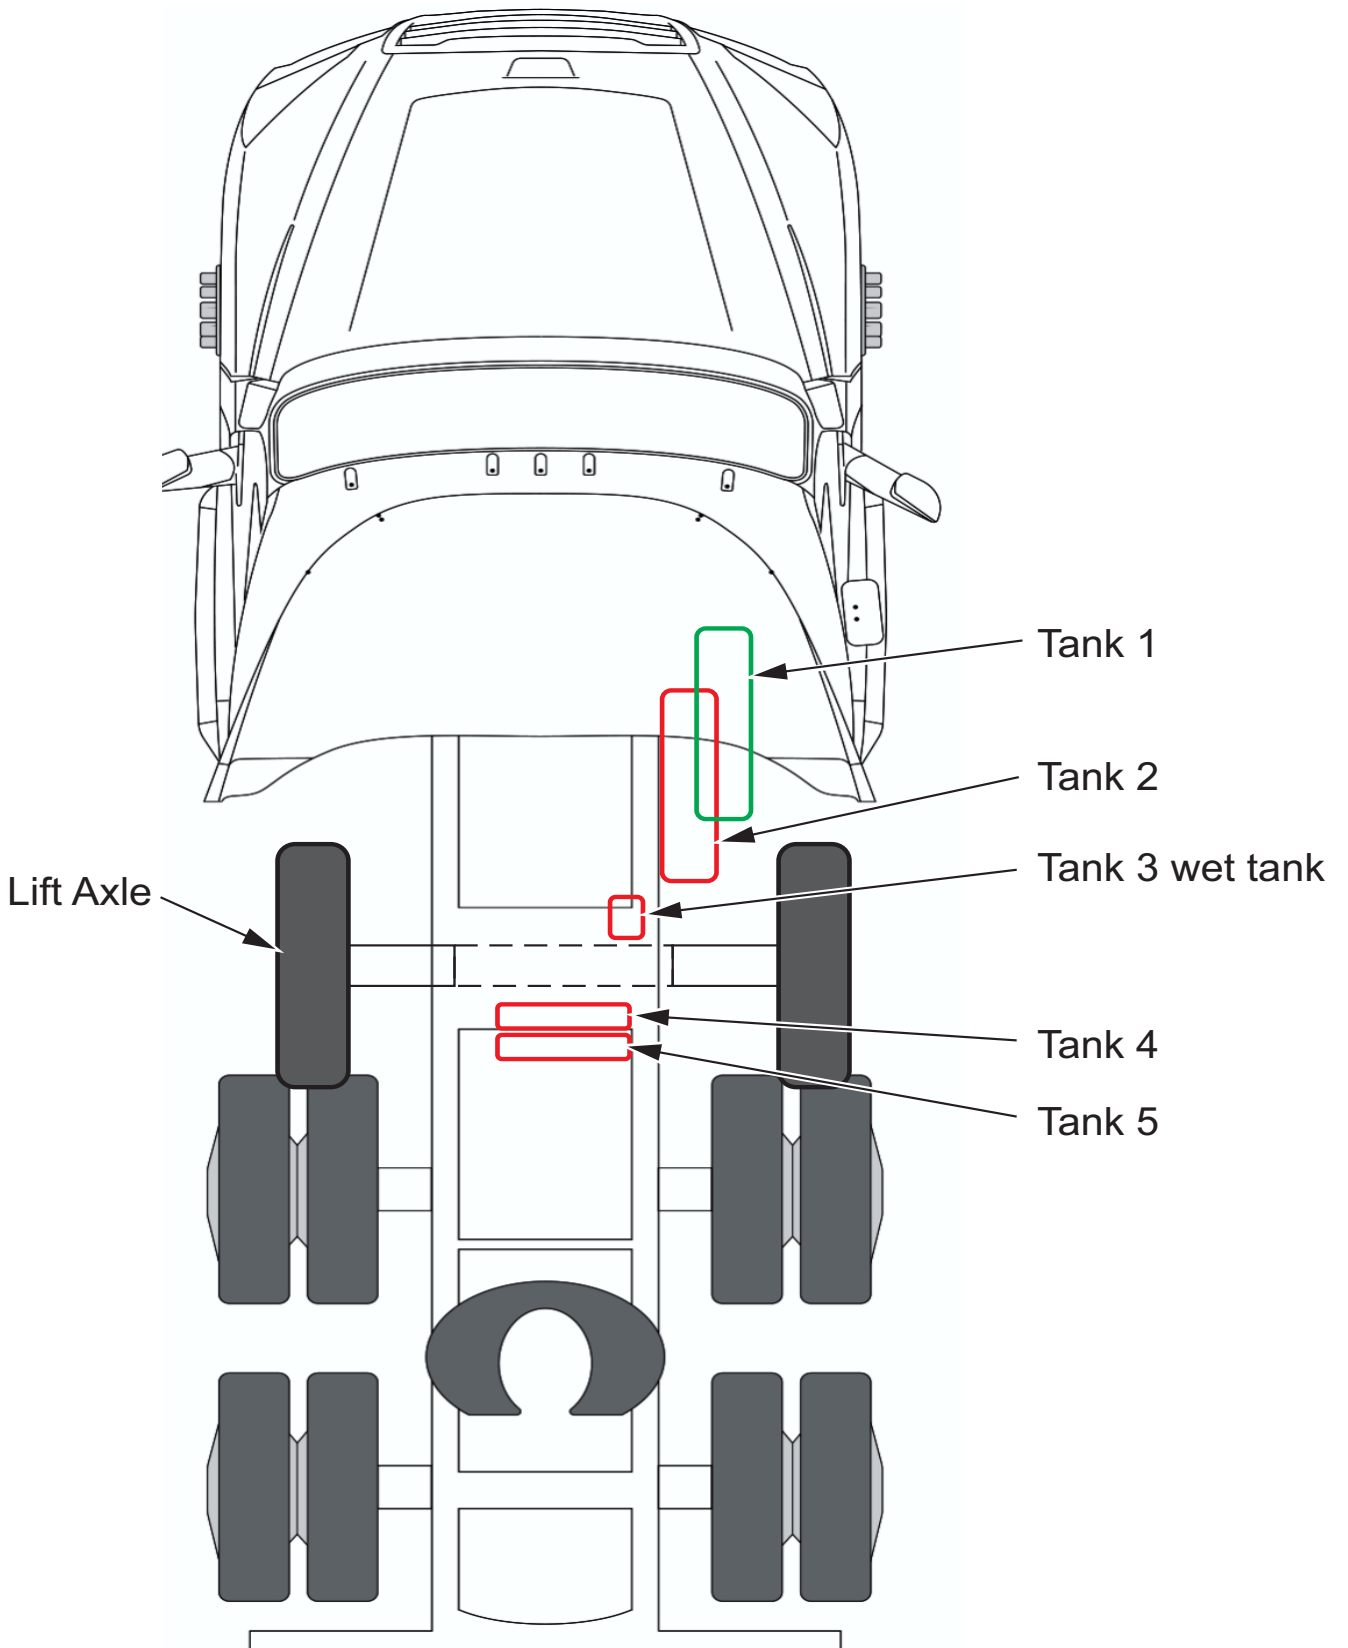
Example - FL815 Existing Air Tank Locations

Mark the location of the existing tanks on the diagram below. Label as Tank 1, Tank 2, etc.
