IMPORTANT SAFETY RECALL

NHTSA Recall Campaign # 19V410

Rear Brake Line Fitting Inspection and Remedy

Applicable for 2014 to 2019 Model Year Toyota Rear Entry Vehicles Produced January 2018 to May 2019

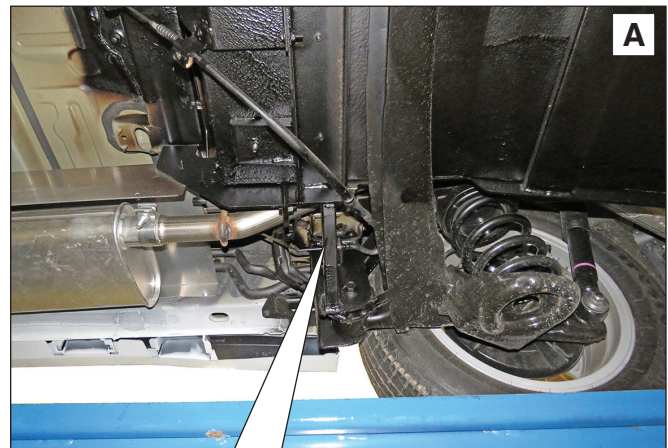
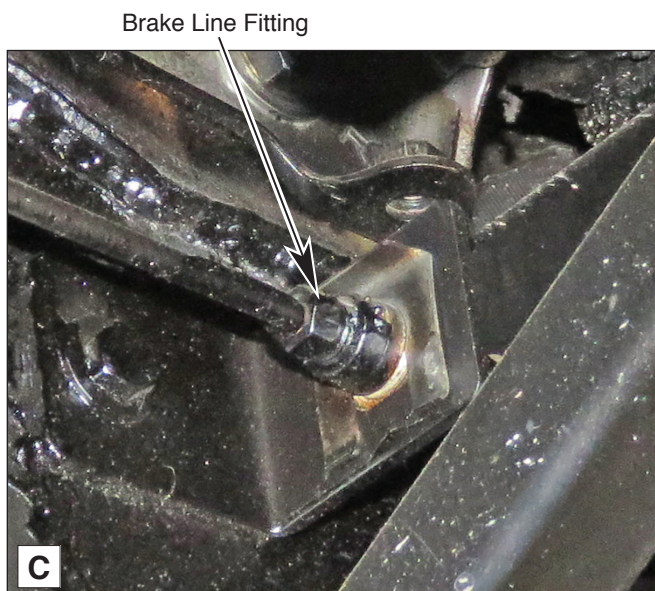
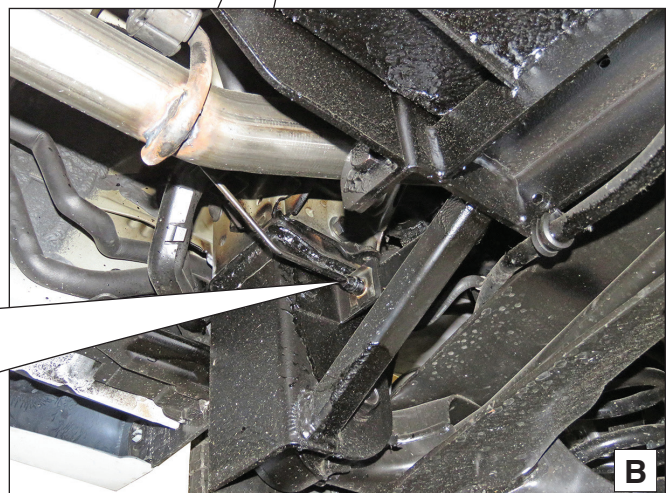
1. Locate brake line fitting at rear passenger side. See Photos A through C.

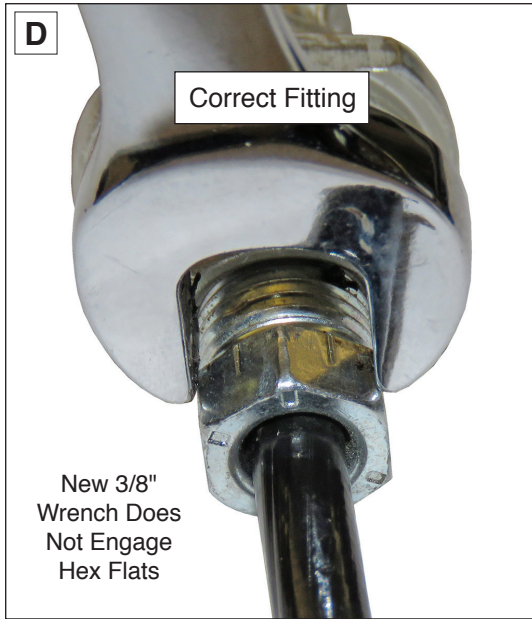
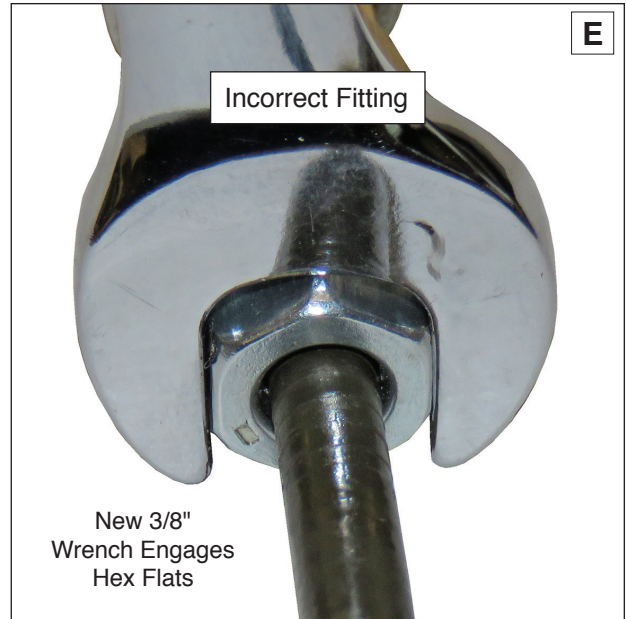
2. Place new 3/8" wrench onto brake line fitting shown in Photo B. If wrench **does not** engage hex flats, the correct line fitting is installed. See Photo D. If the new 3/8" wrench **does** engage hex flats the brake line adapter fitting (included in kit) must be installed. See Photo E.

If wrench **did not** engage hex flats, skip to Step 8.

If the wrench **did** engage hex flats, proceed to Step 3.

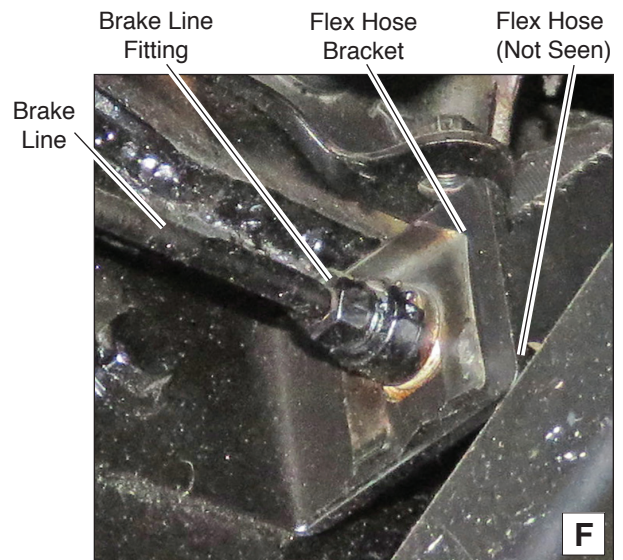
3. Disconnect brake line from flex hose. See Photo F.
4. Install thread adapter (included in kit) to flex hose. Torque to 13 ft•lbs. See Photos G and H.

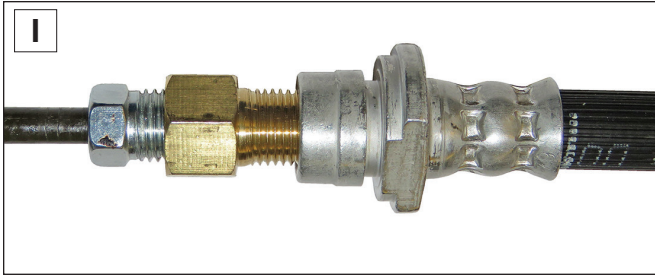
5. Connect brake line to thread adapter. Torque to 13 ft•lbs. See Photo I.

6. Bleed brakes per manufacturer guidelines.

7. Check for brake fluid leaks while someone presses the brake pedal.

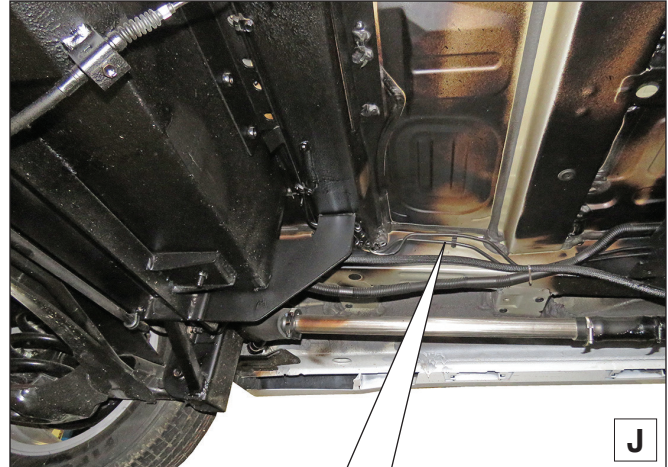
Top Brake Line
to Passenger Side

9. Inspect brake lines, at retainer clip, and confirm the top line routes to the passenger side rear brake. If the top line, at retainer clip, **does not** route to passenger side rear brake contact Vehicle Aftersales at 1-877-272-8633 - Option 3. Refer to Photos J and K.
