Recall Campaign Bulletin

Campaign No. 2019080006, September 2019

SUBJECT: Model S-Class vehicles, (222 platform)

Rework torque of A-, B-, and C-pillar trims, as well as wheel arch liners

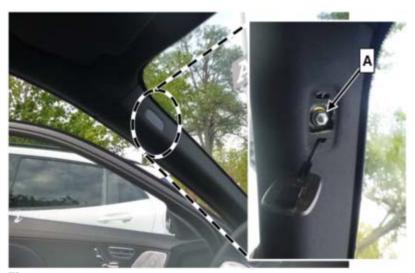
Figure 1

1. Remove SRS cover on A-pillar and correct torque (5) (A, Figure 1).

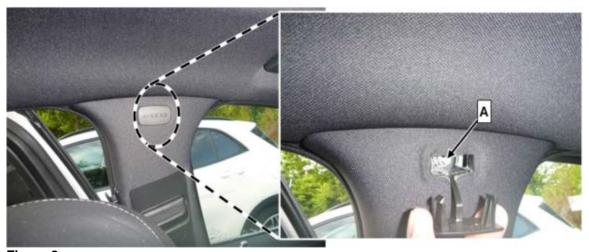
Figure 2

2. Remove SRS cover on B-pillar and correct torque (Mm 5) (A, Figure 2).

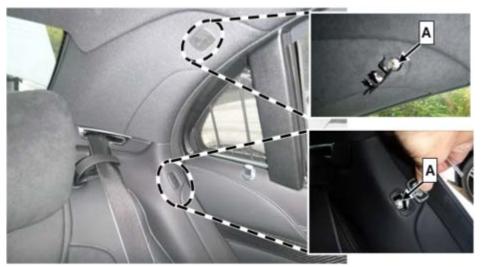
Figure 3

3. Remove SRS cover on C-pillar and wheel arch and correct torque (Mm 5) (A, Figure 3).
