Recall Campaign

June 2020
FL832A
NHTSA#19V-712
Transport Canada #2019-497

Subject: TBB SynTec S3B/S3C Seat Kneeforms

Models Affected: Specific Model Year 2015-2020 Thomas Built Buses Minotour and Saf-T-Liner C2, EFX, and HDX model school buses manufactured August 18, 2014, through August 15, 2019, with certain SynTec S3B or S3C seats.

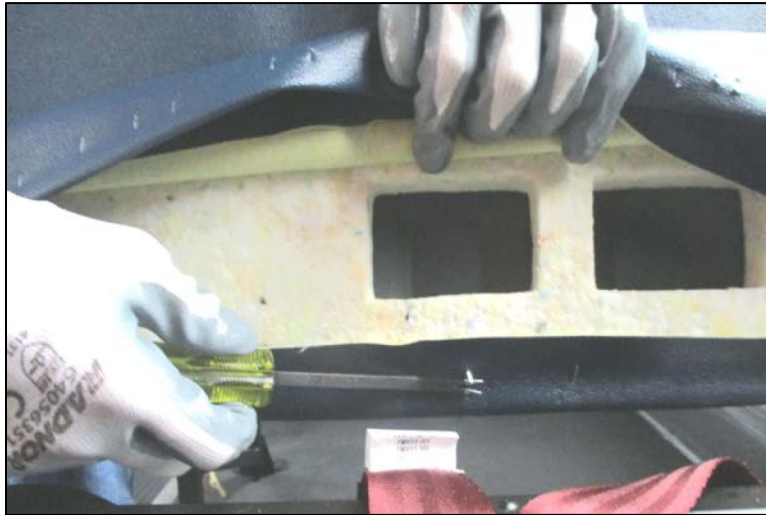
Figure 2: Removing Staples from the Reverse Side of the Vinyl

5. From the front of the seat, using a staple remover or wide-nose pliers, remove the staples from the reverse side of the vinyl. See **Figure 2**.

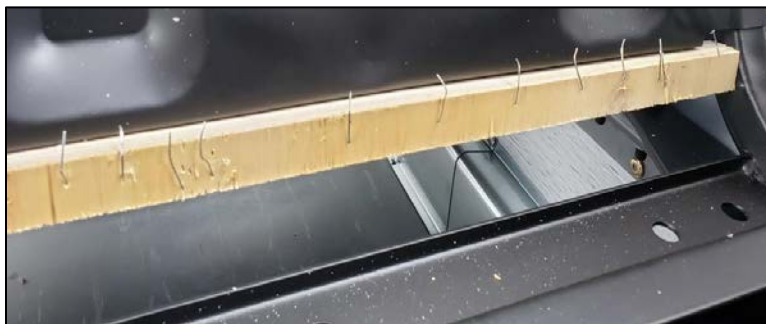
Figure 3: Remove Staples from Wood Strip

6. Using pliers, bend all staples shown in **Figure 3** to ensure there are no sharp points. This will be covered with two layers of vinyl in later steps.

13. Pull the vinyl cover on the back of the seat under the seat and pull tight. Staple to the original wood strip. See **Figure 3**, **Figure 11**, and **Figure 12**.

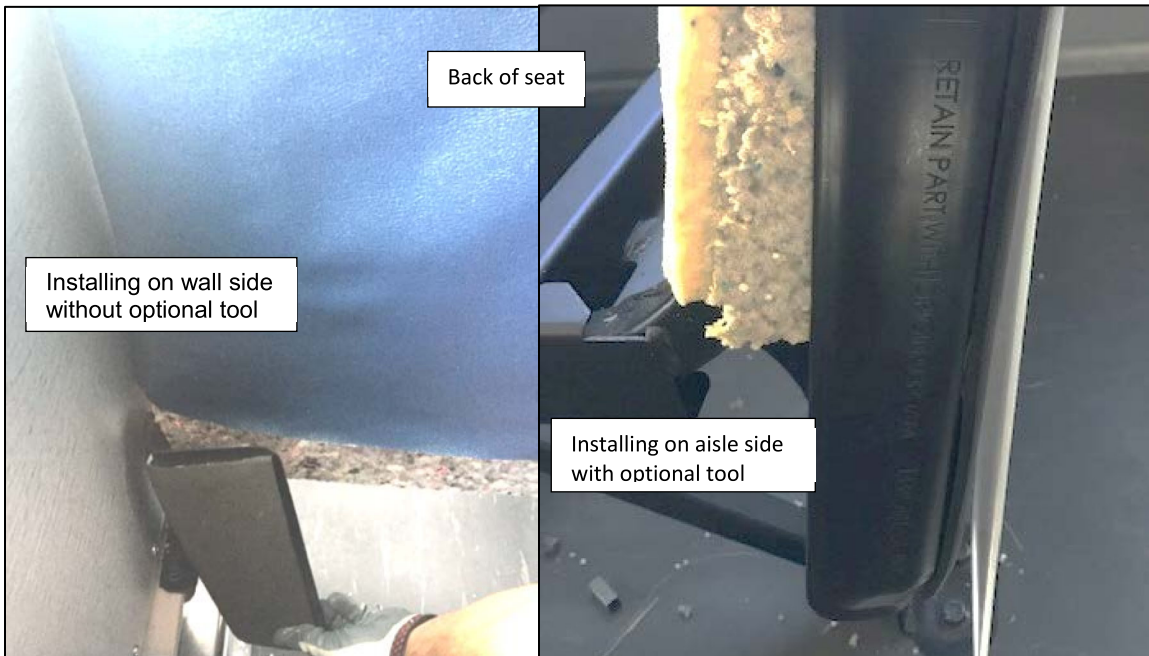
Figure 6: Positioning the Insert

NOTE: An optional tool, provided with new impact material inserts ("insert") shipped to dealers, may be used. It slides up with the insert between the existing foam and the vinyl cover. Once in position, slide the tool out.

9. Place the Insert between the vinyl and the existing foam. The narrower side of the insert is positioned toward the side of the seat and the wider side is positioned toward the back of the seat. See **Figure 6**, **Figure 7**, and **Figure 8**.

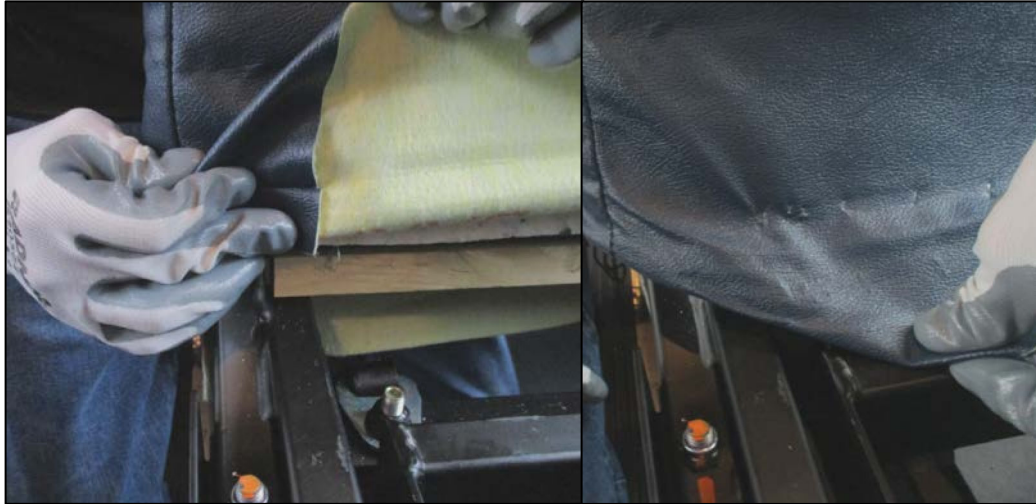
Figure 10: Folding and Tucking the Vinyl Seat Cover

12. Tuck and fold the front and back corners of the seat cover around the rear seat leg. See **Figure 10**.

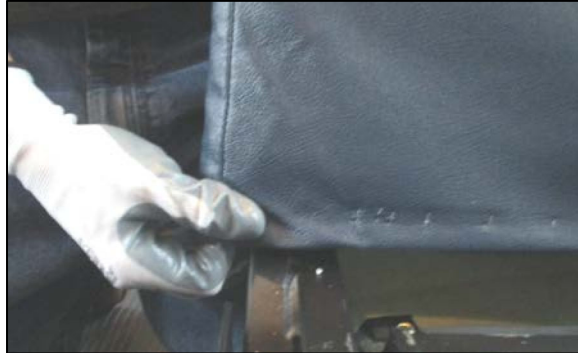
Figure 13: Front Seat Cover When Folded and Stapled

14. Pull the vinyl cover on the front of the seat down. Make sure it is straight and there are no wrinkles.
15. Fold the vinyl underneath itself to match the crease from the original installation.
16. Staple the front vinyl cover to the wood strip (that it was removed from earlier). Ensure no restraint belts are obstructed by the vinyl or staples. See **Figure 13**.
