SUBJECT: NEW VEHICLE DEMONSTRATION / DELIVERY HOLD - Safety Recall 19S38
– Supplement #3
 Certain 2015-2017 Transit Vehicles
 Driveshaft Flexible Coupling

CERTAIN 2015-2017 TRANSIT VEHICLES EQUIPPED WITH A DRIVESHAFT FLEXIBLE COUPLING — DRIVESHAFT FLEXIBLE COUPLING REPAIR

ENHANCED DRIVESHAFT FLEXIBLE COUPLING INSTALLATION

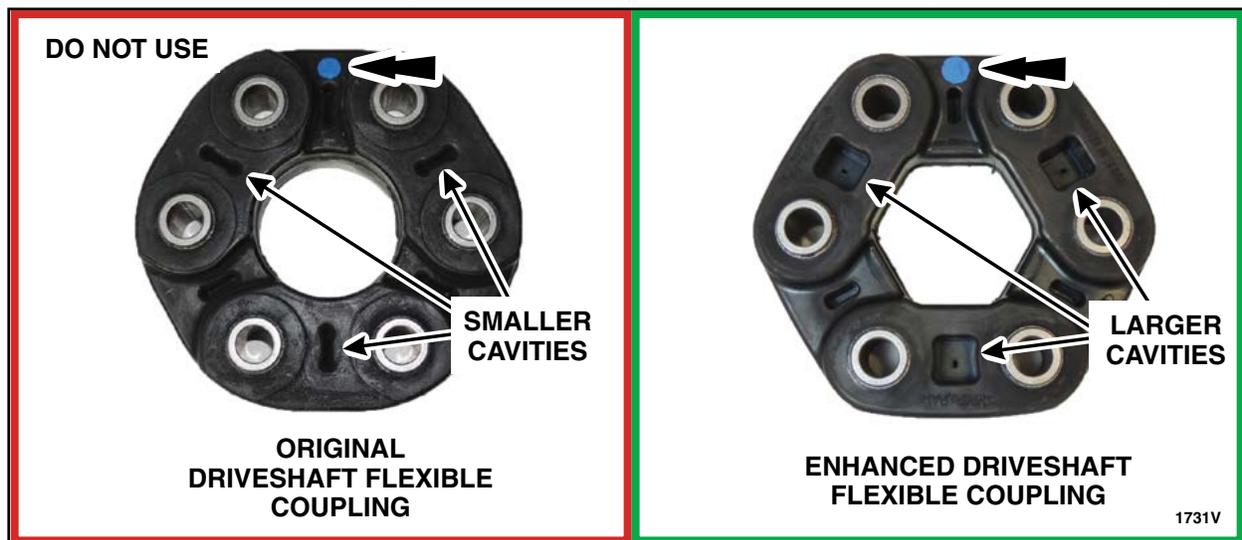
FIGURE 2

- To assist with the removal of the driveshaft flexible coupling-to-transmission output flange bolts, the use of a Mini-Ductor™ induction heating tool, or equivalent, is recommended.
- The blue paint marking on the *new* driveshaft flexible coupling must be installed facing the transmission output flange or premature failure of the flexible coupling will occur. See Figure 2.

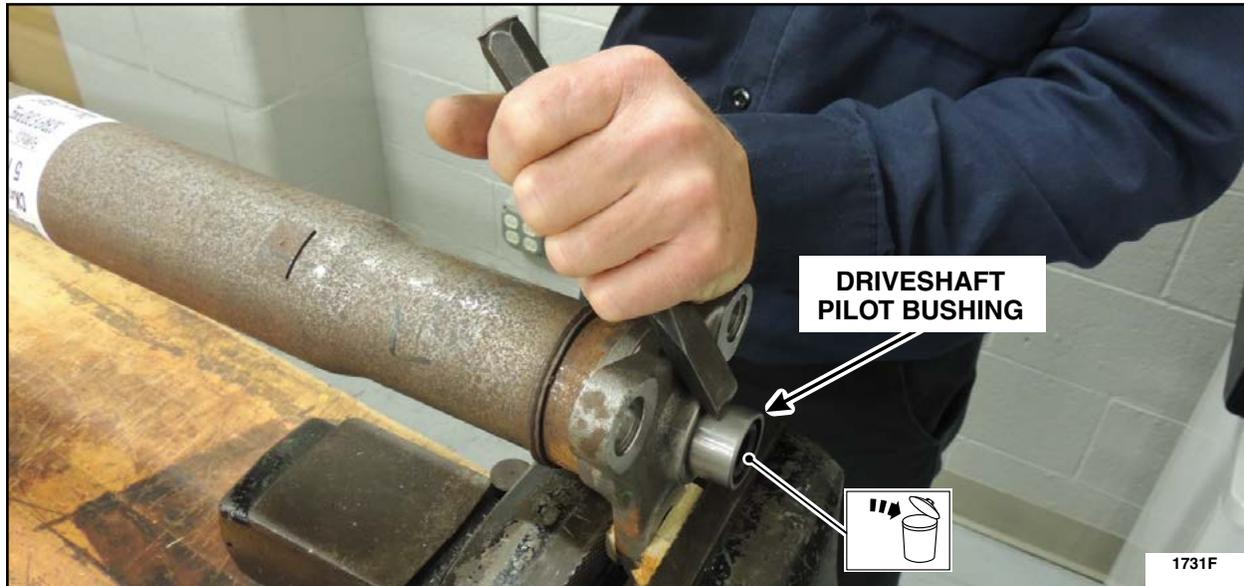
FIGURE 3

- Using a hammer and chisel with a sharp edge, remove and discard the driveshaft pilot bushing.
See Figure 3.

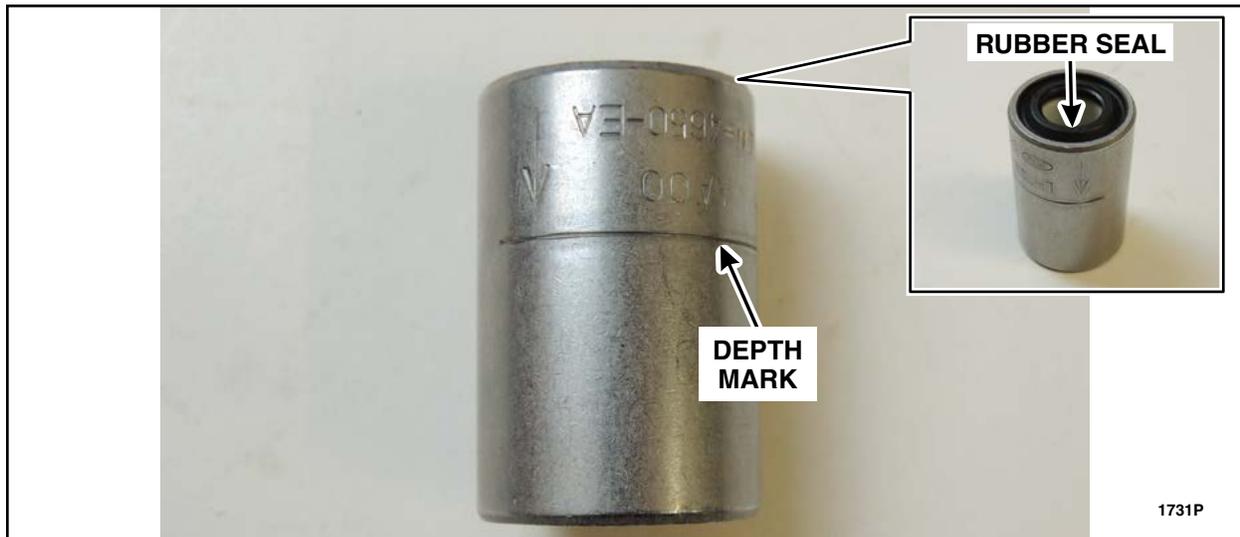
FIGURE 4

- NOTE:** Prior to installation of the *new* driveshaft pilot bushing, make sure the rubber seal end of the bushing is facing outward and the capped end is pressed into the driveshaft. See Figure 4.

Using a 3-jaw puller and a suitable flat piece of metal, press in the *new* pilot bushing until the depth mark on the pilot bushing has been reached. See Figures 4 and 5.

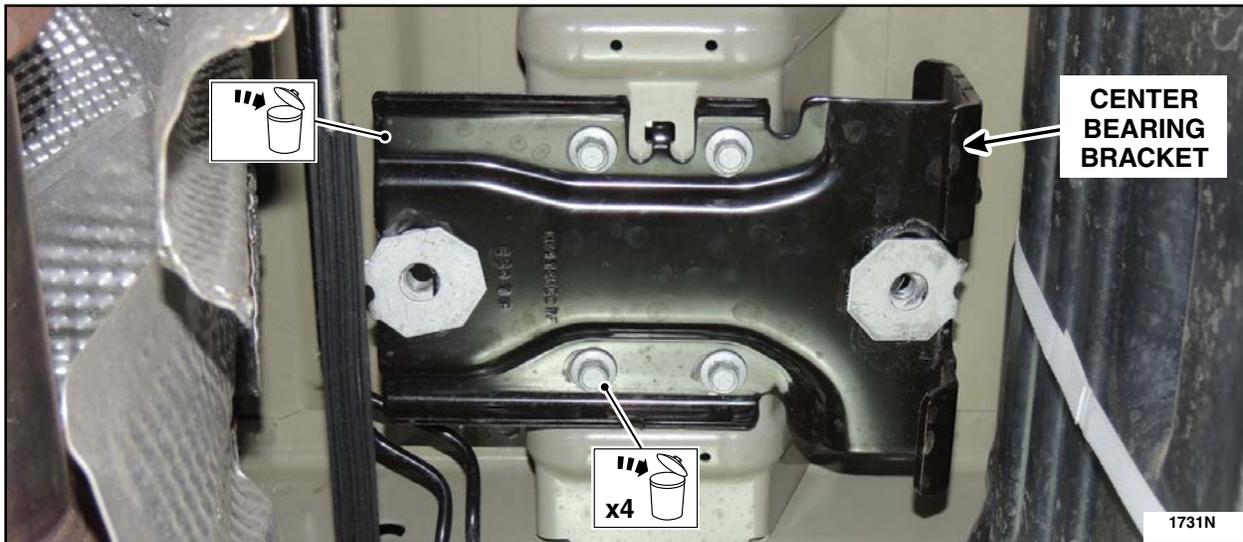
FIGURE 6

6. Remove and discard the four center bearing bracket retaining bolts and the center bearing bracket. See Figure 6.

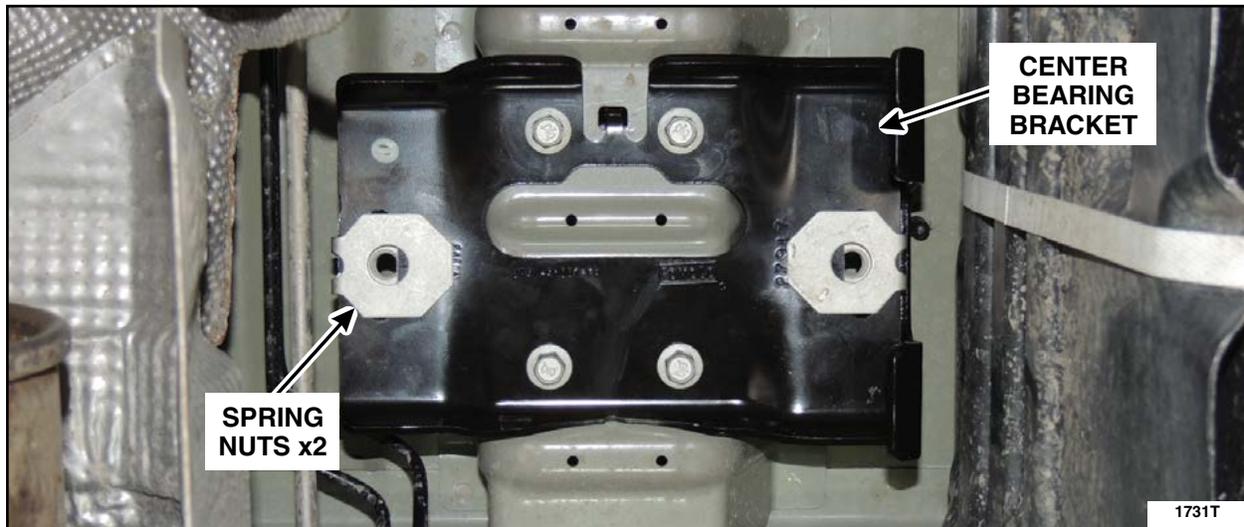
FIGURE 7

8. Install the *new* center bearing bracket using four *new* retaining bolts. See Figure 7.

- Tighten bolts to 18 lb.ft (25 Nm).

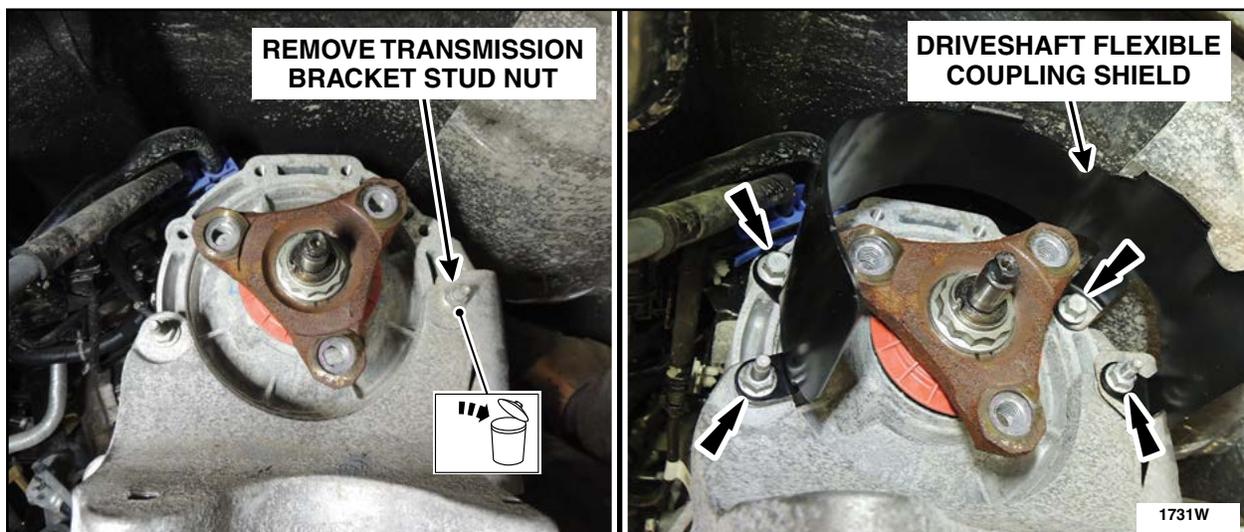
FIGURE 8

9. Install the driveshaft flexible coupling shield. See Figure 8.

- Remove the upper RH transmission bracket stud nut and discard.
- Install the shield onto the transmission rear housing and bracket.
- Install a *new* RH and LH transmission bracket stud nut (LH nut is installed over existing nut), and *new* transmission rear housing bolts to secure the shield.

- Tighten nuts to 23 lb.ft (31 Nm).
- Tighten bolts to 47 lb.ft (64 Nm).

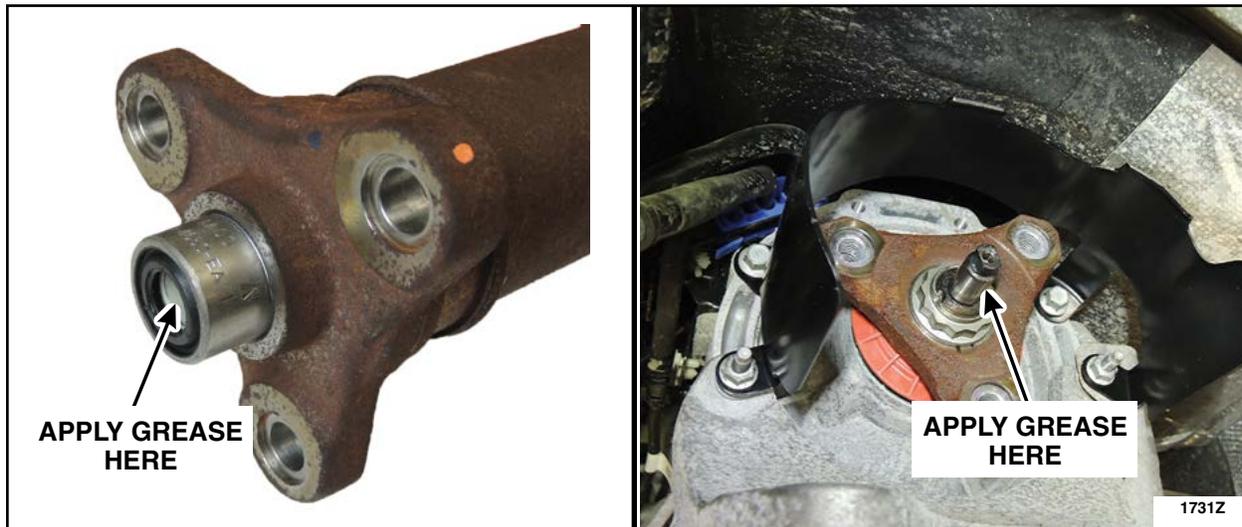
FIGURE 9

10. Lubricate the transmission output shaft and driveshaft bushing using a small amount of Motorcraft® XG-1-E1 Premium Long Life Grease or equivalent. See Figure 9.

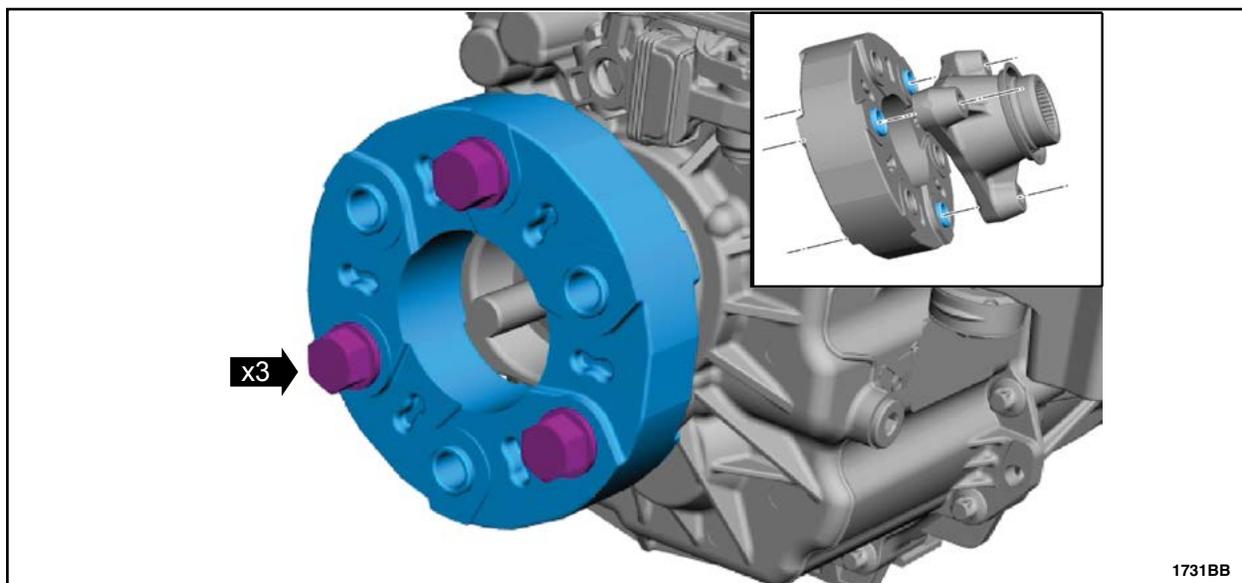
FIGURE 10

11. Install the *new* driveshaft flexible coupling. Please follow the Driveshaft Flexible Coupling Removal and Installation Workshop Manual (WSM) procedure in Section 205-01. See Figures 10 and 11.

NOTICE: The flex coupling must be installed with the blue paint mark facing the transmission output flange. The protruding flex coupling bushings must align with the driveshaft flange and transmission output flange as shown in Figures 10 and 11.

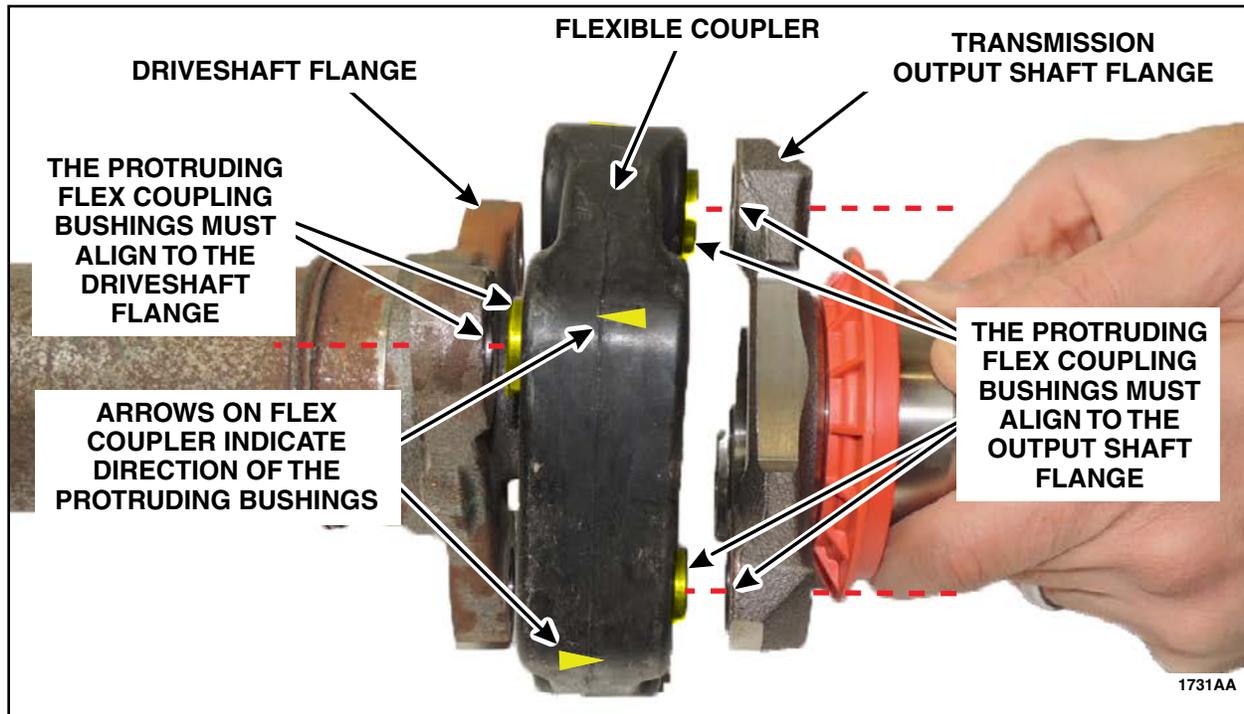
FIGURE 11

NOTE: There are six (6) bushings in the coupler. Three (3) bushings protrude forward and three (3) protrude rearward and they must interlock with each flange. See Figure 11.

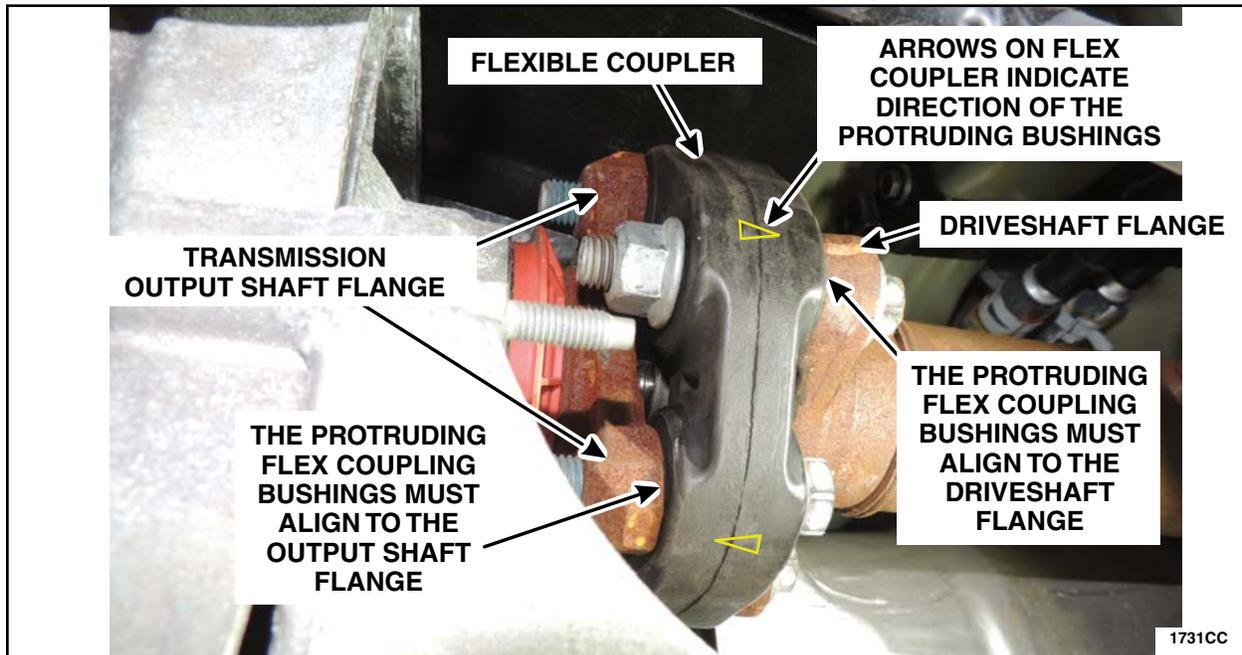
FIGURE 12

12. Reinstall the driveshaft with the appropriate center bearing shim according to the chart in Figure 13. Please follow the Driveshaft Removal and Installation Workshop Manual (WSM) procedure in Section 205-01. See Figures 12, 13 and 14.

NOTICE: The flex coupling must be installed with the blue paint mark facing the transmission output flange. The protruding flex coupling bushings must align with the driveshaft flange and transmission output flange. Arrows should point at the ears of each flange shown in Figure 12.

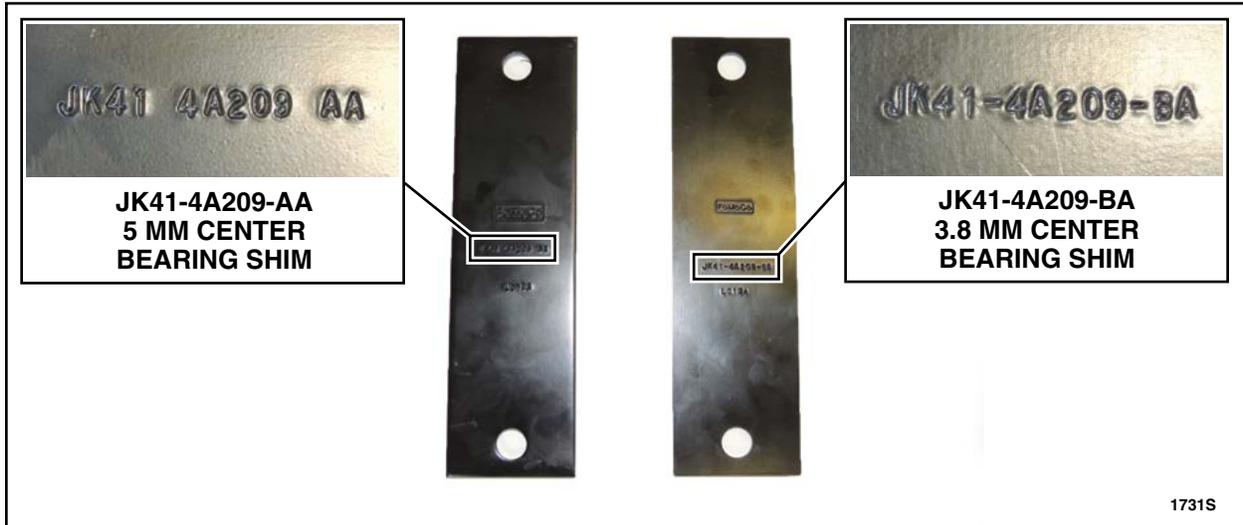
FIGURE 13

SHIM	WHEEL BASE	ENGINE	SRW/DRW
3.8MM SHIM JK41-4A209-BA	129"	3.5L	SRW
5MM SHIM JK41-4A209-AA	148"	3.5L	ALL
		3.7L	
NO SHIM	All Others

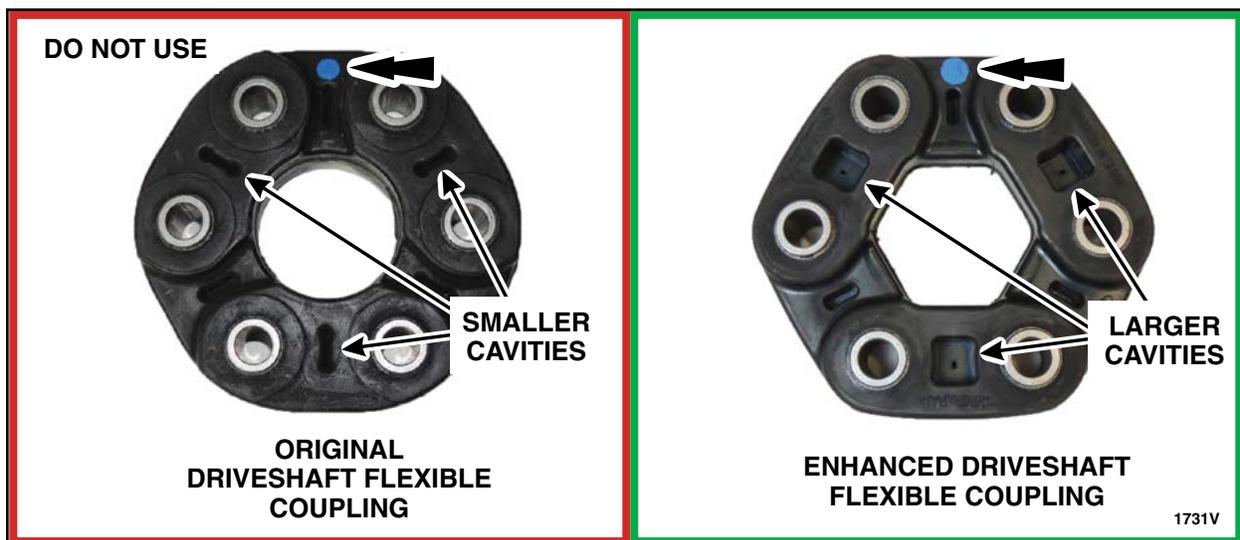
FIGURE 15

1. Replace the Driveshaft Flexible Coupling. Please follow the WSM procedures in Section 205-01.
 - To assist with the removal of the driveshaft flexible coupling-to-transmission output flange bolts, the use of a Mini-Ductor™ induction heating tool, or equivalent, is recommended.
 - The blue paint marking on the *new* driveshaft flexible coupling must be installed facing the transmission output flange or premature failure of the flexible coupling will occur. See Figure 15.

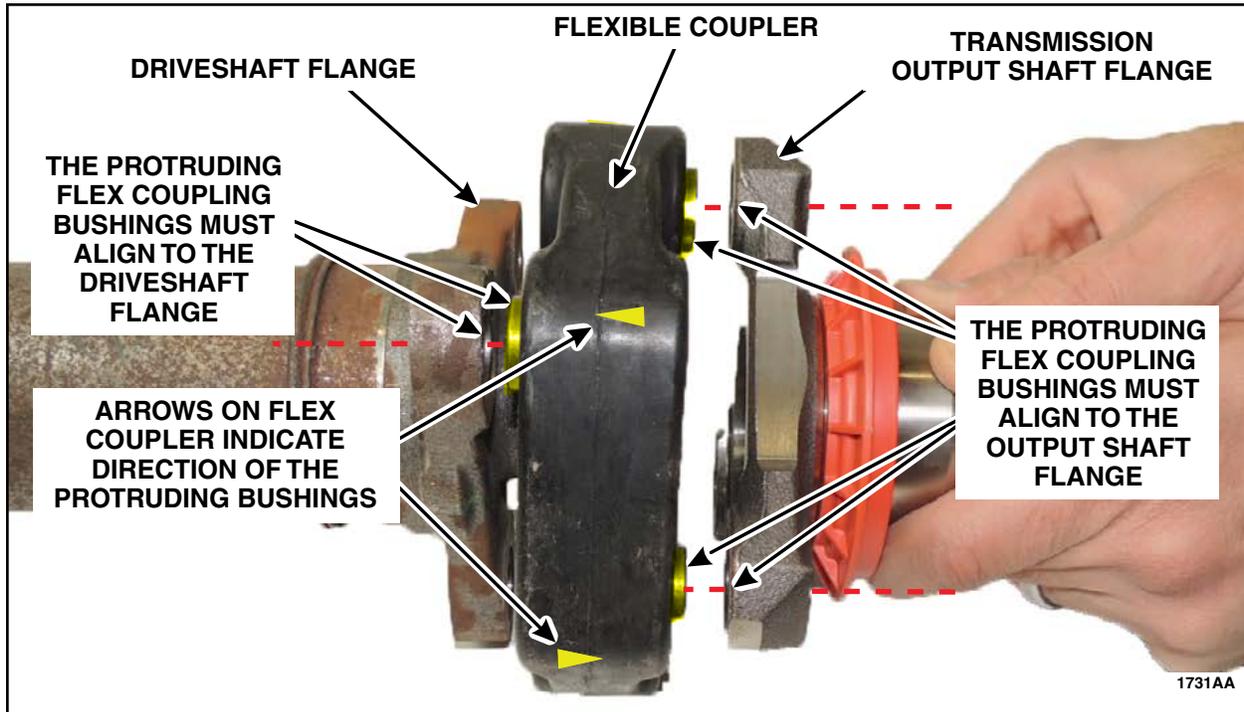
FIGURE 16

NOTE: There are six (6) bushings in the coupler. Three (3) bushings protrude forward and three (3) protrude rearward and they must interlock with each flange. See Figure 16.

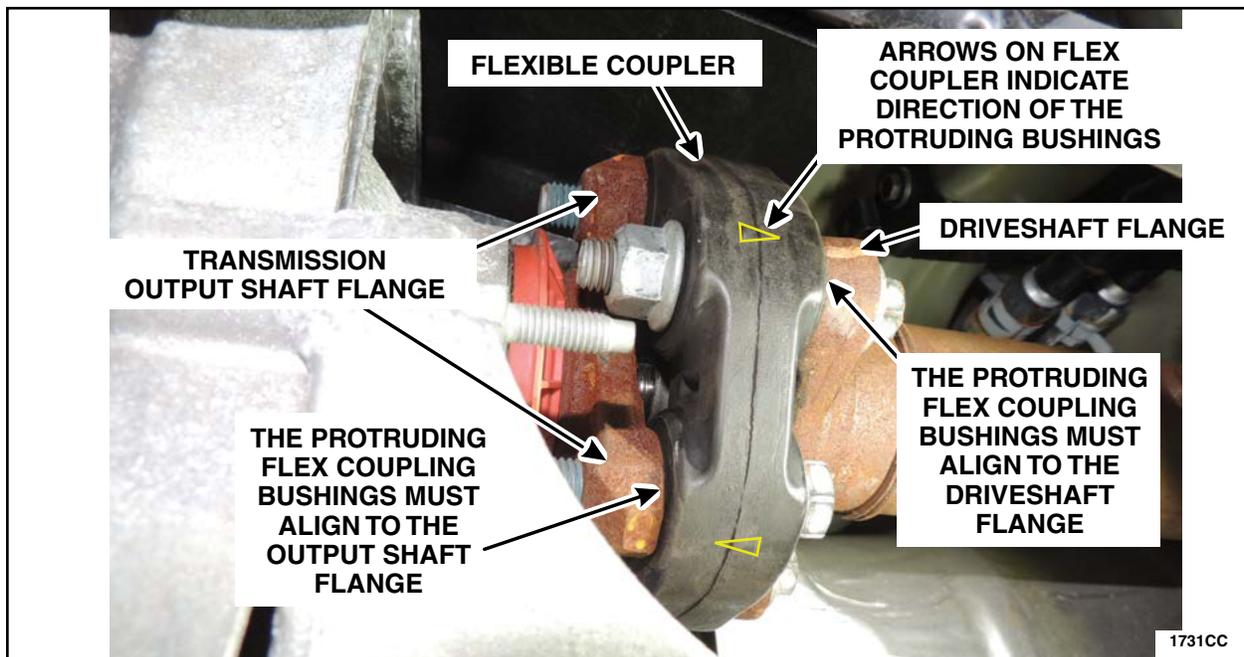
FIGURE 17

NOTICE: The flex coupler must be installed with the blue paint mark facing the transmission output flange. The protruding flex coupler bushings must align with the driveshaft flange and transmission output flange. Arrows should point at the ears of each flange shown in Figure 17.

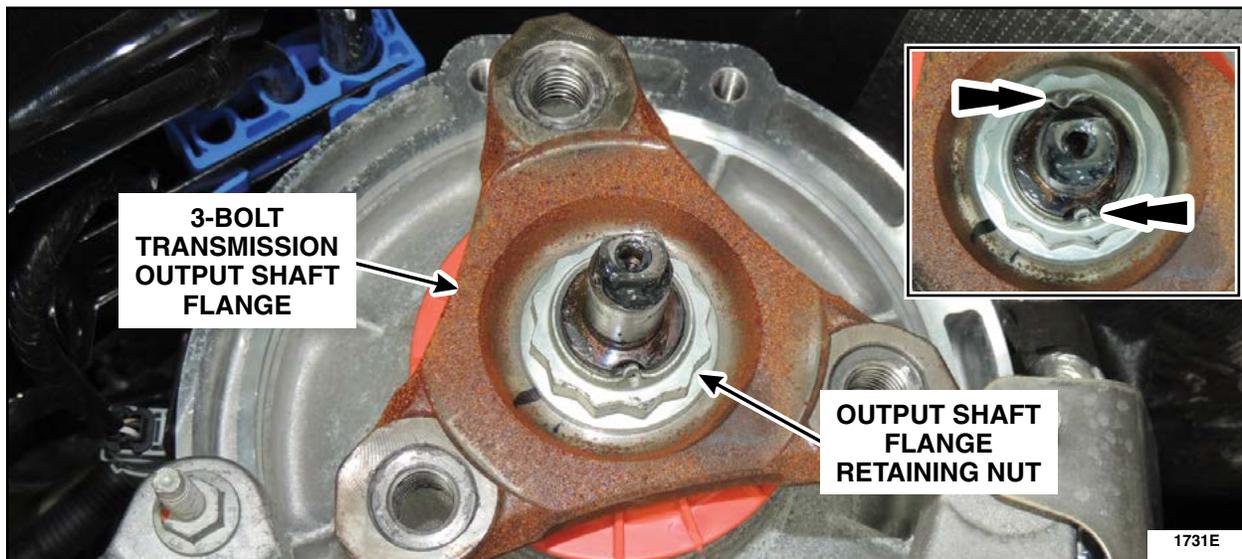
FIGURE 18

1. Remove the driveshaft assembly. Please follow the WSM procedures in Section 205-01.
2. Using a 1/2" drive, 34mm, 12-point deep socket, remove and discard the 3-bolt transmission output shaft flange retaining nut and flange. See Figure 18.

NOTICE: The output shaft flange retaining nut has been staked to prevent it from coming loose. Prior to removing the nut, remove the stake to prevent damage to the output shaft.

- a. Remove the output shaft flange retaining nut stakes.
- b. Place the vehicle in the PARK position and remove and discard the output shaft flange retaining nut.
- c. Remove and discard the 3-bolt transmission output shaft flange.

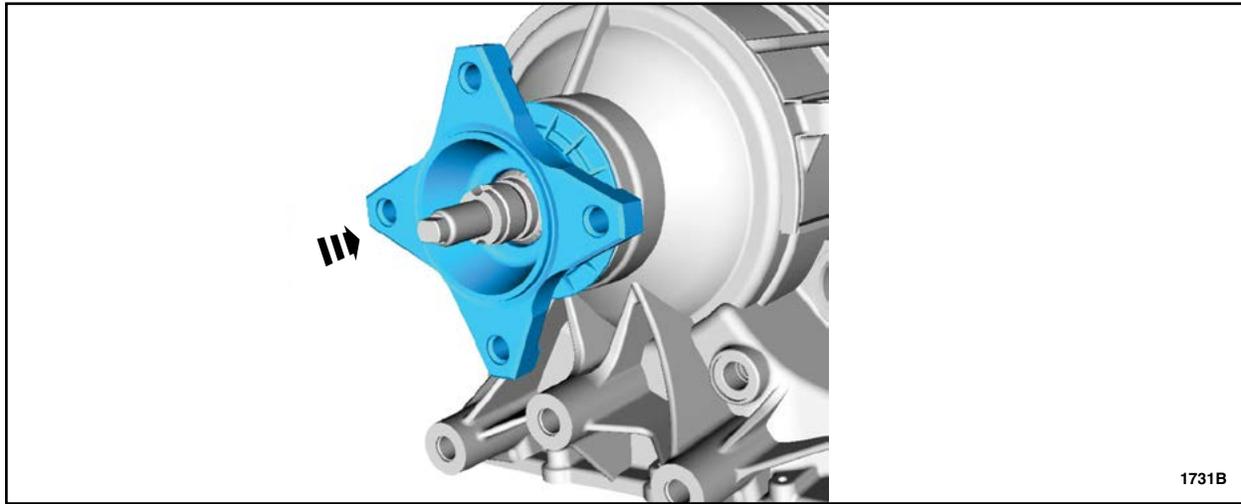
FIGURE 19

- Using a 1/2" drive, 34mm, 12-point deep socket, install a *new* 4-bolt transmission output shaft flange and retaining nut. See Figures 19 and 20.

- Install a *new* 4-bolt transmission output shaft flange.
- Install a *new* output shaft flange retaining nut.
 - Tighten nut to 59 lb.ft (80 Nm).
- Stake the output shaft flange retaining nut.

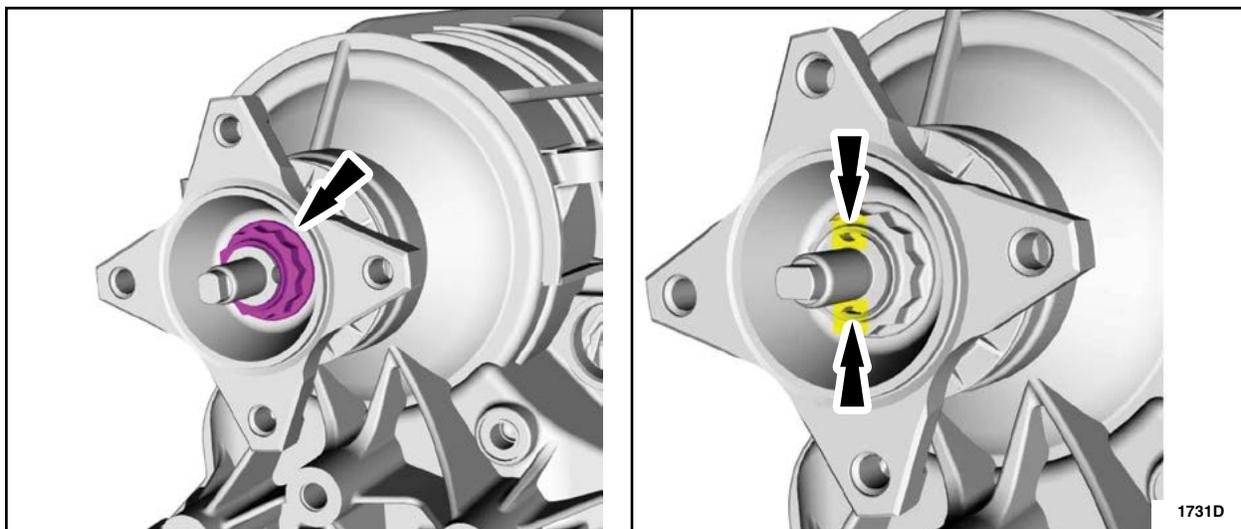
FIGURE 20

NOTICE: The output shaft flange retaining must be staked to prevent it from coming loose.

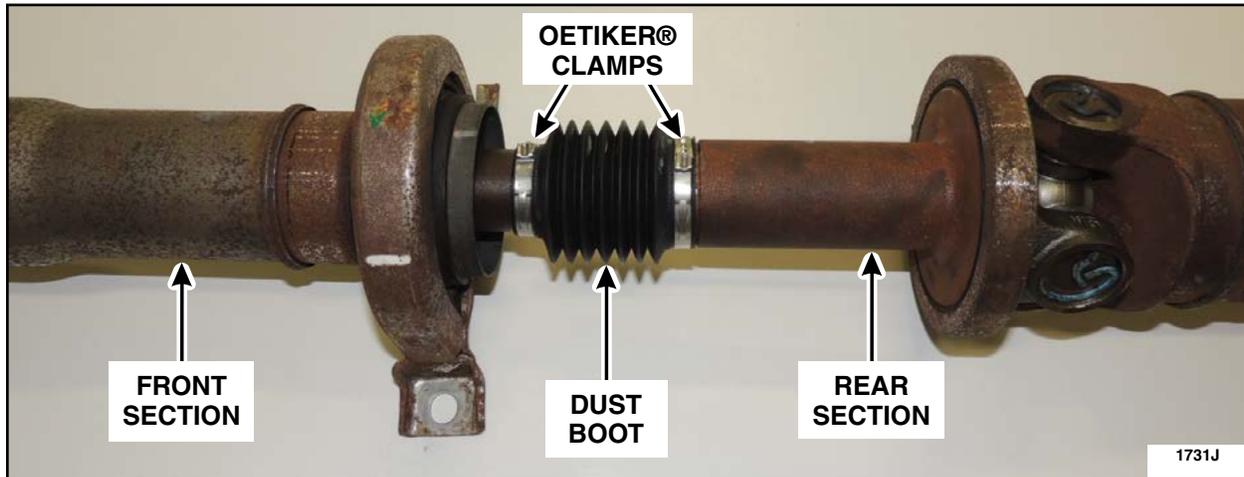
FIGURE 21

1. Separate the driveshaft front and rear sections at the driveshaft slip yoke. See Figure 21.
 - a. Cut and discard both dust boot Oetiker® clamps.
 - b. Separate the driveshaft front and rear sections.
 - c. Remove and discard the dust boot.

2. Install a *new* driveshaft front section onto the rear section. See Figures 21 and 22.
 - a. Slide a *new* slip yoke dust boot and both Oetiker® clamps over the driveshaft rear section.
 - b. Lubricate the front section splines using 10-20 grams (0.35 - 0.7 oz) of Motorcraft® XG-8 PTFE Lubricant.
 - c. Attach the driveshaft front and rear sections. Make sure the front and rear driveshaft spline keys are aligned when mating the two sections together.
 - d. Make sure the slip yoke dust boot is properly aligned over each driveshaft section and tighten the dust boot Oetiker® clamps.

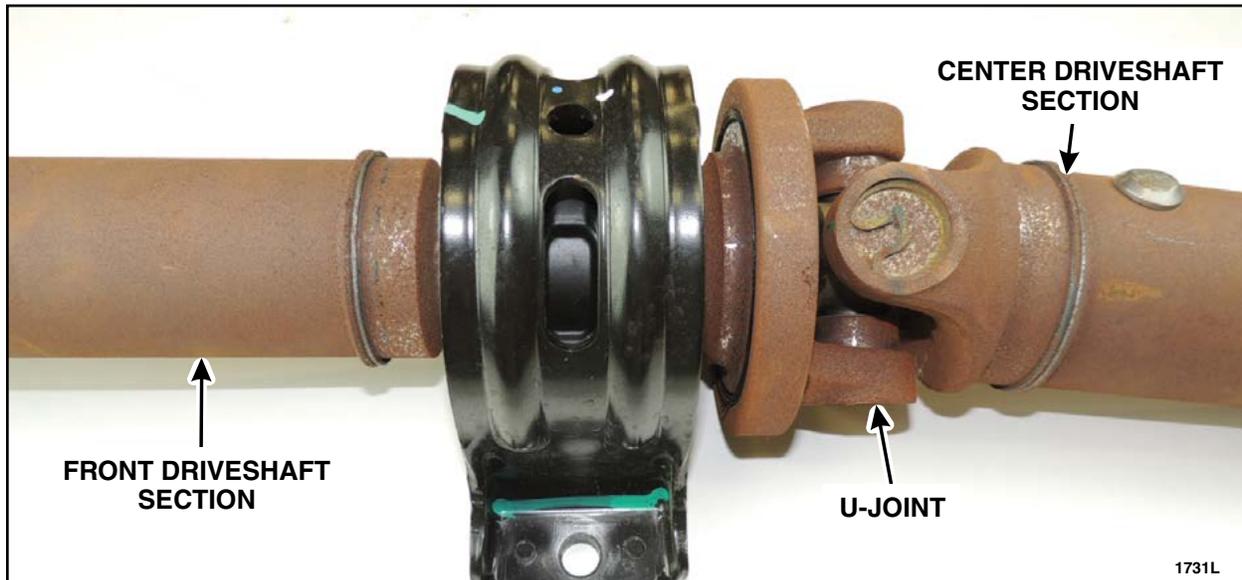
FIGURE 23

1. Remove and discard the four snap rings and center u-joint to separate the front driveshaft section from the center section. Please follow the universal joint kit instructions. See Figure 23.

2. Install a *new* center u-joint and snap rings to attach the front driveshaft section to the center section. Please follow the universal joint kit installation instructions.
3. Install the driveshaft assembly. Please follow the WSM procedures in Section 205-01.

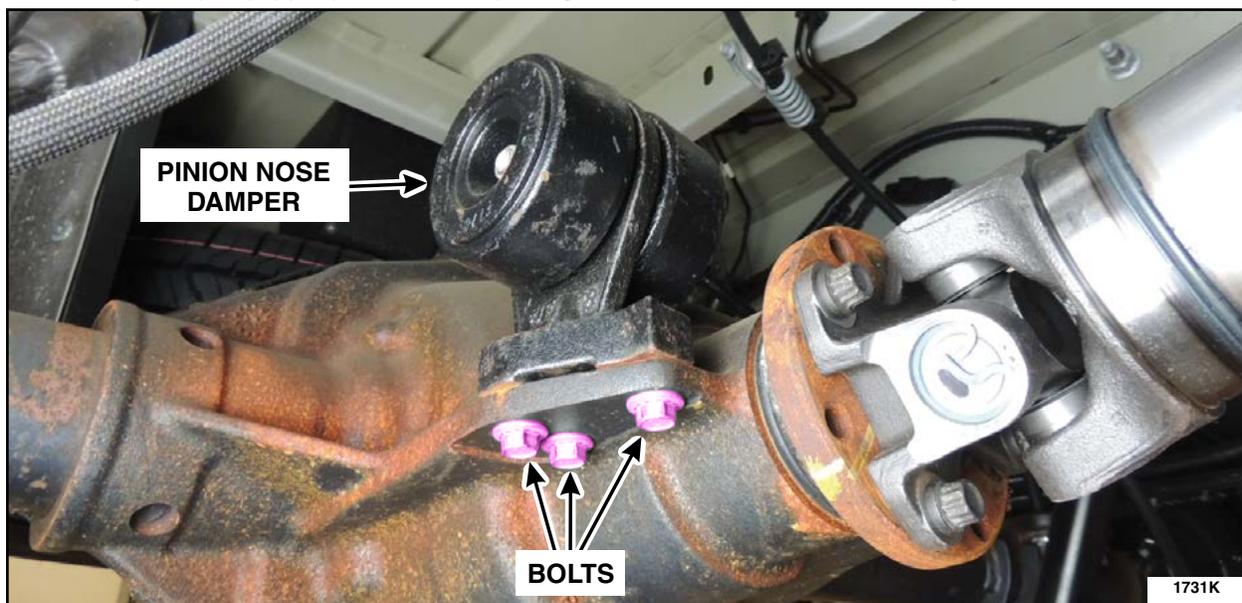
FIGURE 24

1. If a pinion nose damper is present, remove and discard the three bolts and the original pinion nose damper located on the RH side of the rear axle center housing. See Figure 24.
2. Install a *new* pinion nose damper and tighten the three bolts. See Figure 24.
 - Tighten bolts to 46 lb.ft (62 Nm).

NOTE: Original pinion nose damper is shown. *New* pinion nose damper may appear similar to the original (if equipped), but the dampening characteristics have been changed.
