RE: **Recall Campaign Launch Notification**
Implausible Seatbelt Detection
MY18-19 213, 253, 257, 290, 463 (CLS-Class, E-Class, G-Class, GLC-Class, GT-Class)

Campaign No. 2020020017, March 2020

SUBJECT: **Models Various**
Model Year 2018-2019
Implausible Seat Belt Detection

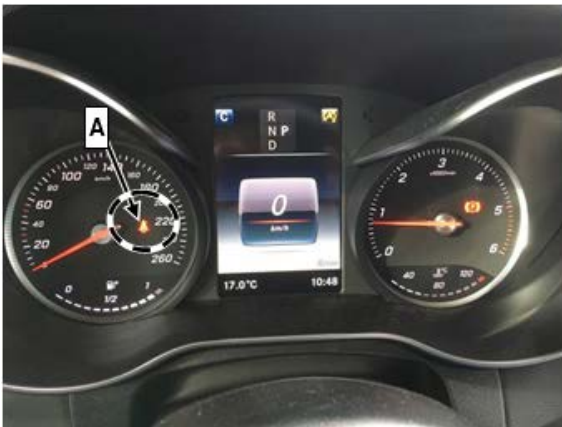
Figure 1

2. Start the engine.
 - 2.1. After the engine starts, wait until the indicator lamps in the instrument cluster go out.
 - 2.2. The fasten seat belts symbol (**A, figure 1**) is illuminated.

- a. The indicator lamp **(A)(figure 1)** does *not* go out when the test is carried out using the **correct** driver's side seat belt tongue: Carry out **work procedure 1**.
- b. The indicator lamp **(A)(figure 1)** goes out when the test is carried out using the **correct** driver's side test seat belt tongue: Carry out **check/test procedure B**.

- c. The indicator lamp (**A**)(**figure 1**) does **not** go out when the test is carried out using the **correct** front passenger side seat belt tongue: Carry out **work procedure 2**.
- d. The indicator lamp (**A**)(**figure 1**) goes out when the **correct** front passenger side seat belt tongue is used for testing: **End measure**.

i Replace the driver's side seat belt buckle only if the indicator lamp (A) does not go out after having been tested correctly.

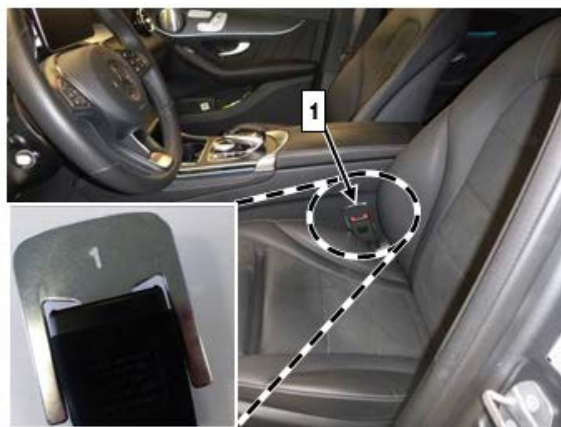
Figure 2

- 2.3. The engine must be running during the entire test.
 - 2.4. As the first step, the correct test seat belt tongue needs to be determined.
3. Insert test seat belt tongues (beginning with test seat belt tongue 1) into the driver's side seat belt buckle in accordance with the test sequence specification (1, figure 2).

- i** The following specification must be followed in order to find the correct test seat belt tongue.
 - i** **ATTENTION: Pay attention to the insertion direction of the test seat belt tongue.** The number of the test seat belt tongue must face the sitting surface of the vehicle occupant (figure 2), and the seat belt tongue must be inserted so that it is straight (not misaligned).

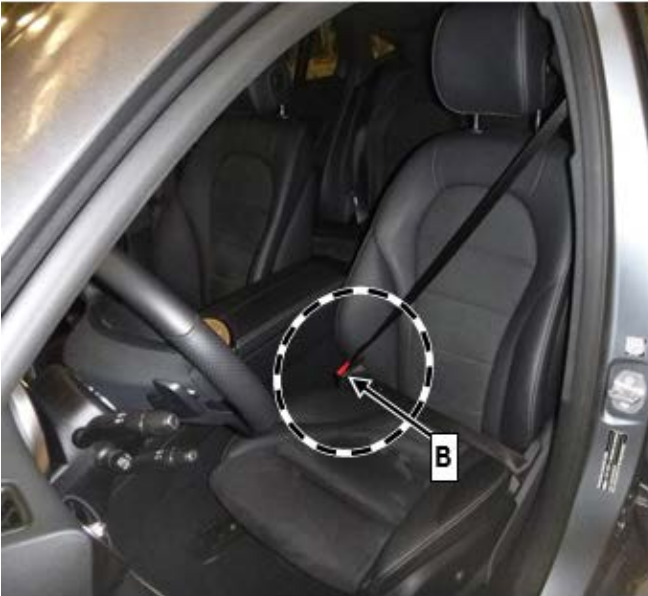
Figure 3

4. Insert seat belt **(B, figure 3)** into the **driver's side** seat belt buckle.

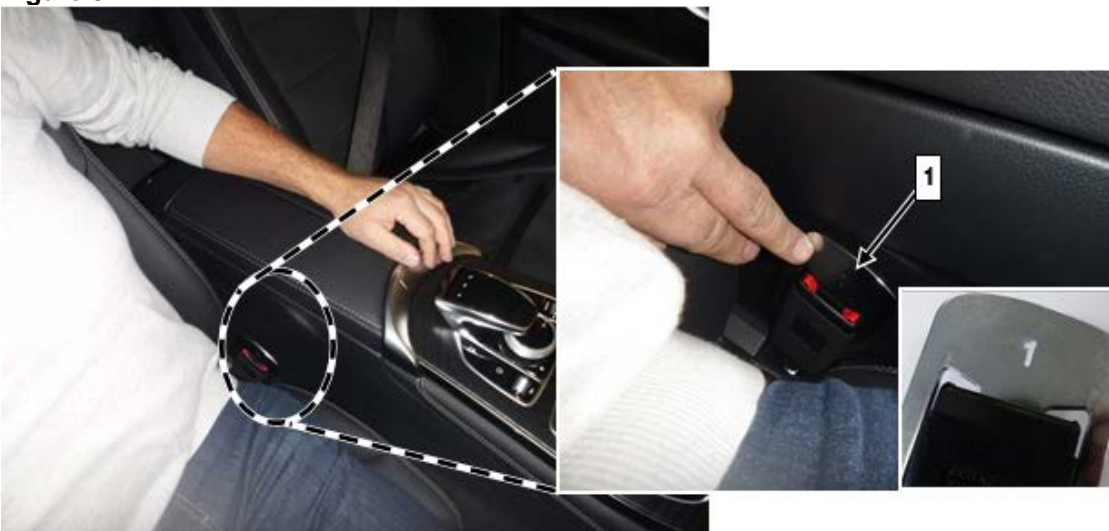
Figure 4

6. Insert test seat belt tongues (**beginning with test seat belt tongue 1**) into the front passenger side seat belt buckle in accordance with the specification of the test sequence (**1, figure 4**).

i **ATTENTION: Pay attention to the insertion direction of the test seat belt tongue.** The number of the test seat belt tongue must face the sitting surface of the vehicle occupant (figure 4), and the seat belt tongue must be inserted so that it is straight (not misaligned).
