## PRODUCT CAMPAIGN BULLETIN

**APPLICABILITY:** 2019MY Ascent  
2019MY Crosstrek Hybrid (PHEV)  
2019MY Forester

**SUBJECT:** PCV Valve- Design Change

**NUMBER:** WUW-08R  
**NHTSA ID:** 19V-856  
**DATE:** 12/04/19  
**REVISED:** 10/13/21

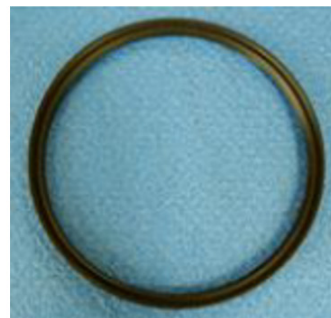
A Service Parts Kit, **p.n. X1181AA010** for use on **ASCENT** models only is now available. The kit will consist of a new PCV valve and the 2- **one-time use** o-rings required to be replaced when removing the intercooler assembly.

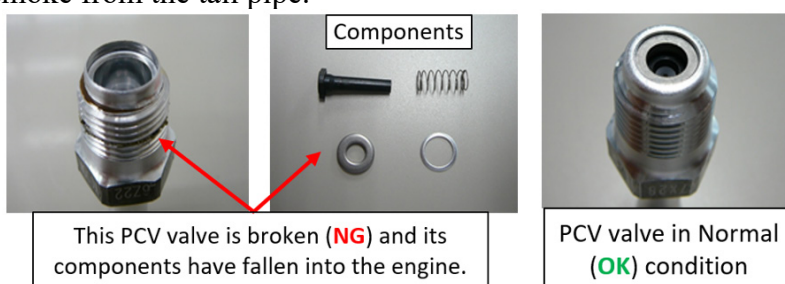
The PCV Valve on the affected models listed above may have been produced improperly. If the PCV Valve is broken, its internal components may have fallen into the engine. This may result in a large amount of white smoke from the tail pipe.

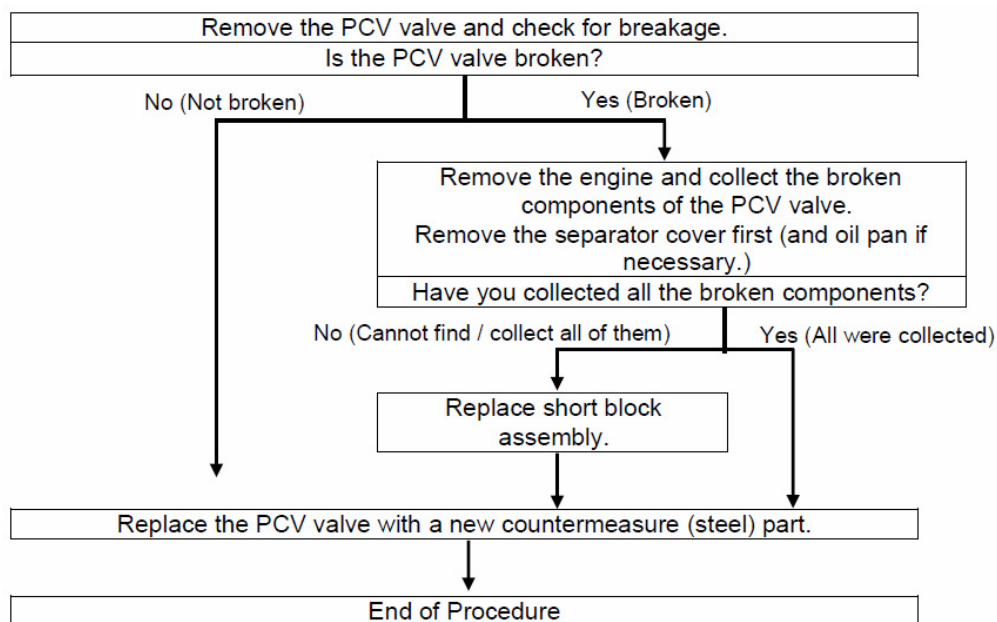
**Flow Chart:**

**Step 1:** Remove the PCV Valve following the procedure in the applicable Service Manual.

- If the PCV valve is **BROKEN (NG)**, proceed to **Step 2** and remove the engine following the procedure in the applicable Service Manual.
- If the PCV valve is **OK (NOT broken)**, replace it with a new PCV valve to complete the procedure following the applicable Service Manual. Proceed to the Claim Reimbursement and Entry Procedures section.

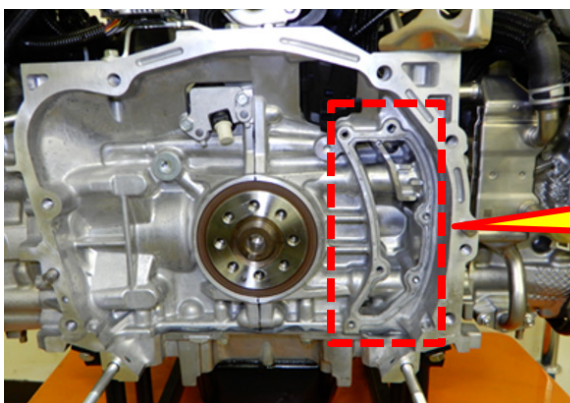
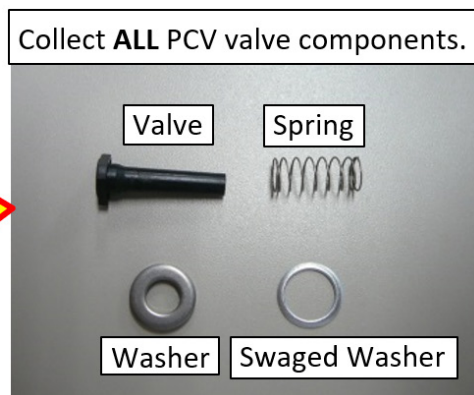
**Step 2:** Following the applicable Service Manual procedures, remove the oil separator cover and collect the PCV valve components (4 small parts) as shown in the photos below. If all four (4) of the PCV valve components cannot be collected after removing the oil separator cover, proceed with removing the oil pan to collect any remaining components.

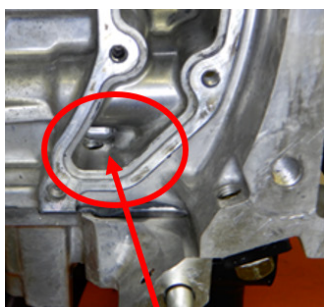
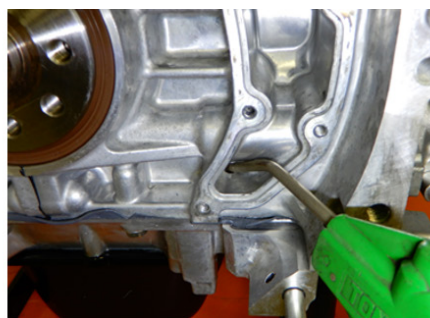
Oil Pan-side Passage

**TIP:** If any PCV valve components remain in the oil pan-side passage, apply compressed air to the oil pan side passage as shown below.

**CAREFULLY** blow air into the oil pan-side passage to collect the remaining PCV valve components.
