TO: Mercedes-Benz Dealer Principals, General Managers, Sales Managers, Service Managers, Parts Managers	FROM: Gregory Gunther, Department Manager, Vehicle Compliance and Analysis, Engineering Services
RE: Recall Campaign Launch Notification Check Sliding Roof Bonding – Phase 2 MY01-11 Various Models	DATE: July 10, 2020

Campaign No. 2020040011, June 2020

Phase 2 update 7/10/2020

SUBJECT: **Models C-Class, CLK-Class, E-Class, and CLS-Class (203, 209, 211, and 219 platform)**
Model Years 2006-2007
Sliding Roof Bonding - Phase 2

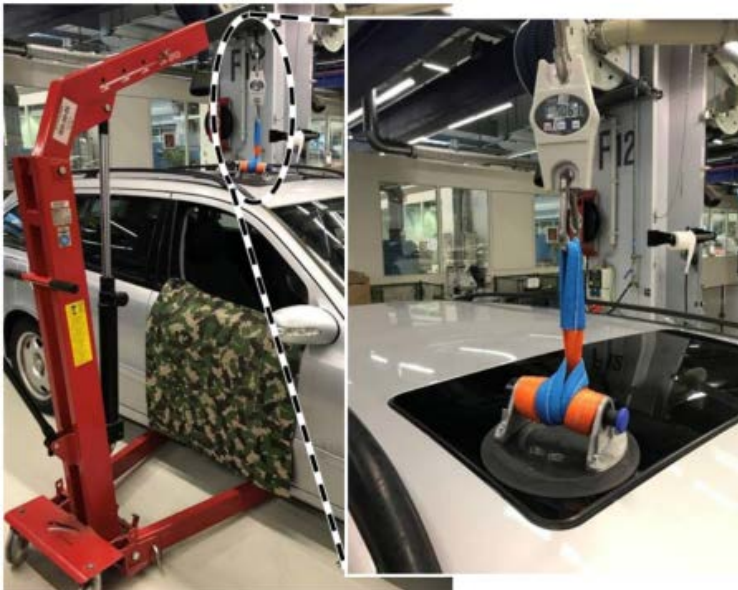
Figure 2

3. Position cup suction tool (**figure 2**) and pull as **vertically** as possible (tolerance of ± 10 degrees) using lifting tool.
