TECHNICAL INSTRUCTIONS

SAFETY RECALL G0P/G0R/H0A FRONT PASSENGER AIRBAG INFLATOR MODULE CERTAIN 2011-2014 MODEL YEAR SIENNA

Updated 01-14-2021

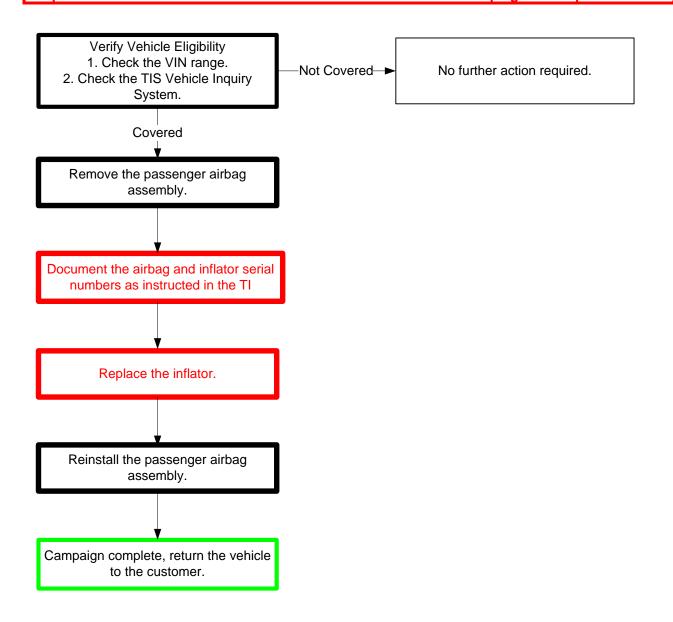
I. OPERATION FLOW CHART

The flow chart is for reference only. *DO NOT* use it in place of the full technical instructions. Follow *ALL* steps as outlined in the full technical instructions to confirm the campaign is completed correctly.

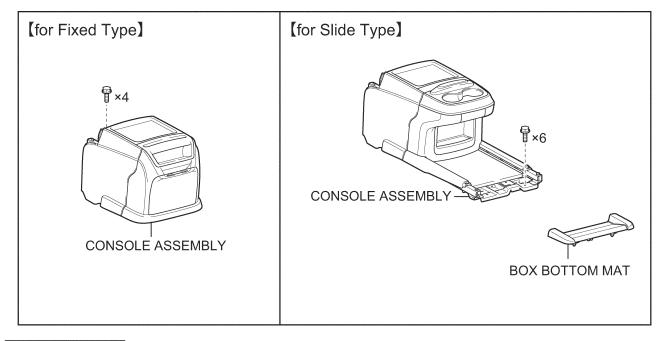
R1701060003

N*m (kgf*cm, ft.*lbf) : Specified torque

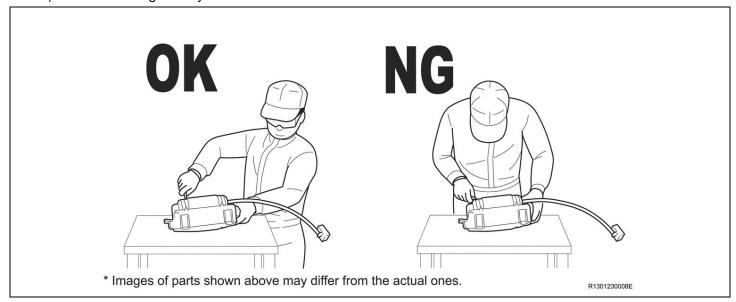
- a) Carefully place the airbag on the bench inflator side up.
 - NOTE: Place clean sheet(s) of paper on the bench to protect the airbag.
- b) Avoid standing directly over the inflator.

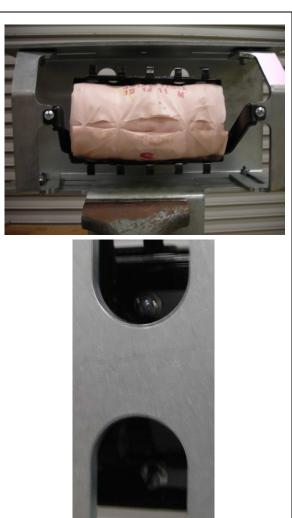
e) Mark all 5 nuts so they will not be reused.

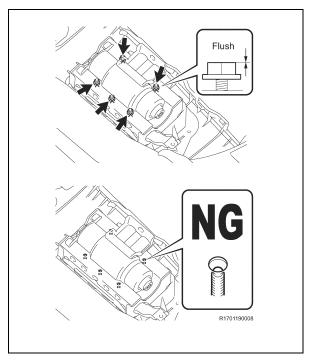
f) Mount the airbag into the mounting bracket as shown.

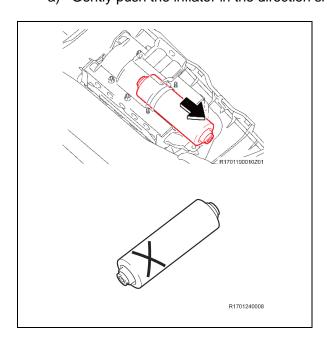
a) Gently push the inflator in the direction shown.

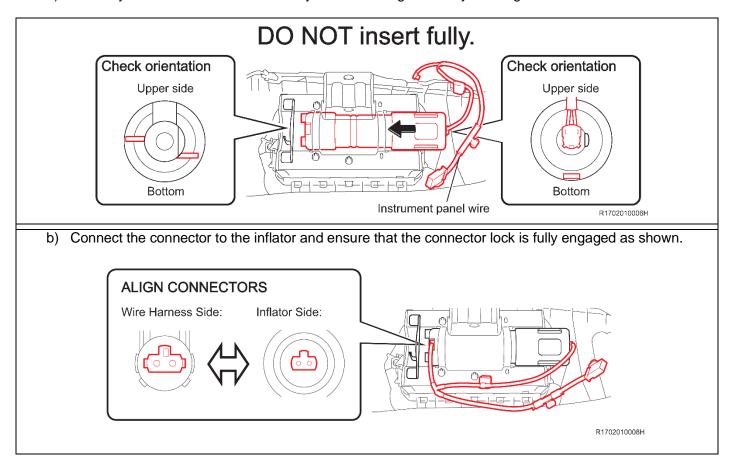
a) Carefully slide the new inflator half way into the airbag assembly and align as shown.

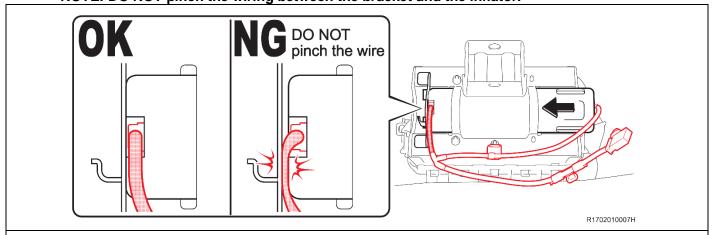
a) Fully insert the inflator and ensure that the inflator is correctly orented as shown. NOTE: DO NOT pinch the wiring between the bracket and the inflator.

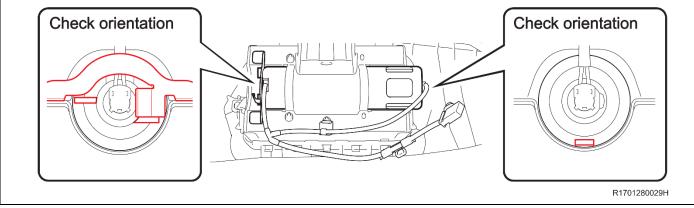
NOTE: Ensure the inflator is correctly oriented.

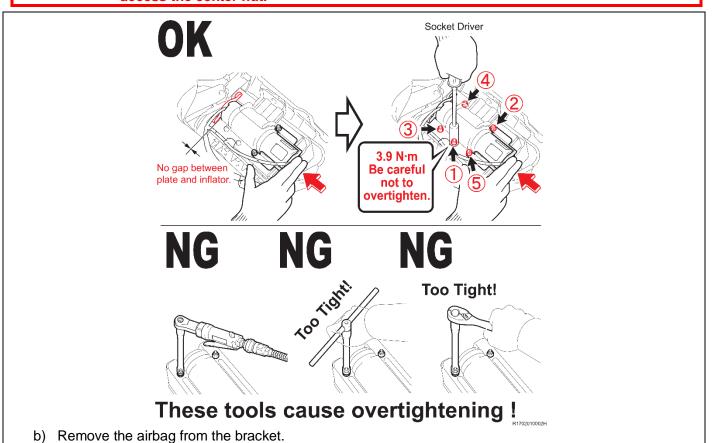
a) Tighten the 5 nuts evenly in several increments in the sequence shown. Use a socket driver or torque wrench to tighten the nuts.

Torque: 35in. lbf (40 kgf.cm,3.9N·m)

- There will be some resistance when tightening the nuts because they are self-locking, confirm the nuts are tightened correctly.
- DO NOT use a power tool, T-handle, or ratchet when tightening the nuts to avoid over torqueing and deforming the studs.
- You may need to turn the airbag to the left or right with in the mounting bracket to access the center nut.

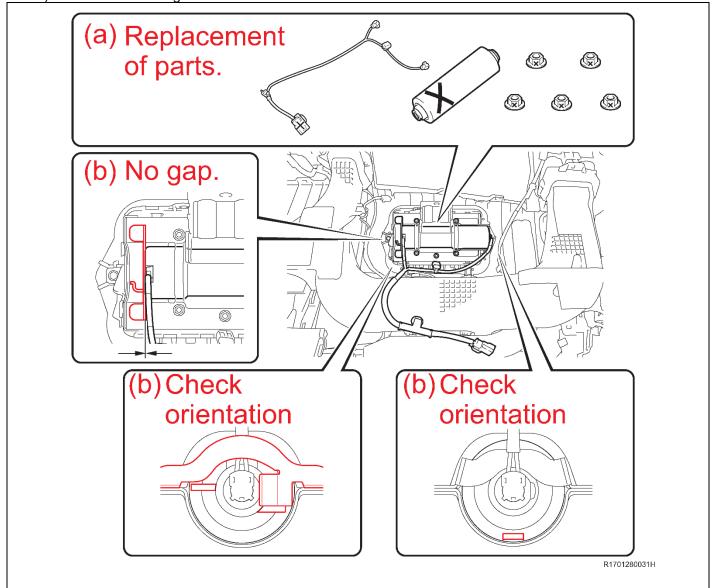
- a) Confirm the **NEW** inflator and 5 **NEW** nuts have been installed.
- b) Confirm the position of the inflator and position determining plates are correct.
- c) Confirm the routing of the inflator wire harness.
