IMPORTANT UPDATE

**TECHNICAL INSTRUCTIONS
FOR
SAFETY RECALL GLG/GLH/HLA
FRONT PASSENGER AIRBAG MODULE
CERTAIN 2007 – 2012 MY ES 350
Updated 01-14-2021**

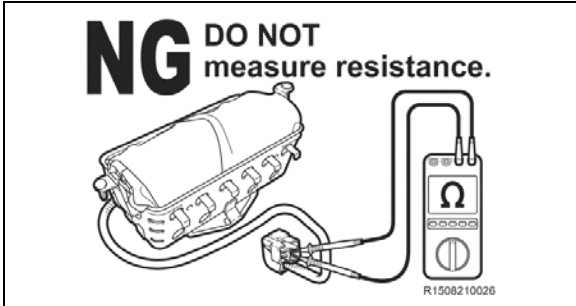
2. DO NOT MEASURE RESISTANCE

- a) **NEVER** measure the resistance of an airbag, this may cause accidental activation.

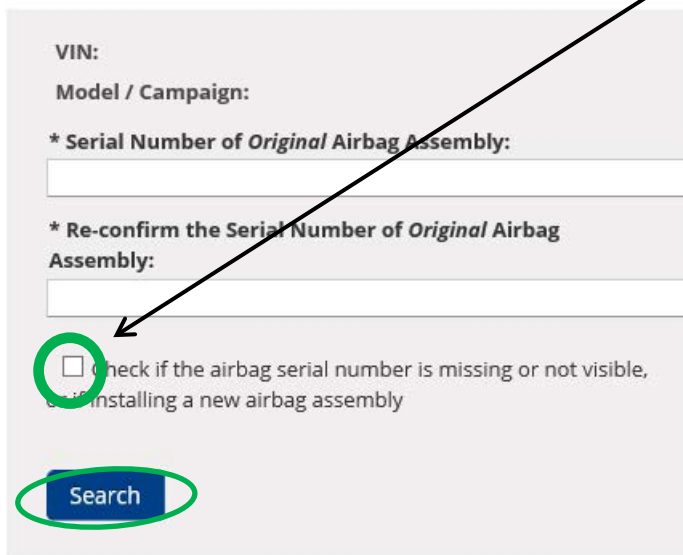
ORIGINAL Airbag Assembly Serial Number

- The airbag serial number is **ALWAYS** the 12 **DIGITS** located between the asterisks.
- The 3 digits before the asterisk **ARE NOT** part of the serial number, and **SHOULD NOT** be entered or an inaccurate response may be returned.

Scan or enter the **original** Airbag Assembly serial number into the website.

A screenshot of a web form for entering the original airbag assembly serial number. The form includes fields for VIN, Model / Campaign, and two fields for the serial number. A checkbox is checked, and a "Search" button is highlighted with a green oval. A black arrow points from the checkbox to the photograph of the airbag module on the right.
