TECHNICAL INSTRUCTIONS FOR SAFETY RECALL G0P/G0R/H0A FRONT PASSENGER AIRBAG INFLATOR MODULE CERTAIN 2009 – 2013 MODEL YEAR COROLLA

Updated 01-14-2021

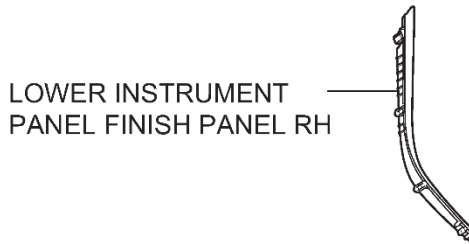
w/ Curtain Shield Airbag:

● : Replacement part

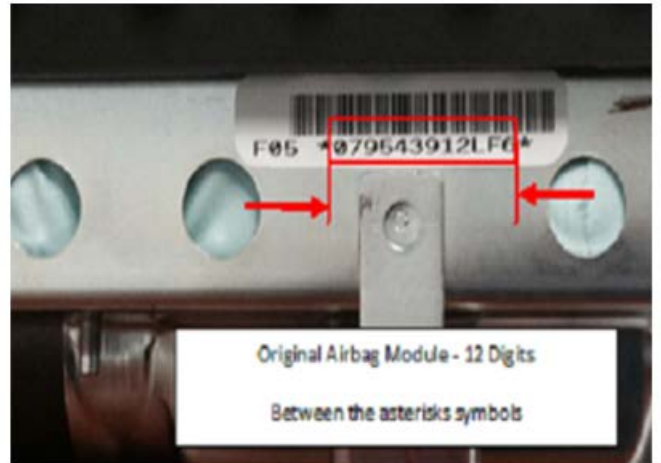
* Re-confirm the Serial Number of *Original Airbag Assembly*:

Check if the airbag serial number is missing or not visible, or if installing a new airbag assembly

AIRBAG SERIAL NUMBER IS MISSING OR IS UNREADABLE

NOTE: Skip this section and jump to Section X if the airbag assembly is scannable

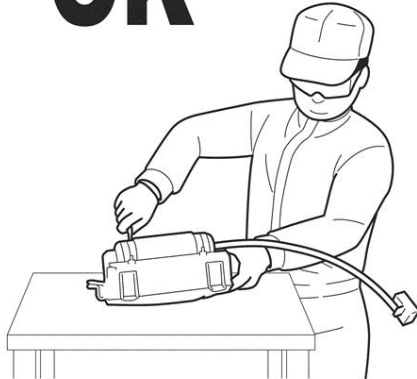
OK

b) Avoid standing directly over the inflator.

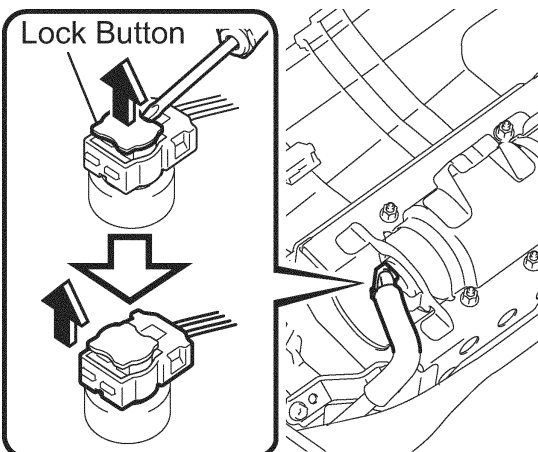
Lock Button

a) Use a screwdriver to release the lock button.

b) Disconnect the connector.

c) Disconnect the wire harness clamps.

NOTE: Disconnect the connector where the fixed stop plate is located.

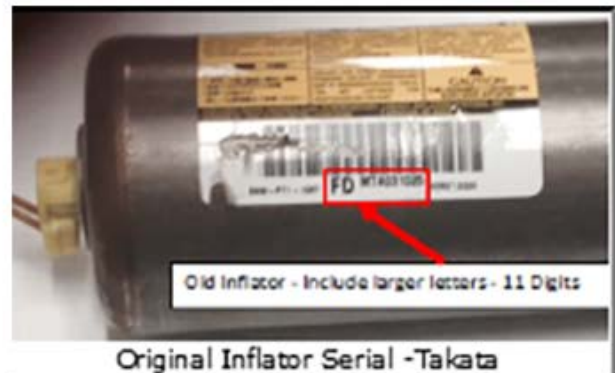
Check if the inflator serial number is missing or not visible, OR if installing a new airbag assembly

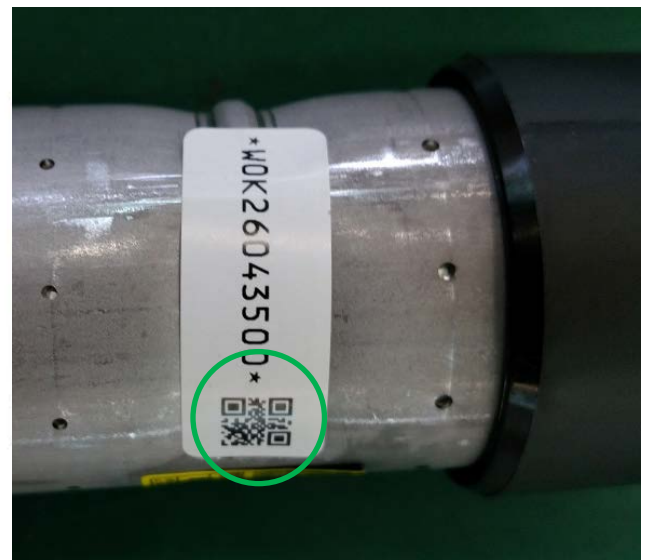
REPLACEMENT Inflator Serial Number

Scan or enter the **replacement** Inflator serial number into the website.

* Serial Number of **Replacement** Inflator:

* Re-confirm the Serial Number of **Replacement** Inflator:
