TECHNICAL INSTRUCTIONS FOR SAFETY RECALL G0P/G0R/H0A FRONT PASSENGER AIRBAG INFLATOR MODULE CERTAIN 2009 –2013 MODEL YEAR MATRIX

Updated 1-9-2019

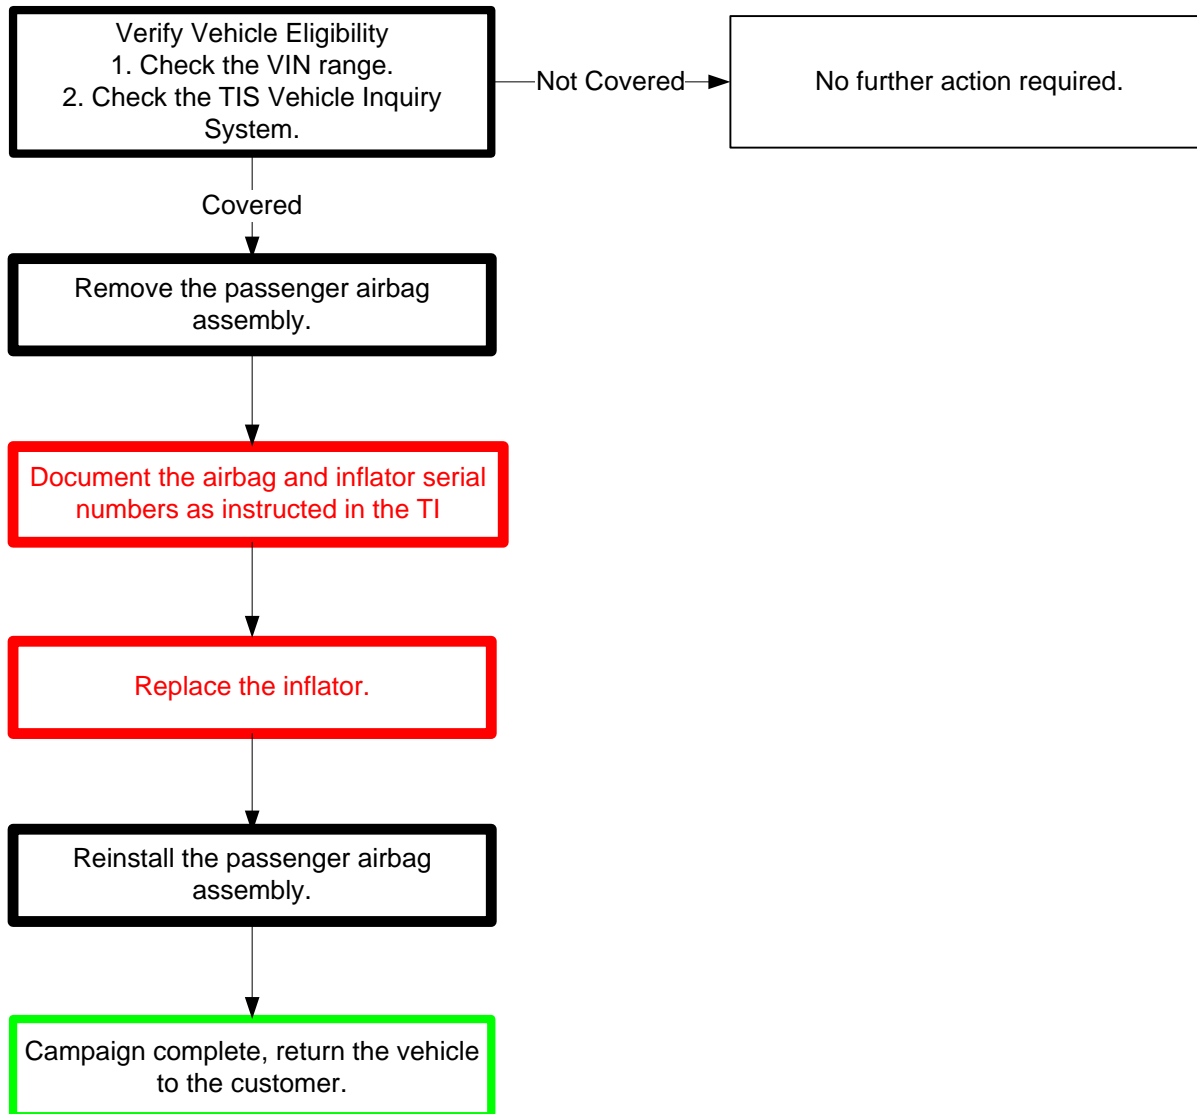
I. OPERATION FLOW CHART

The flow chart is for reference only. **DO NOT** use it in place of the full technical instructions. Follow **ALL** steps as outlined in the full technical instructions to confirm the campaign is completed correctly.

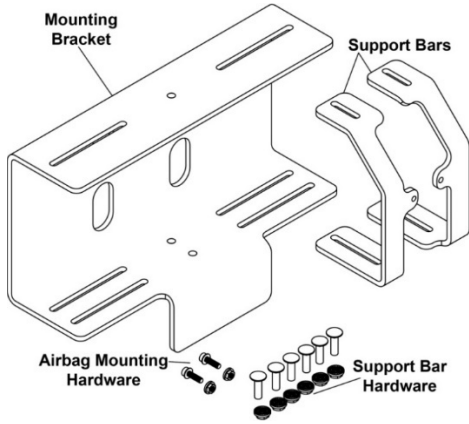
Airbag Mounting Bracket & hardware	1

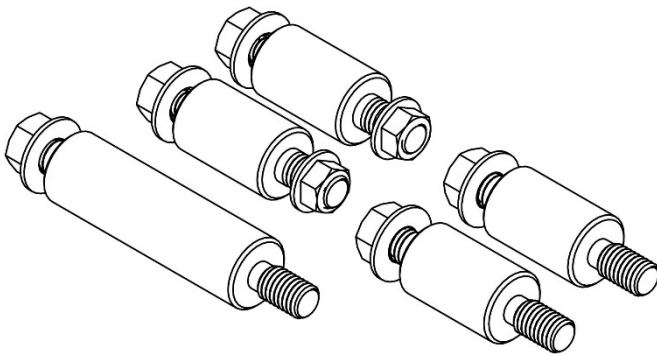
Adaptor set*	1

*The adaptor set was sent to dealers at the start of this campaign.

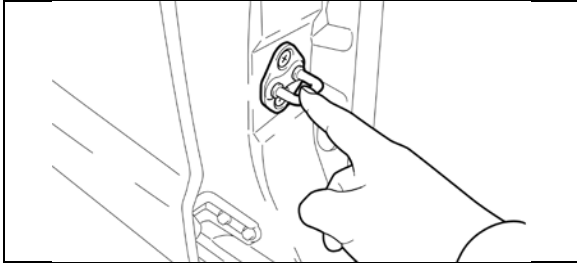
1. ELIMINATE STATIC ELECTRICITY

- Before starting work and periodically while working on the vehicle, touch a metallic part of the vehicle to discharge static electricity in the body.

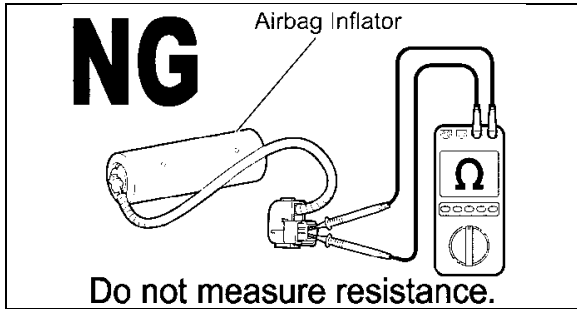
2. DO NOT MEASURE RESISTANCE

- DO NOT** measure resistance of airbag components, this may cause accidental activation.

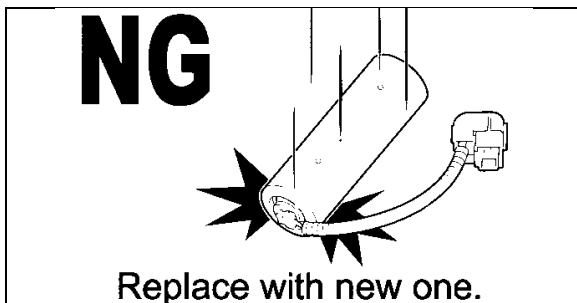
3. HANDLE THE AIRBAG CAREFULLY

- If an inflator is dropped, replace it with a **NEW** inflator.

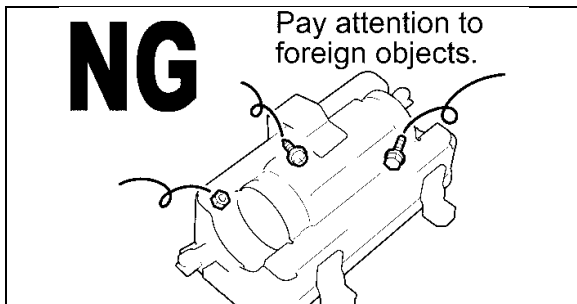
4. DO NOT ALLOW FOREIGN OBJECTS NEAR AIRBAG

- Be sure to collect and account for all removed nuts/bolts to prevent them from landing in the airbag assembly.
- Any foreign objects in the airbag assembly may cause damage or injury if the airbag is activated.

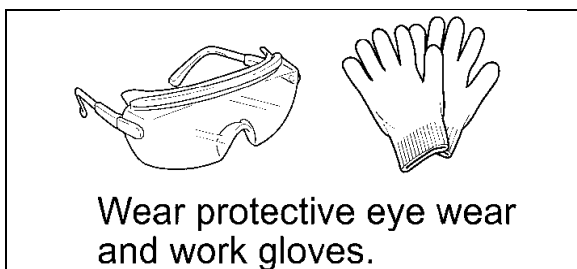
5. WEAR PROTECTIVE EQUIPMENT

- Always wear appropriate protective equipment when working on the SRS.

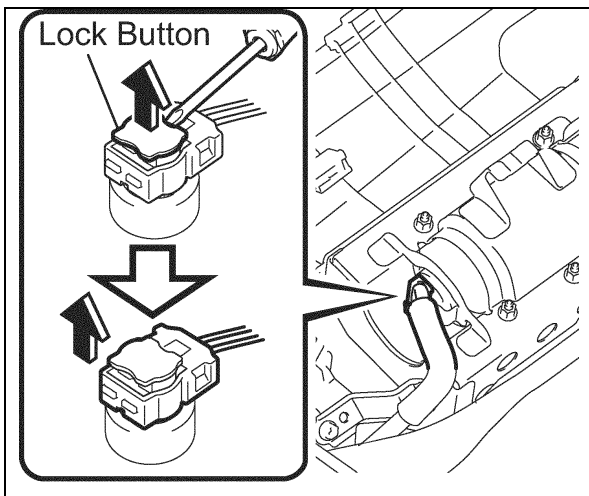
2. AIRBAG PREPARATION

- Use a screwdriver to release the lock button.
- Disconnect the connector.
- Disconnect the wire harness clamps.

NOTE: Disconnect the connector where the fixed stop plate is located.

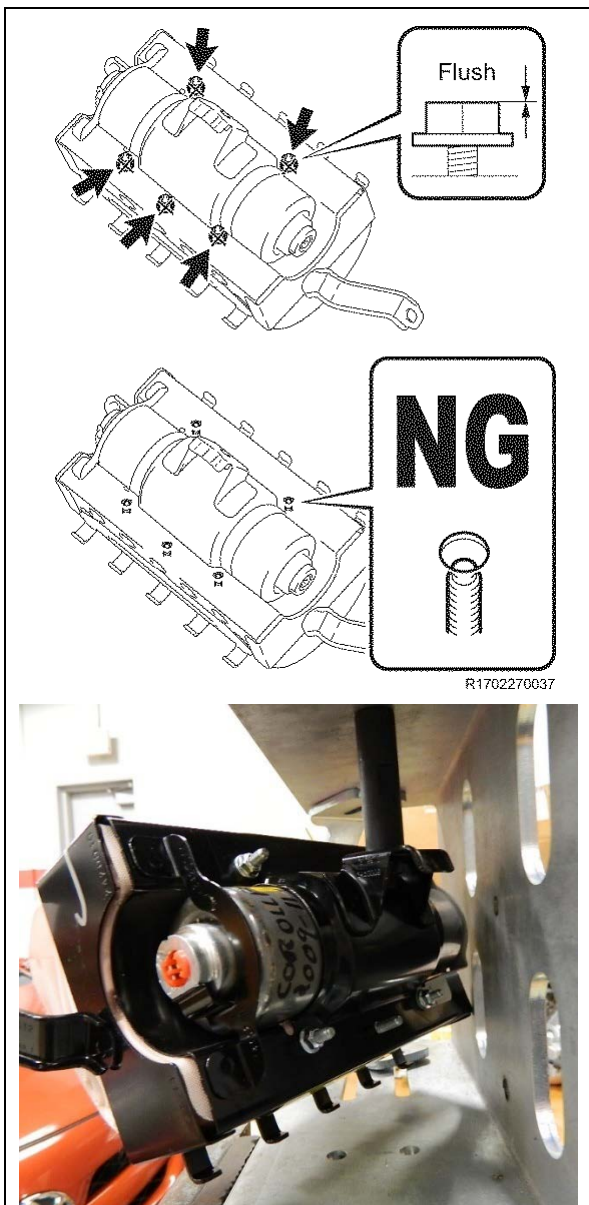
3. REMOVE THE SELF LOCKING NUTS

- a) Loosen the 5 nuts until the nuts are at the top of the studs as shown, through the openings in the mounting bracket.

Note: The airbag may need to be turned to the left or right to access the center nut.

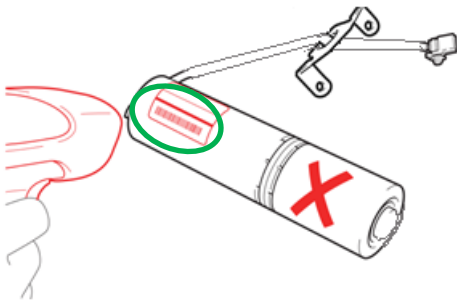
Step a) Old Inflator (bar code)

- Scan the **OLD** inflator bar code.
- Scan the **NEW** inflator QR code.

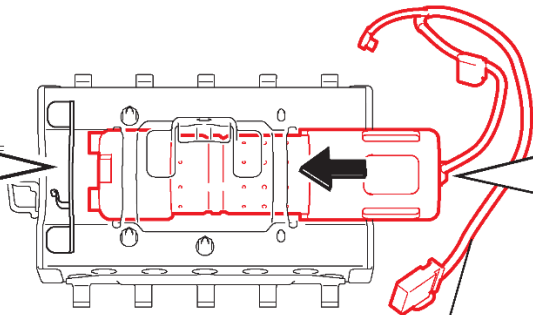
R1702270040

a) Carefully slide the new inflator into the airbag assembly and align as shown.

- **DO NOT** connect the inflator harness at this time. It is **CRITICAL** to first confirm that the inflator is installed in the correct position before connecting the harness.

DO NOT insert fully.

Check orientation

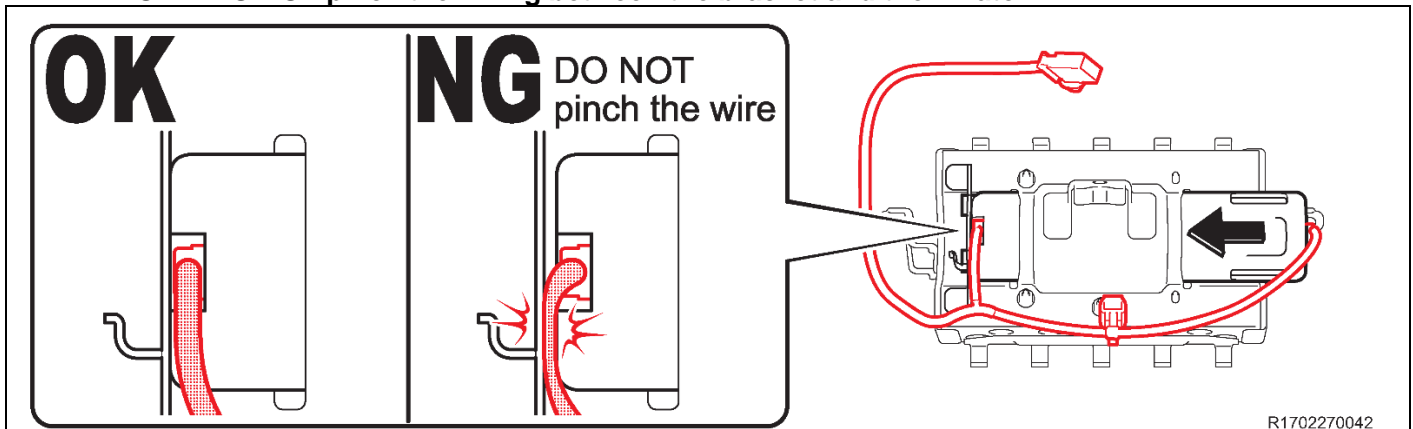
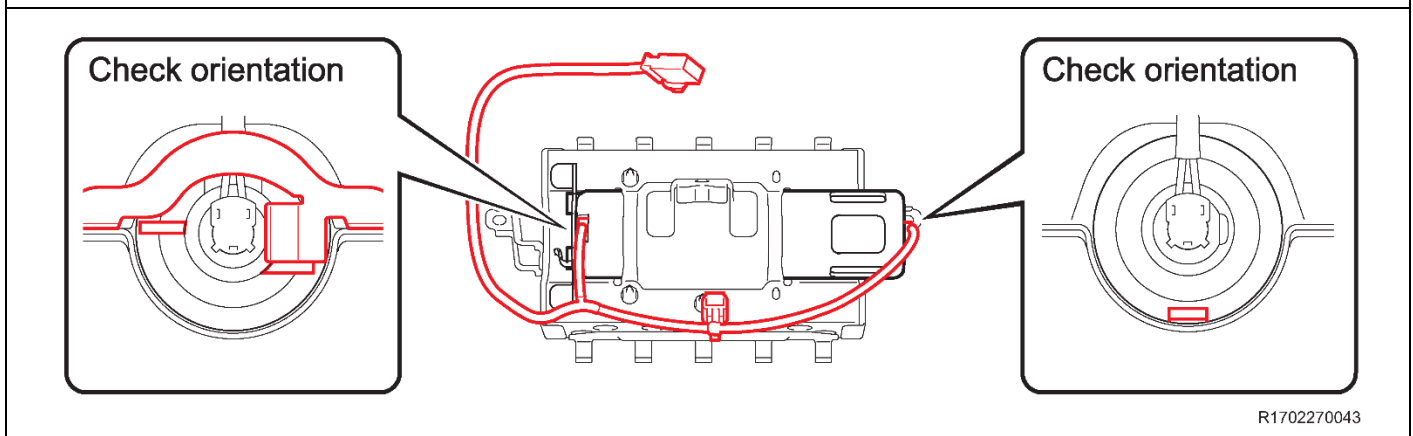
d) Fully insert the inflator and ensure that the inflator is correctly oriented as shown.

NOTE: DO NOT pinch the wiring between the bracket and the inflator.

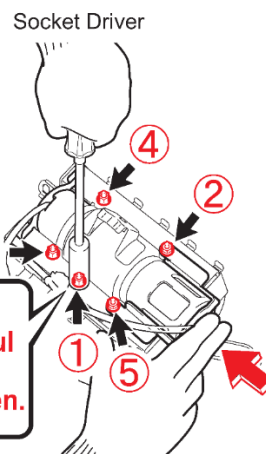
R1702270046

Torque: 35in. lbf (3.9N·m)

- There will be some resistance when tightening the nuts because they are self-locking, confirm the nuts are tightened correctly.
- **DO NOT** use a power tool, T-handle, or ratchet when tightening the nuts to avoid over torqueing and deforming the studs.
- You may need to turn the airbag to the left or right with in the mounting bracket to access the center nut.

3.9 N·m
Be careful
not to
overtighten.

These tools cause overtightening !

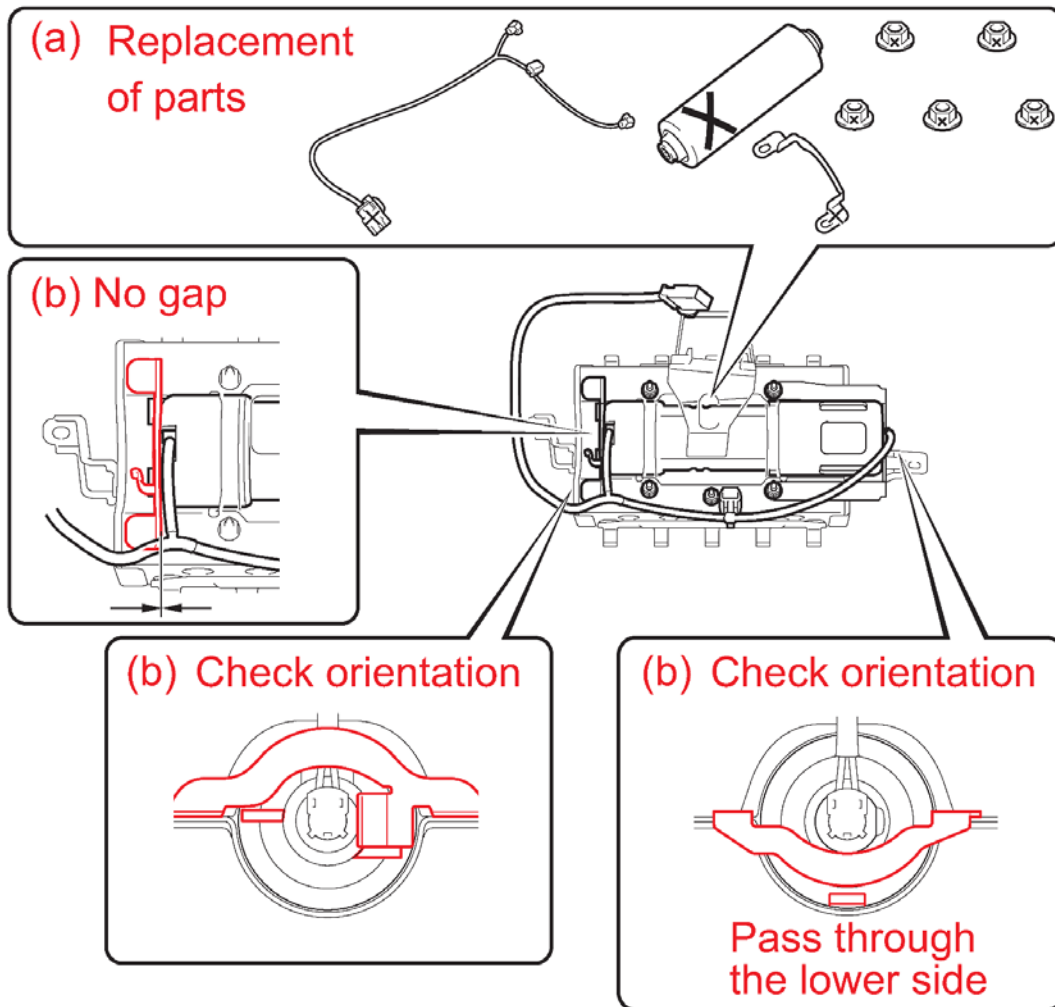
R1703080022

- a) Confirm the **NEW** inflator and 5 **NEW** nuts have been installed.
- b) Confirm the position of the inflator and position determining plates are correct.
- c) Confirm the routing of the inflator wire harness.
