Campaign No.2021040001, April 2021

**SUBJECT: Model E-Class Coupe and Cabriolet (C/A207) Vehicles  
Model Year 2012-2017  
Replace Front Passenger-side Airbag**

Based on the defect decision of TK Holdings, Inc. ("Takata"), in certain passenger side airbags produced by Takata used in certain Model Year 2012-2017 Mercedes-Benz vehicles, under specific circumstances, the front passenger-side airbag inflator housing may explode during deployment due to excessive internal pressure. This condition is more likely to occur if the vehicle has been exposed to high levels of absolute humidity for extended periods of time. A frontal passenger-side inflator explosion during deployment could result in sharp metal fragments striking the passenger or other occupants, possibly causing serious injury or death. To remedy this concern, an authorized Mercedes-Benz dealer will replace the front passenger-side airbag on the affected vehicles.

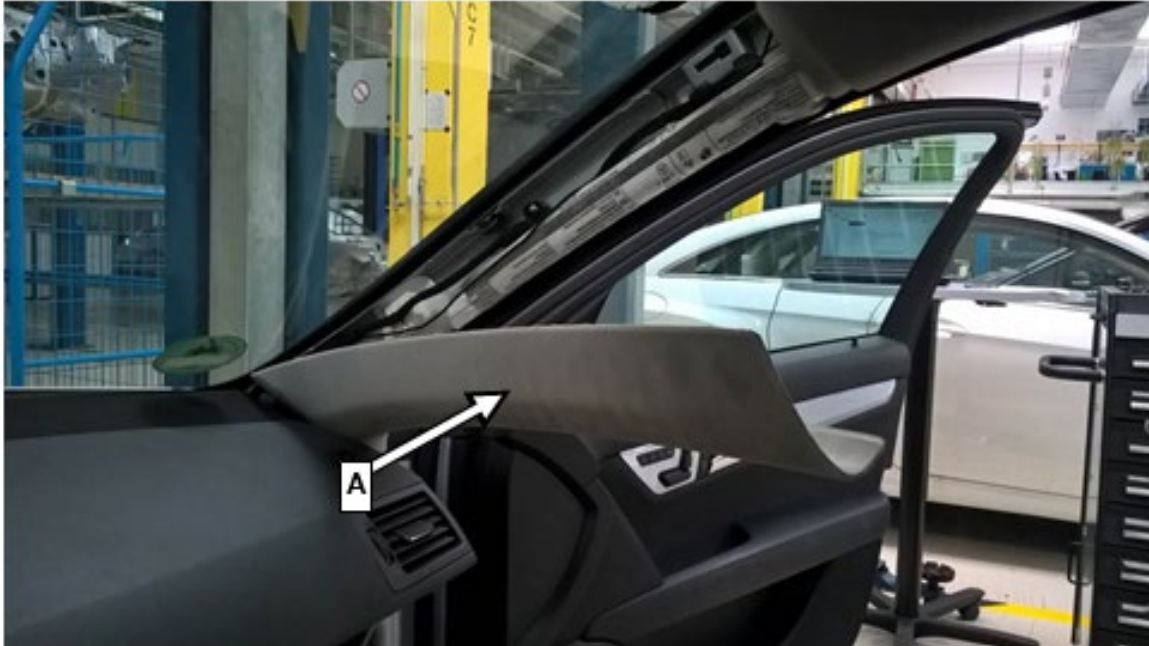
Figure 2

1. Disconnect ground line from the on-board electrical system battery.
2. Remove right A-pillar trim (**A, figure 2**).

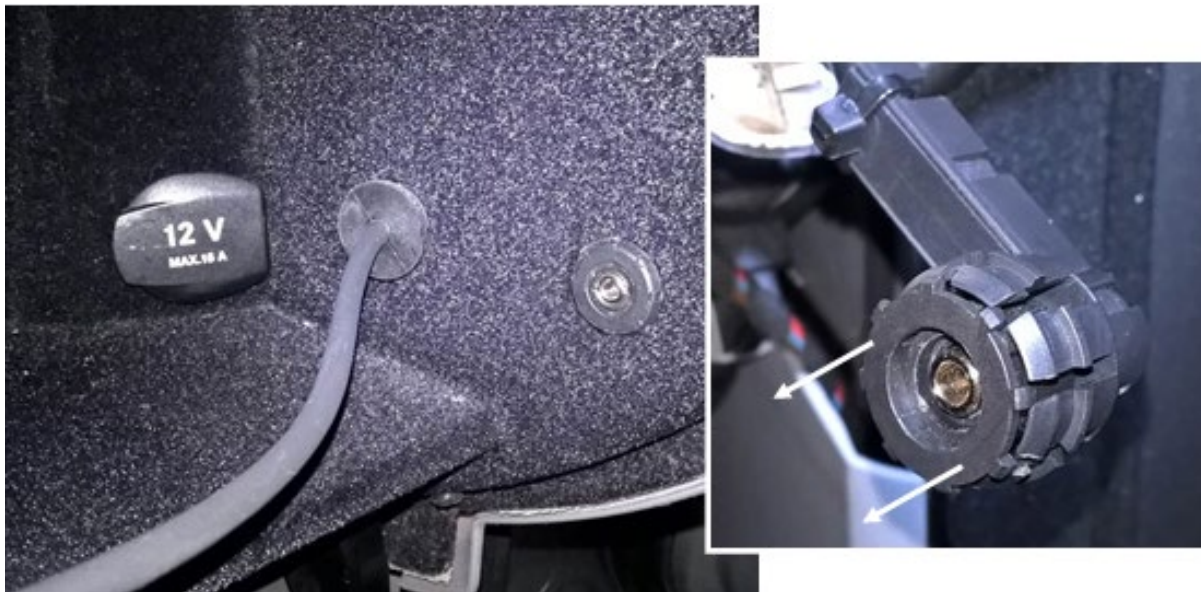
Figure 3

**i** Release inner retaining ring (**figure 3**) at the AUX connection towards the inside. The connection can then be removed from the glove box housing.

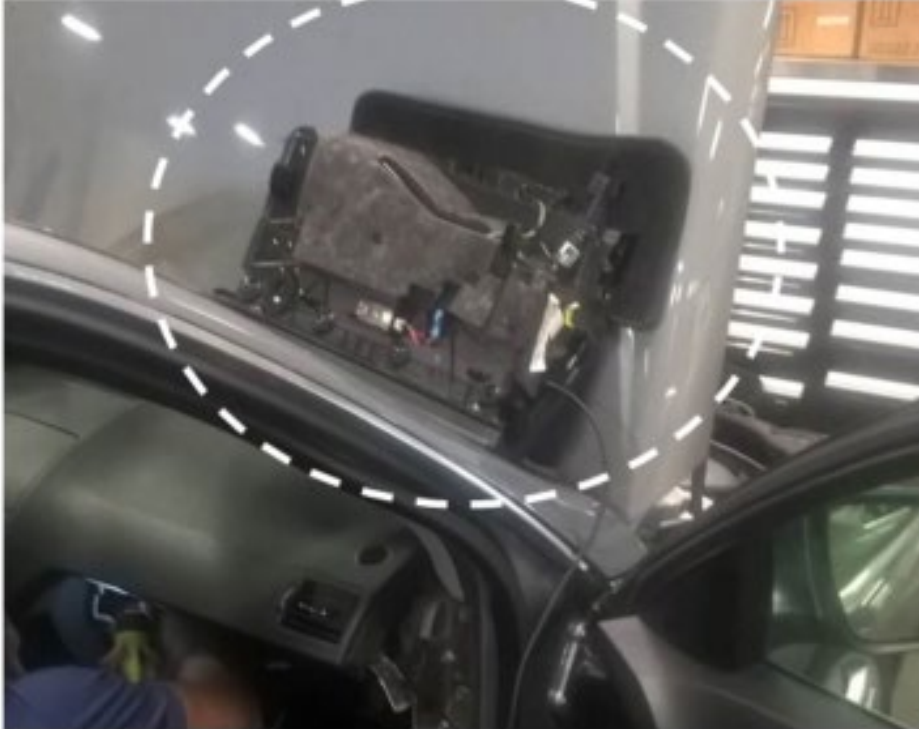
Figure 4

**i** Pull out the iPod cable as far as possible and set down glove box housing on the windshield **with** exterior iPod cable connected (**figure 4**).

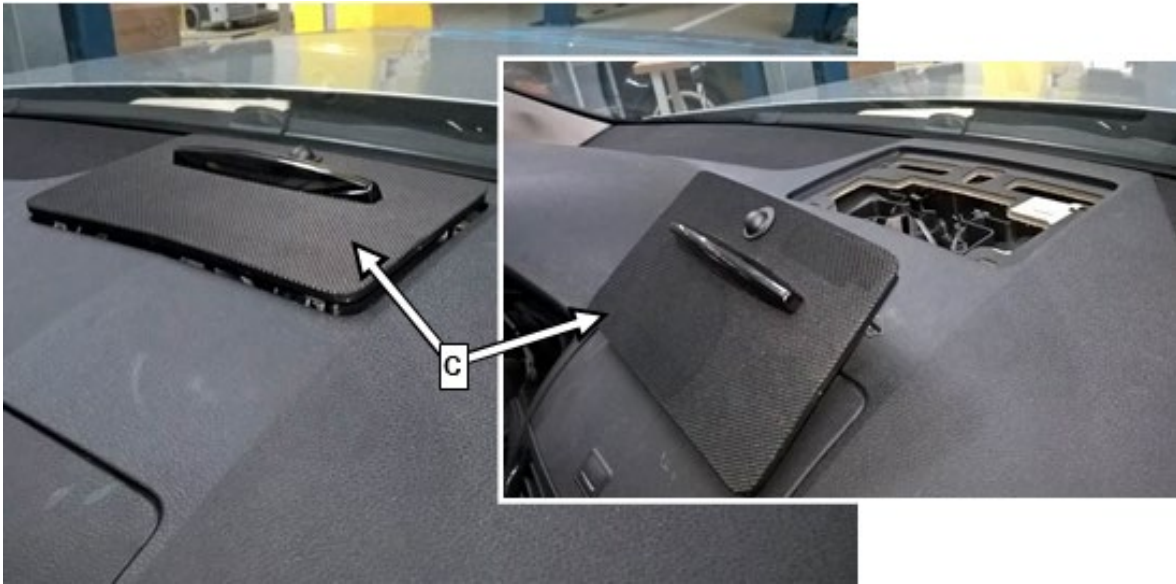
Figure 6

5. Unclip and remove cover (**C**, figure 6) at the instrument panel on top.
  - i** With a sound system, also remove speaker under the cover.

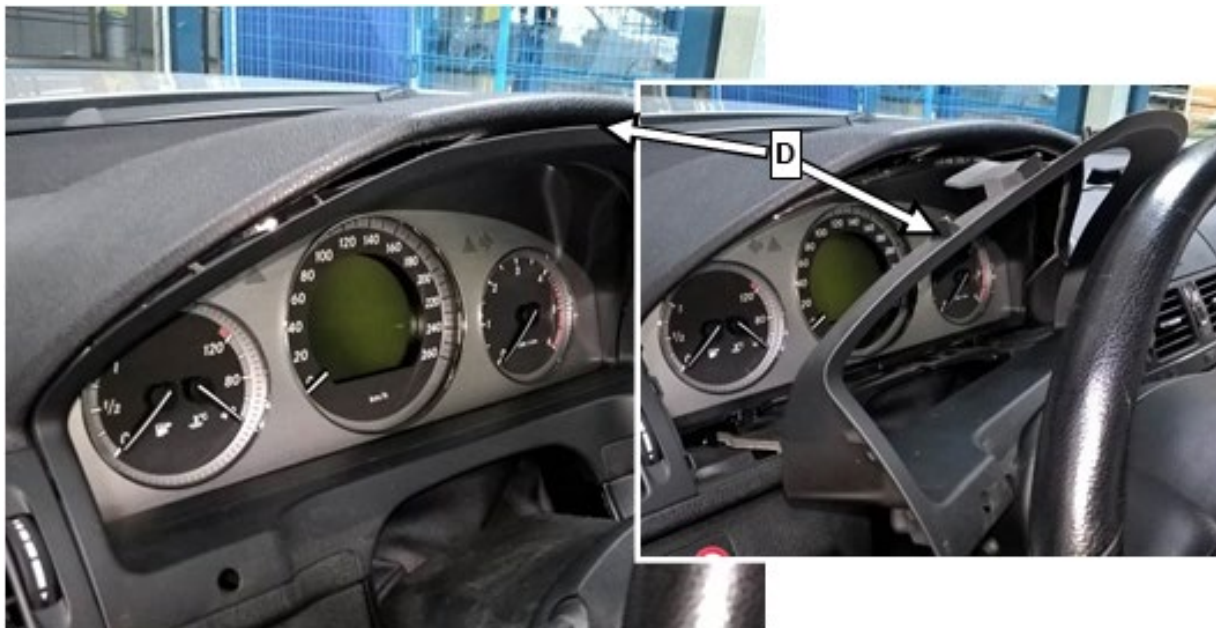
Figure 7

6. Remove center console (**AR68.20-P-2000CW**).
7. Remove automatic climate control and operating unit.
  - i** For basic data of model 207, see **AR83.25-P1124EC**.
8. Remove trim (**D, figure 7**) around the instrument cluster.
  - i** For basic data of model 207, see **AR54.30-P-6015EZ**.

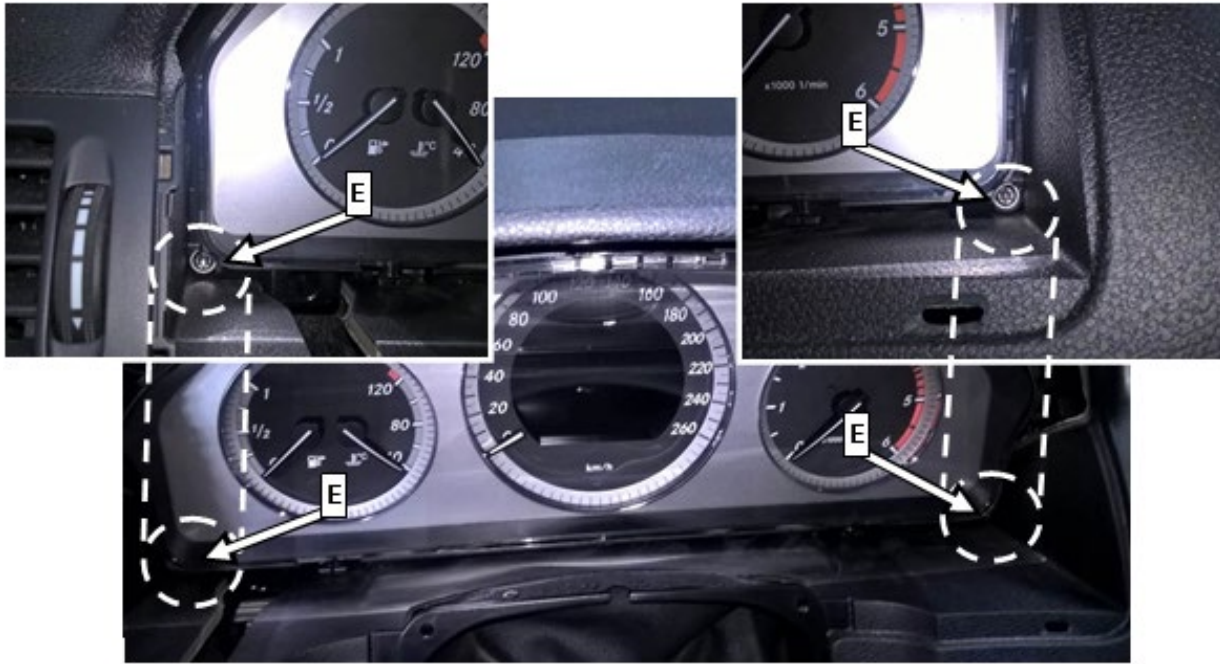
**Figure 8**

9. Remove the two bottom threaded connections (**E, figure 8**) of the instrument cluster.

**i** These screws are simultaneously fasteners for the instrument panel.

**i** The upper two screws do not need to be removed.

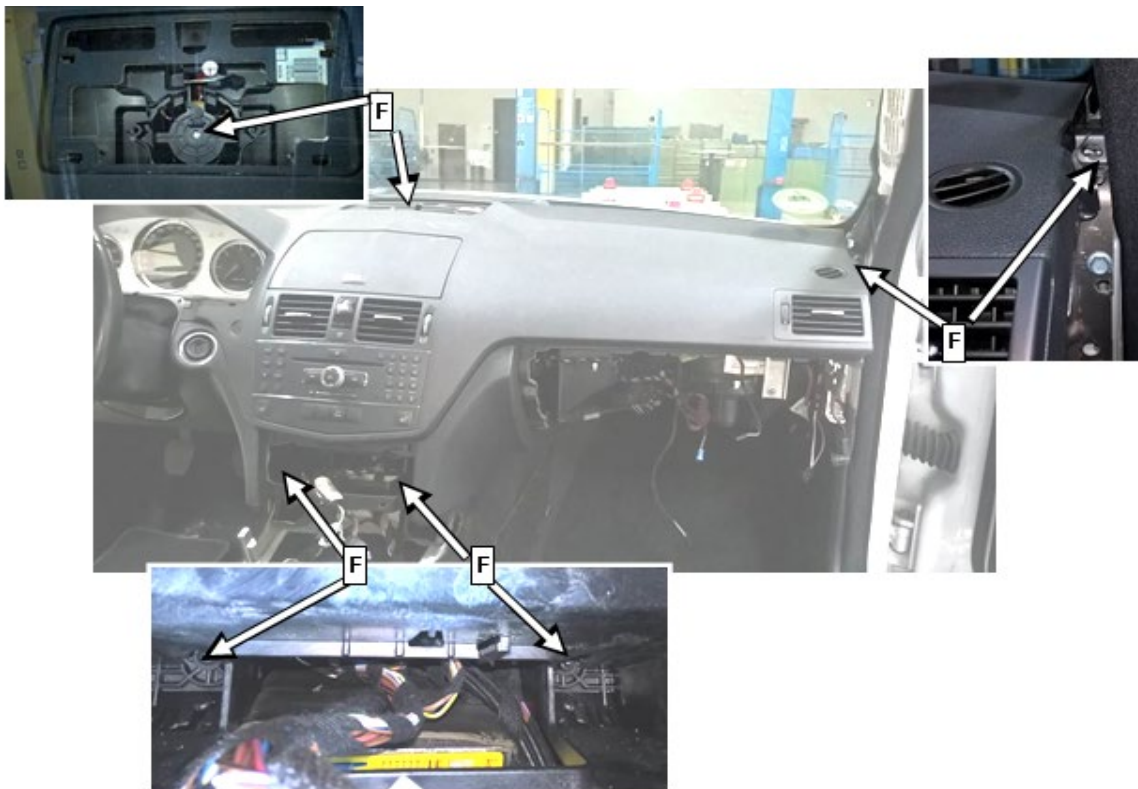
**Figure 9**

10. Remove four screws (**F, figure 9**) for fastening the instrument panel

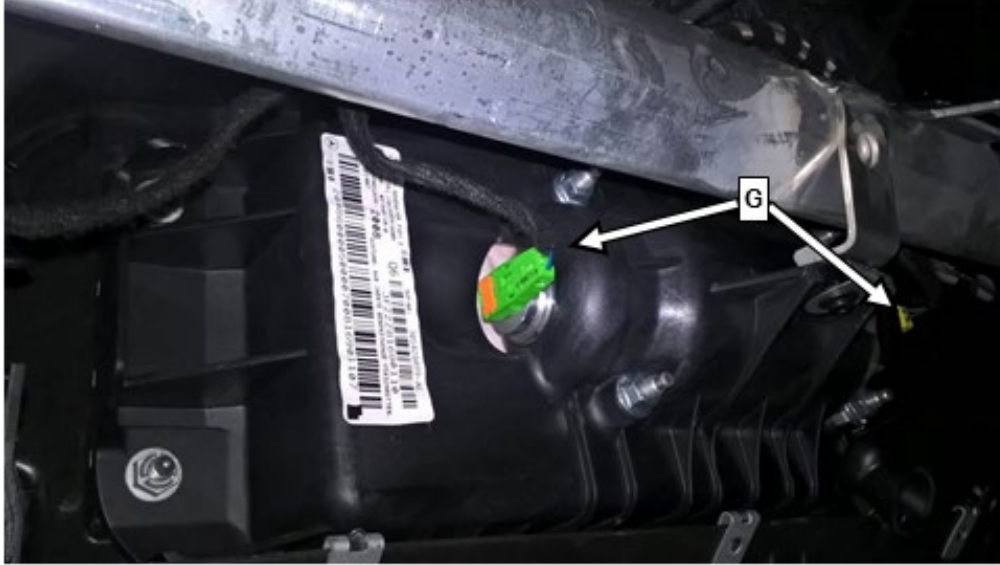
Figure 10

11. Disconnect electrical contacts (**G**, **figure 10**) at the front passenger airbag.

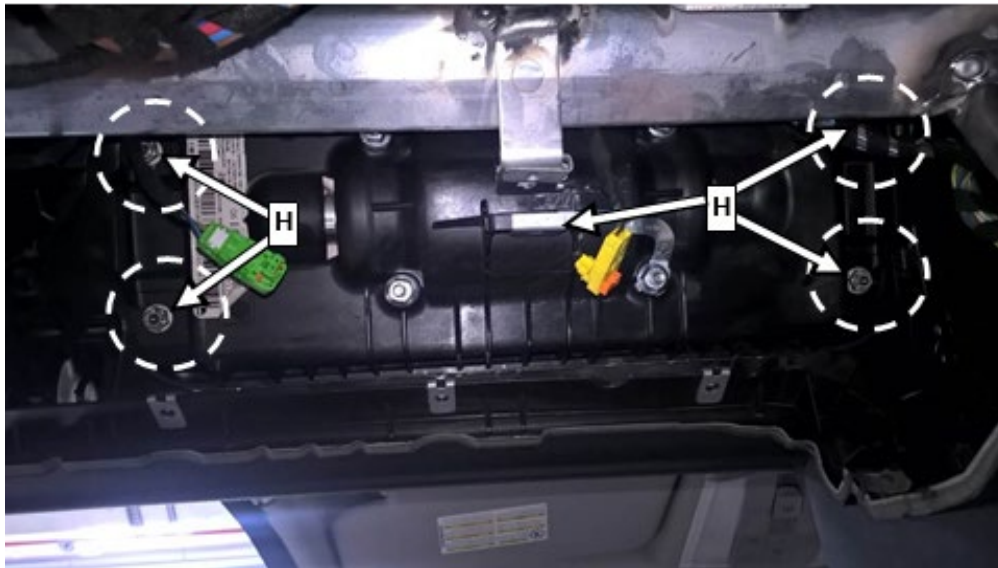
Figure 11

12. Remove lock nuts (**H**, **figure 11**) for the front the passenger airbag.

**i** Lock nuts should only be replaced if they are damaged. For more info see: **AH00.00-N-0001-01A / Modification notes 27.10.2016**

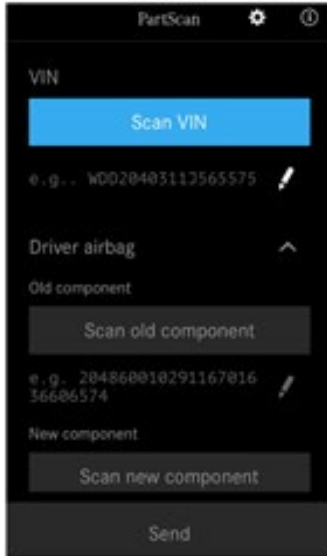
Figure 12

14. The PartScan App **must** be utilized properly for every Takata airbag recall repair. Use the "Scan VIN" button (**figure 12**) to scan the vehicle identification number either by the barcode or the text field.

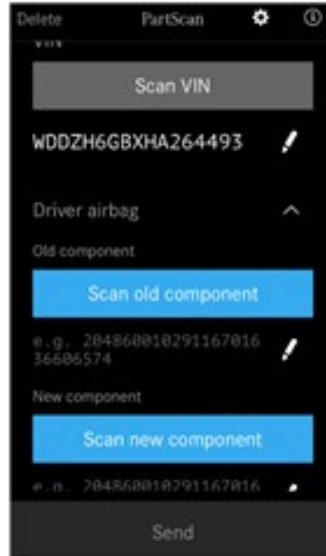
Figure 13

16. Scan barcodes of the removed passenger airbag using the button "Scan old component" (figure 13).

17. Scan the barcodes of the new passenger airbag using the button "Scan new component" (figure 13).

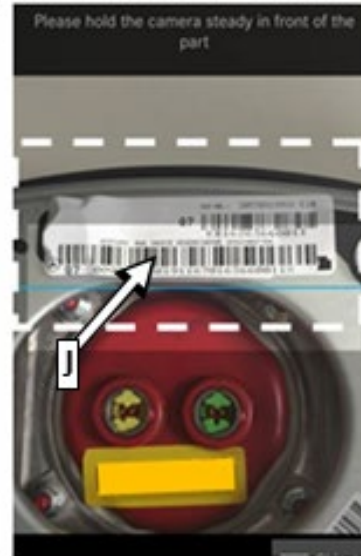
Figure 14

**i** Ensure that the lower barcode (J, figure 14) is scanned.

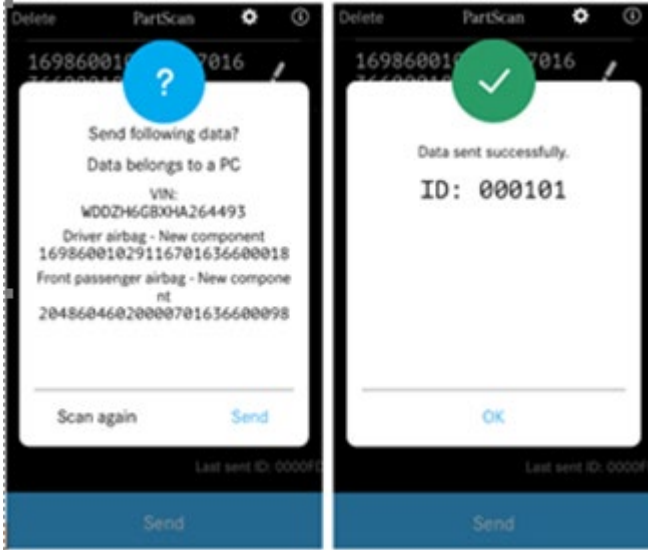
Figure 15

18. Create a scan ID via the "Send" button (figure 15).

**i** The generated scan ID (figure 16) must be recorded in writing in the workshop order and then stored in a tamper-proof manner.

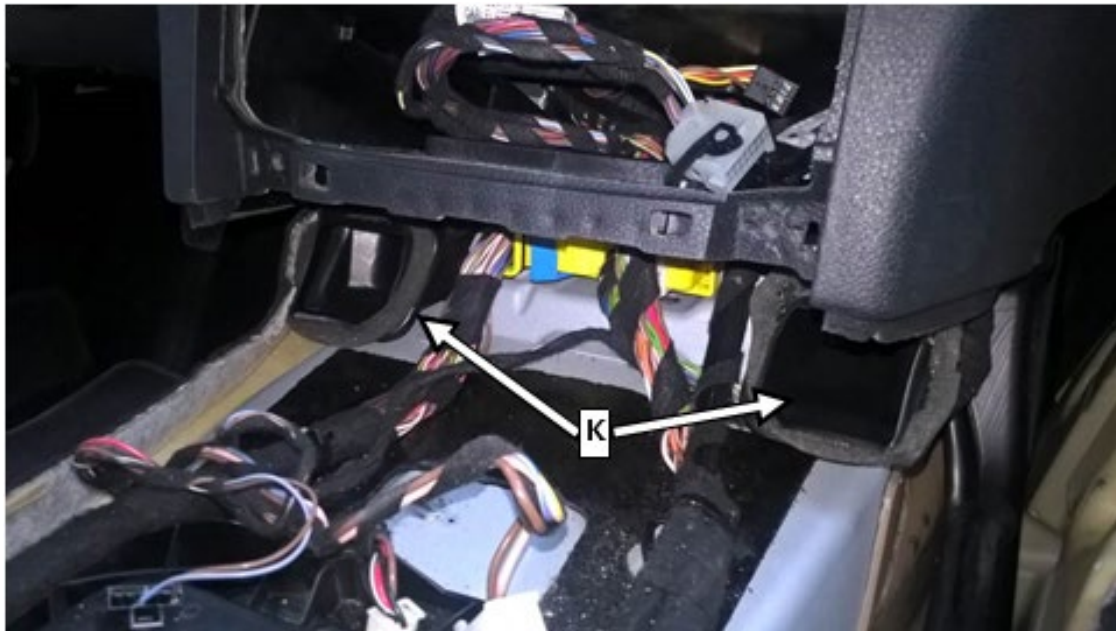
Figure 17

20. Place instrument panel back into position and install the air ducts (**K**, figure 17) correctly.

**i** The air ducts are pulled out when the instrument panel is raised.

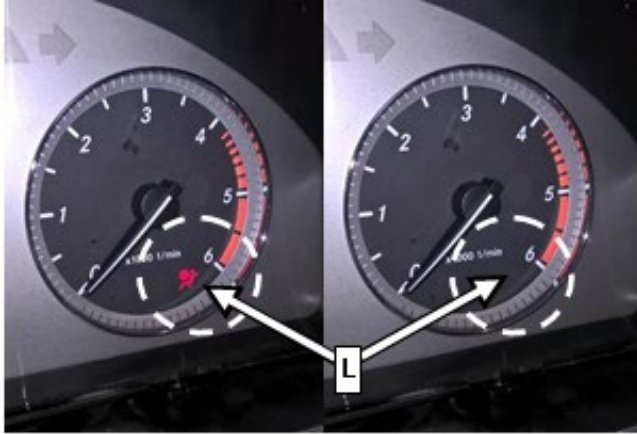
Figure 18

23. Turn the transmitter key in the electronic ignition lock to **position 1** and check whether the airbag indicator lamp (**L**, **figure 18 or 19**) correctly switches off after a few seconds.

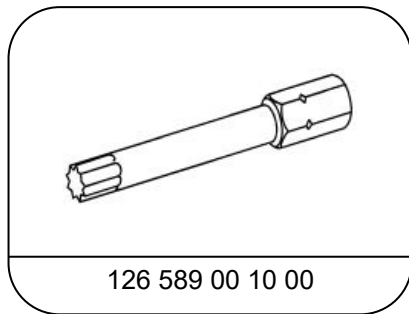
Screwdriver bit

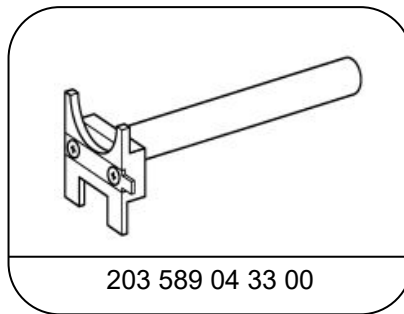
Removal lever

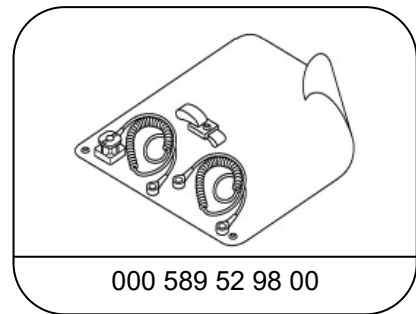
Electro Static Discharge (ESD) kit (or locally sourced equivalent)

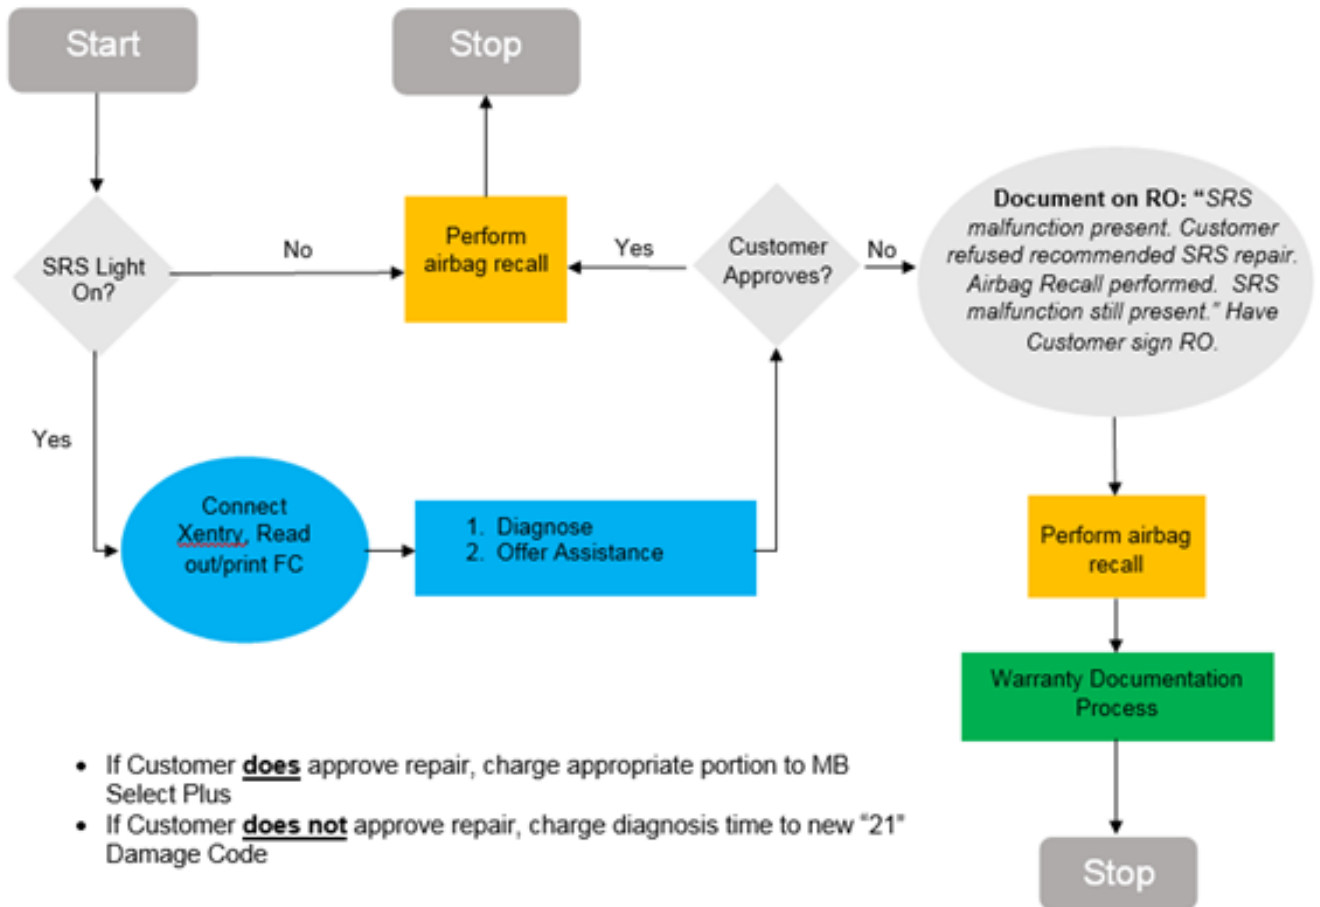
**Attachment A - SRS Light Diagnosis/Repair Process - Takata Airbag Recall Only**

- If Customer **does** approve repair, charge appropriate portion to MB Select Plus
- If Customer **does not** approve repair, charge diagnosis time to new "21" Damage Code

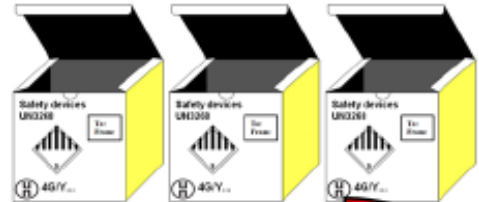
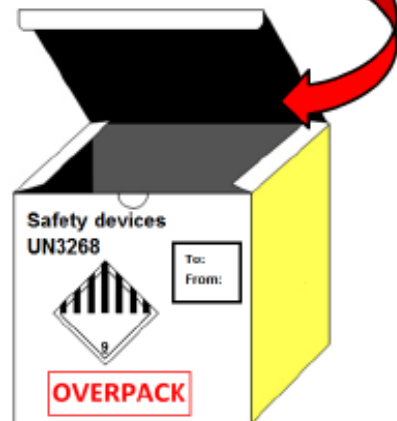
- Package each airbag in a separate UN spec box prepared with the labels/markings described above.
- Place each individual airbag box inside a larger non-UN spec box to keep the shipment together.
- This larger box is called an "OVERPACK."

- The OVERPACK must have the identical markings and label as the boxes contained inside.
- The OVERPACK must have the "OVERPACK" statement on the same face as the hazard markings and labels. **Package example:**
