Mercedes-Benz

Campaign No. 2019090009, Sept 2019

SUBJECT: **Model 204, 207, X204 and 197**  
**Model Years 2010 – 2015**  
**Replace Driver-Side and Front Passenger-side Airbag**

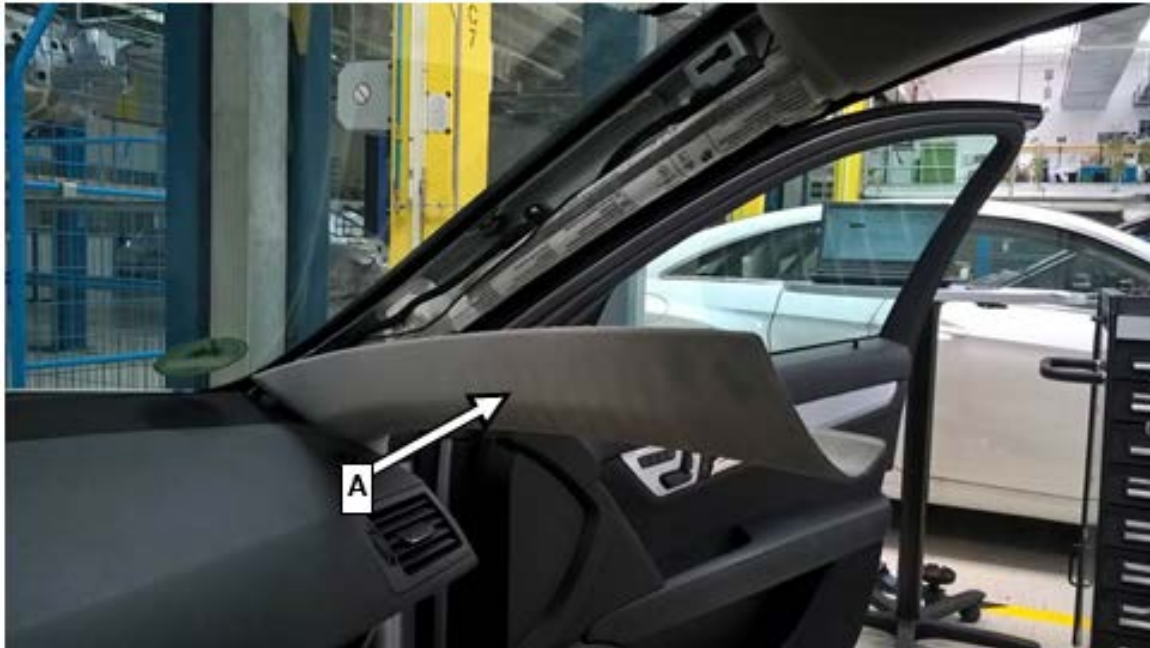
Figure 2

1. Disconnect ground line from the on-board electrical system battery.
2. Remove driver airbag at the steering wheel.
  - i** For basic data of model 204, see **AR91.60-P-0660CW**
  - i** For basic data of model 207, see **AR91.60-P-0660EW**
  - i** For vehicles with code 428, switch up the connector coupling for steering wheel shift paddles, rework to the new driver airbag (**BT54.18-P-0002-01CW**).
  - i** Do not install the new driver airbag at the steering wheel until after the scan procedure in operation step 19.
3. Remove right A-pillar trim (**A, figure 2**).

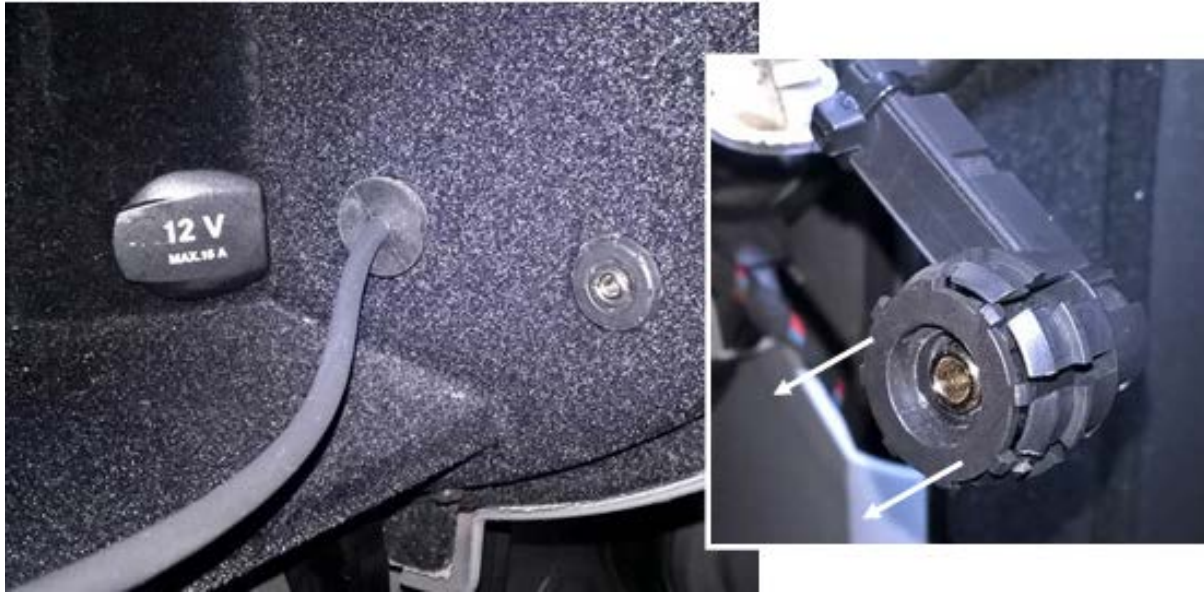
Figure 3

4. Remove glove box housing
  - i** For basic data of model 204, see **AR68.10-P-1200CW**
  - i** For basic data of model 207, see **AR68.10-P-1400EC**
  - i** Release inner retaining ring (**figure 3**) at the AUX connection towards the inside. The connection can then be removed from the glove box housing.
  - i** Pull iPod cable **with** rubber grommet out of glove box housing until the connector plug makes contact with the housing. **Do not pull cable out of rubber grommet** because it is bonded to the rubber grommet and will otherwise be damaged!

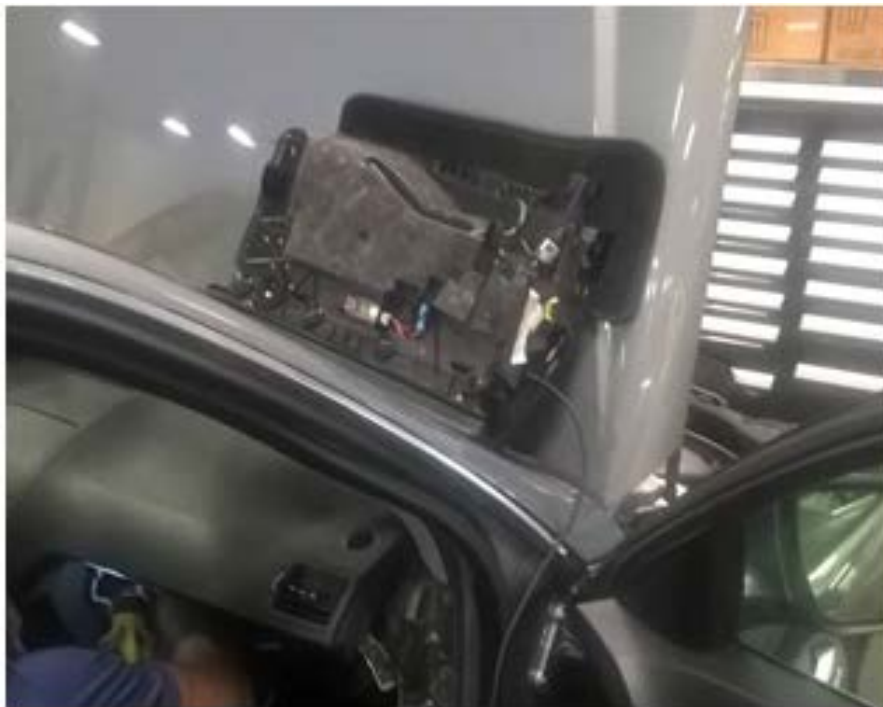
Figure 4

**i** Pull out the iPod cable as far as possible and set down glove box housing on the windshield *with* exterior iPod cable connected (**figure 4**).

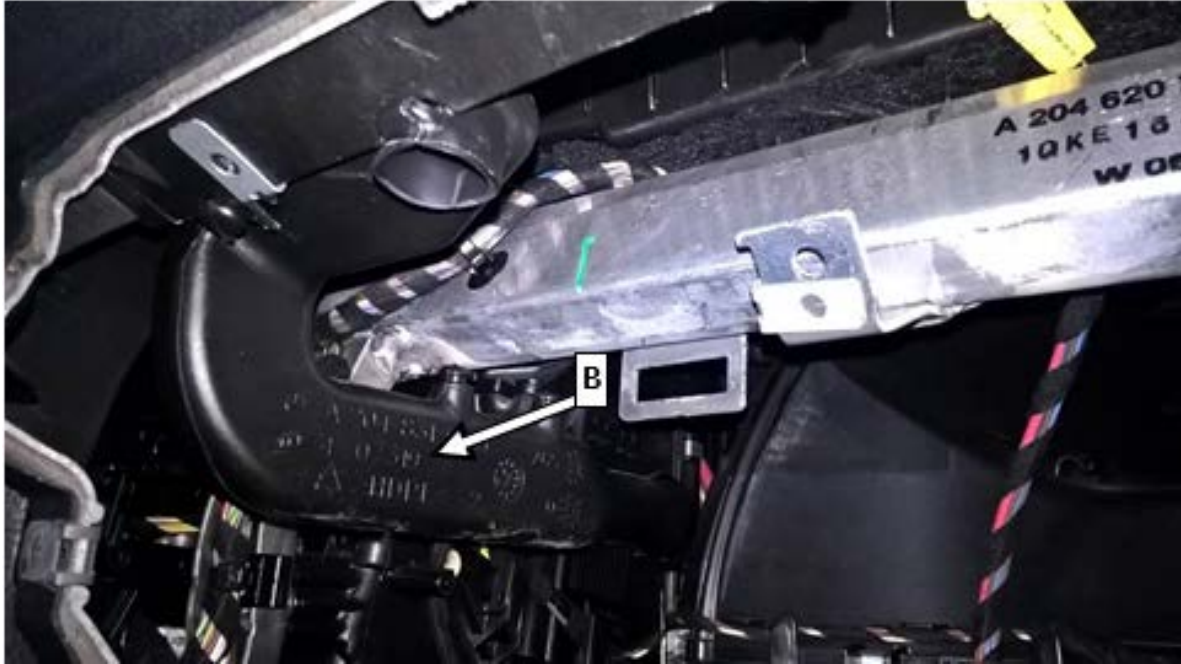
Figure 5

5. Remove air duct (**B, figure 5**) above the glove compartment.

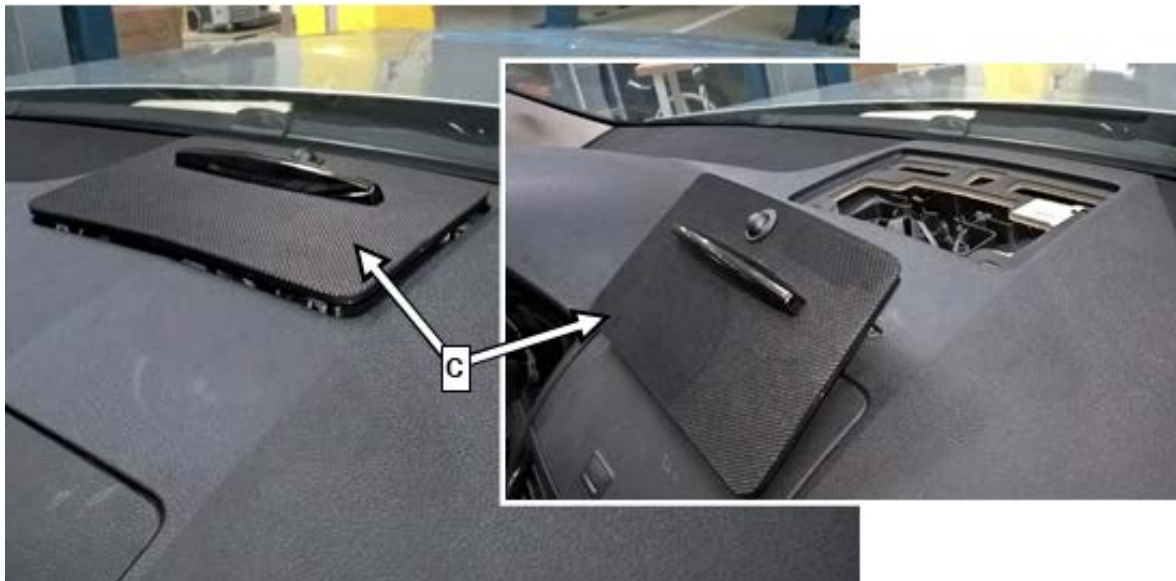
Figure 6

6. Unclip and remove cover (**C, figure 6**) at the instrument panel on top.  
**i** With a sound system, also remove speaker under the cover.

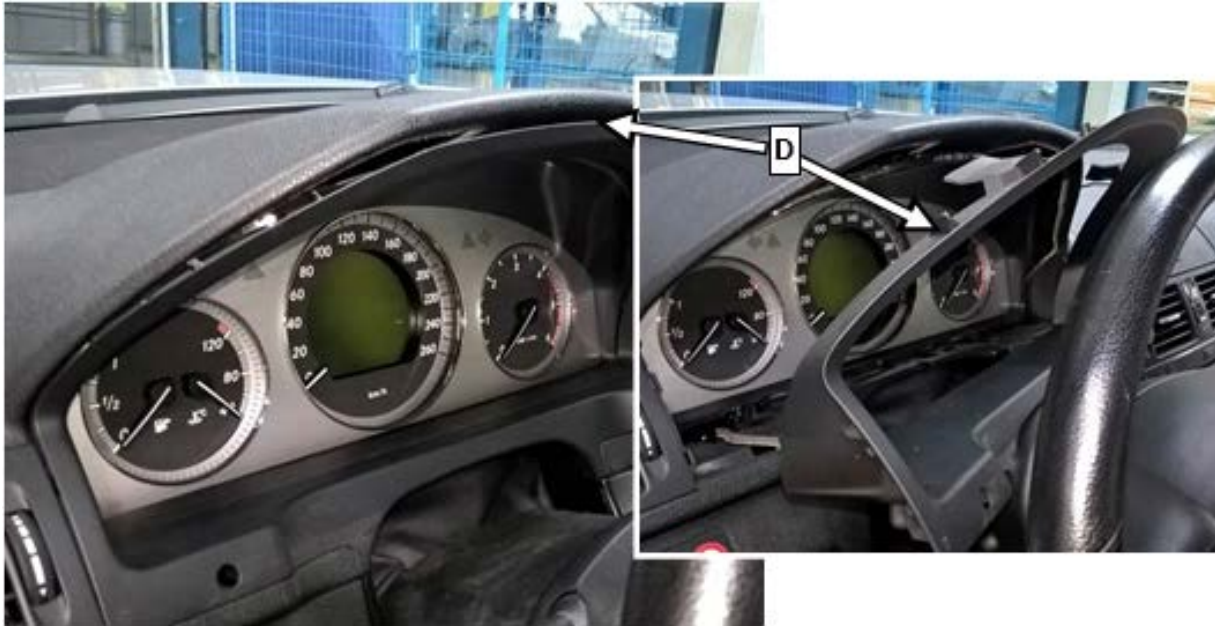
Figure 7

9. Remove trim (**D, figure 7**) around the instrument cluster.

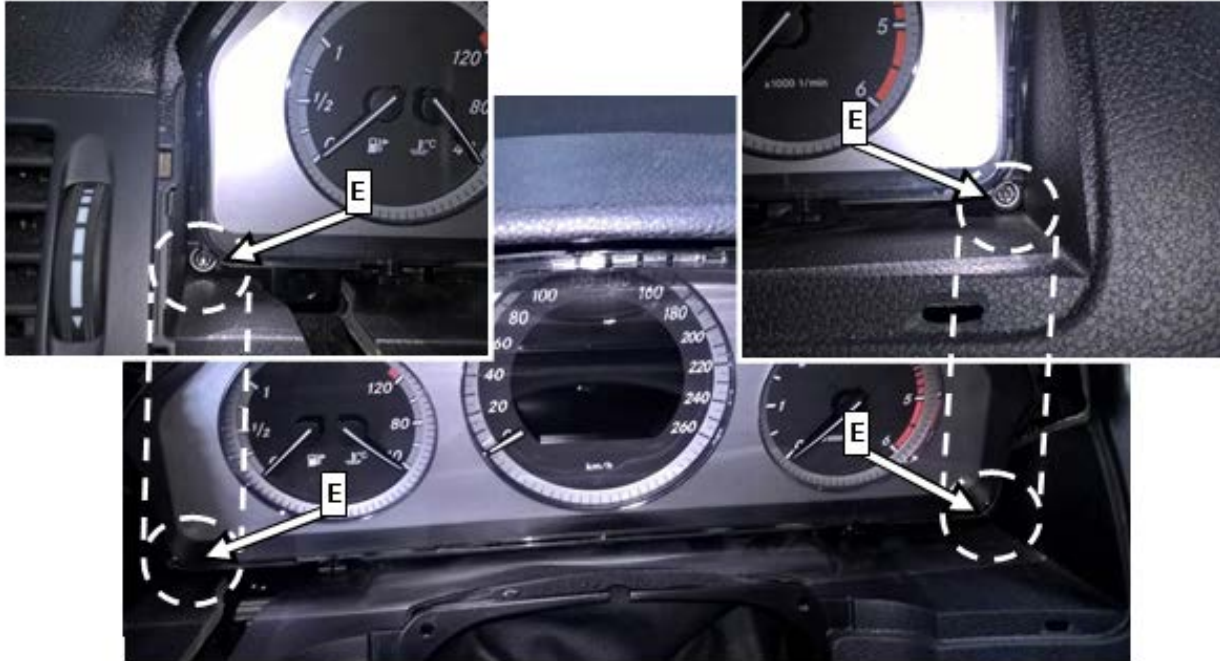
Figure 8

10. Remove the two bottom threaded connections (**E, figure 8**) of the instrument cluster.

**i** These screws are simultaneously fasteners for the instrument panel.

**i** The upper two screws do not need to be removed.

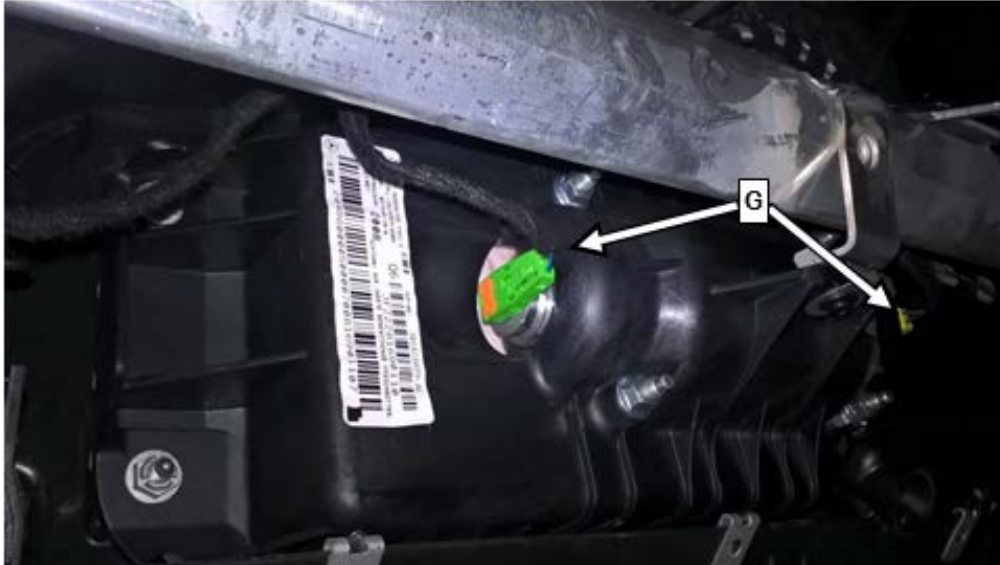
Figure 10

12. Disconnect electrical contacts (G, figure 10) at the front passenger airbag.

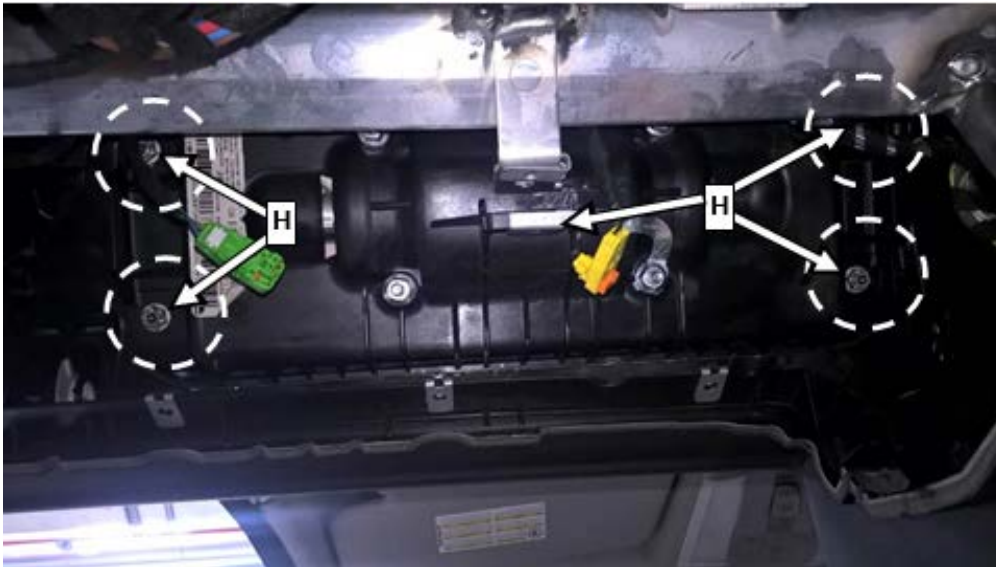
Figure 11

13. Remove lock nuts (**H, figure 11**) for the front the passenger airbag.

**i** Lock nuts should only be replaced if they are damaged. For more info see: **AH00.00-N-0001-01A / Modification notes 27.10.2016**

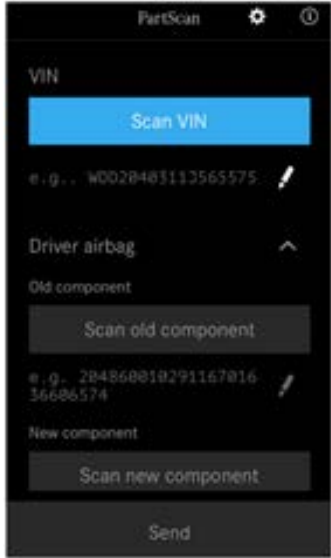
Figure 12

14. Slightly raise instrument panel at the front passenger side and remove the front passenger airbag in a downwards direction. Take special care not to crack the dashboard material. **DO NOT REMOVE THE DASHBOARD**
15. Use the "Scan VIN" button (**figure 12**) to scan the vehicle identification number either by the barcode or the text field.

**i** After scanning, compare the vehicle identification number that has been read in the app and correct any scanning errors manually.

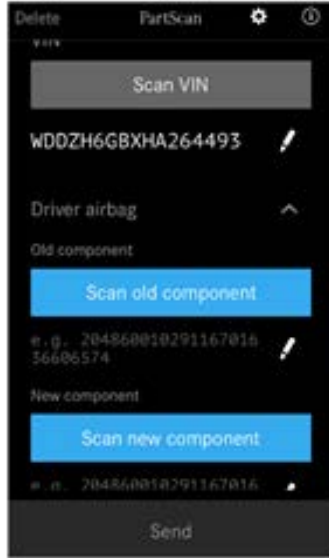
Figure 13

16. Scan barcodes of the removed driver airbag using the button "Scan old component" (figure 13).

17. Scan the barcodes of the new driver airbag using the button "Scan new component" (figure 13).

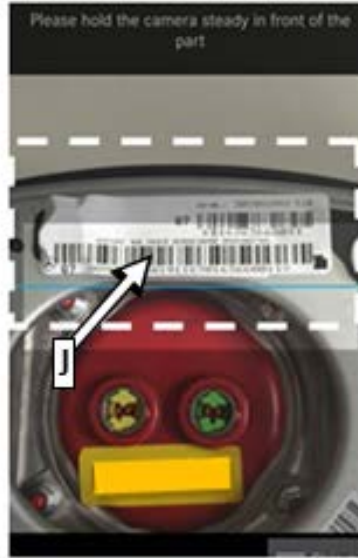
Figure 14

- i** Ensure that the lower barcode (J, figure 14) is scanned.
- i** All required data can also be read off and entered manually.

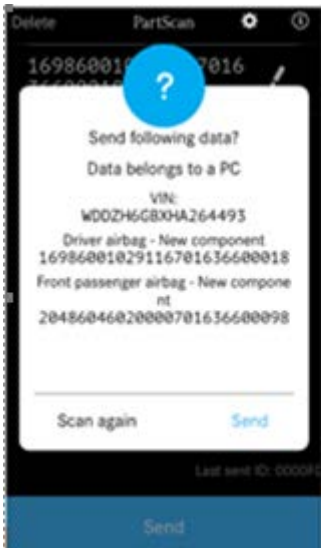
Figure 15

19. Create a scan ID via the "Send" button (figure 15).

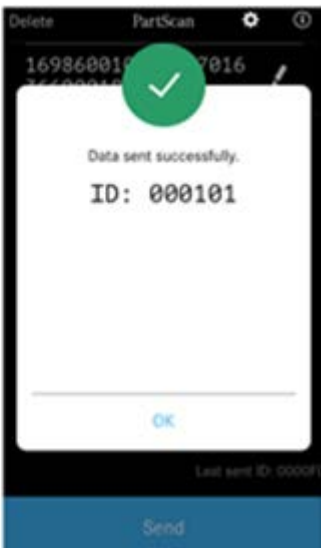
Figure 16

- i** The generated scan ID (figure 16) must be recorded in writing in the workshop order and then stored in a tamper-proof manner.

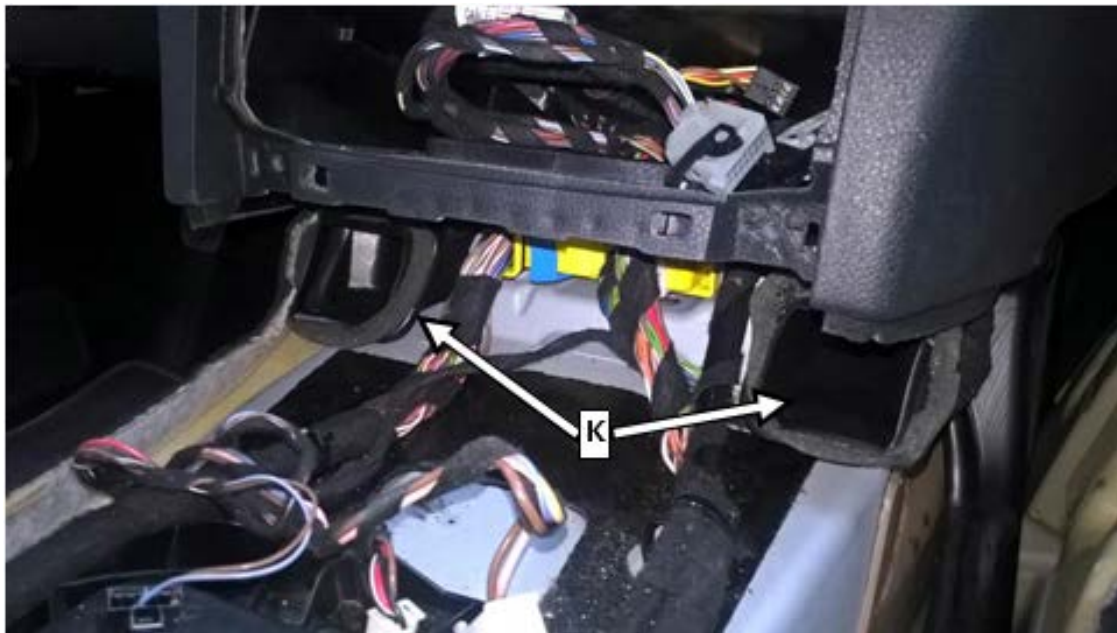
Figure 17

22. Place instrument panel back into position and install the air ducts (**K**, **figure 17**) correctly.

**i** The air ducts are pulled out when the instrument panel is raised.

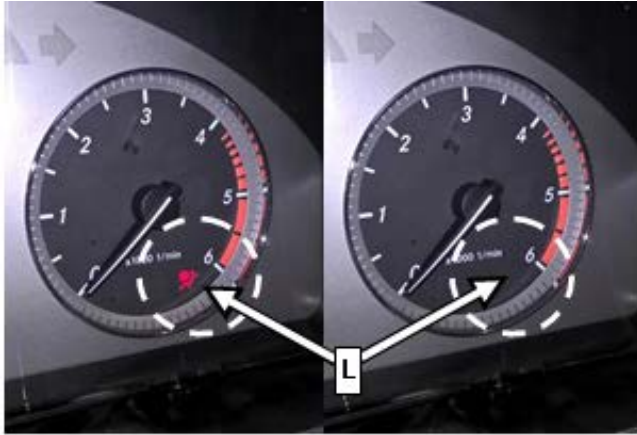
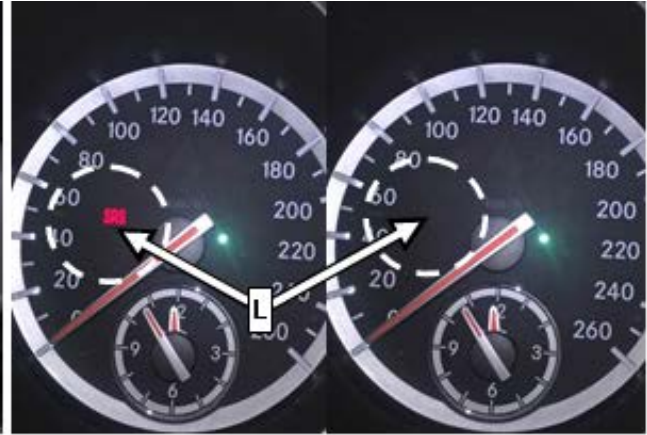
25. Turn the transmitter key in the electronic ignition lock to **position 1** and check whether the airbag indicator lamp (**L**, **figure 18 or 19**) correctly switches off after a few seconds.

**i** The SRS check is thus completely ensured after airbag replacement.

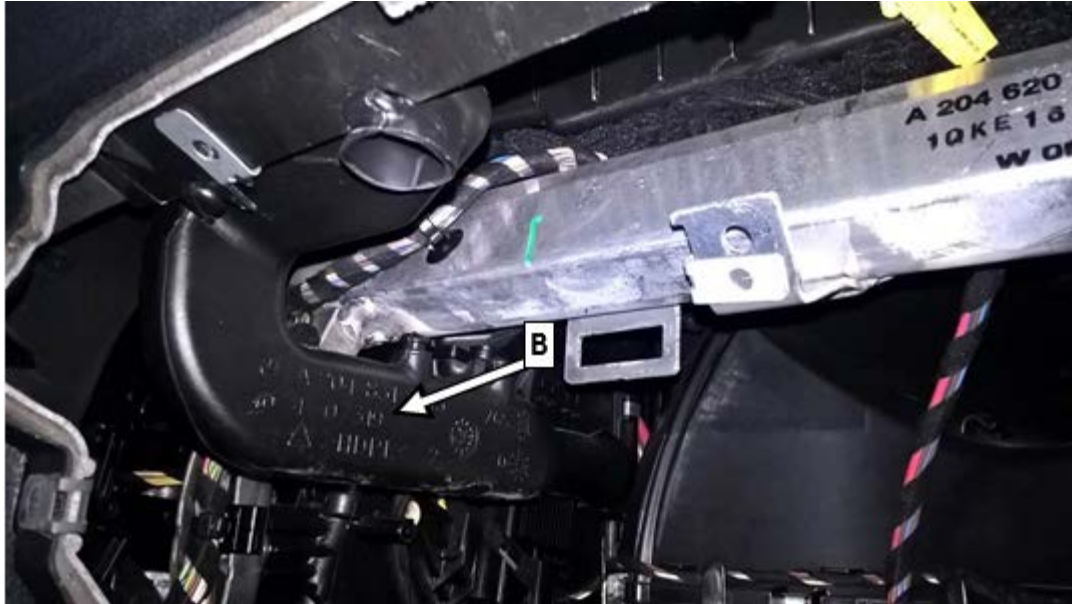
**Figure 1**

1. Disconnect ground line from the on-board electrical system battery.
2. Remove driver airbag at the steering wheel.  
**i** For basic data of model X 204, see **AR91.60-P-0660CW**
3. Remove glove compartment housing (**AR68.10-P-1200CY**).
4. Remove air duct (**B, figure 1**) above the glove compartment.

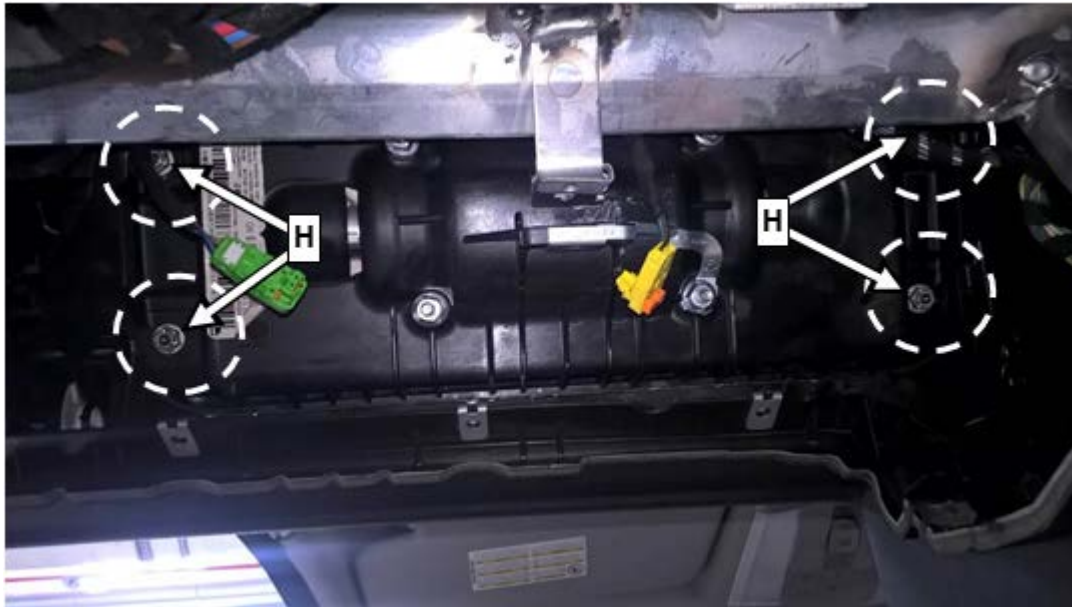
Figure 3

6. Remove threaded connections (**H**, figure 3) for the front the passenger airbag.

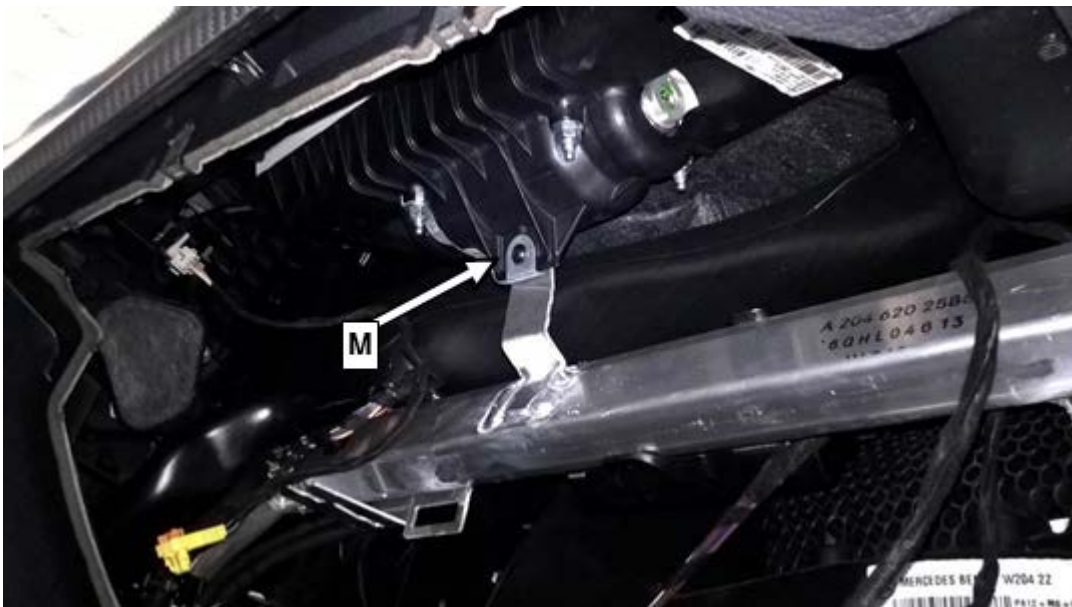
Figure 4

7. Remove Screw (**M**, figure 4) for the front passenger airbag.

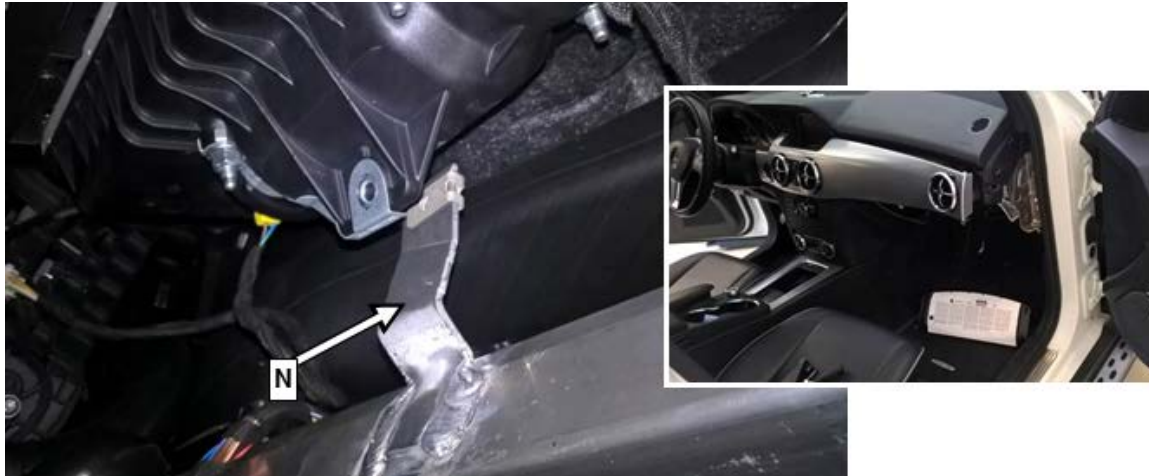
Figure 5

**i** To remove the front passenger airbag, slightly push the bracket (**N**, **figure 5**) forward.

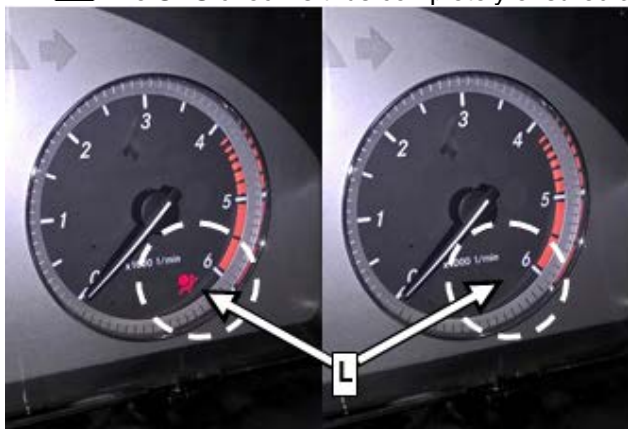
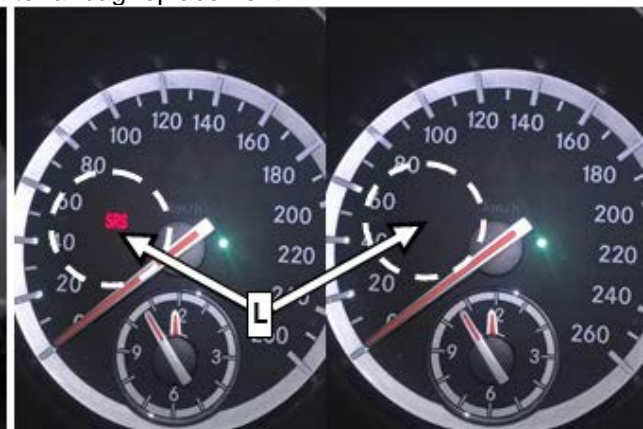
14. Turn the transmitter key in the electronic ignition lock to **position 1** and check whether the airbag indicator lamp (**L**, **figure 6 or 7**) correctly switches off after a few seconds.

**i** The SRS check is thus completely ensured after airbag replacement!

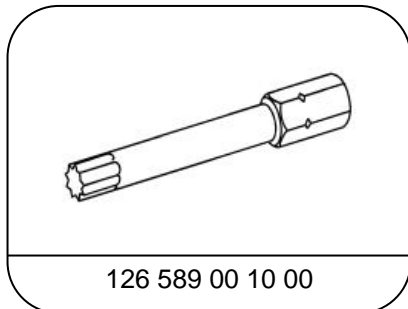
Screwdriver bit

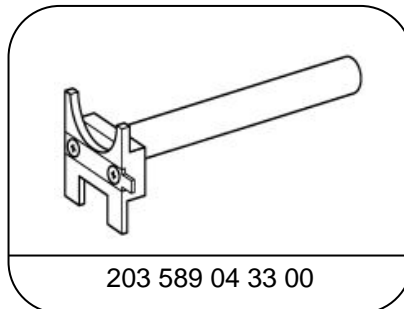
Removal lever

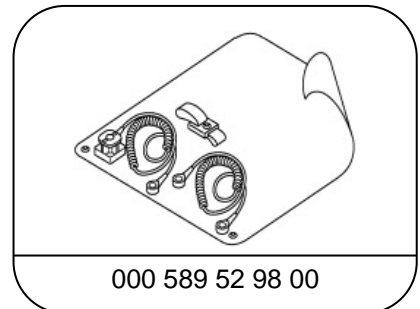
Electro Static Discharge (ESD) kit (or locally sourced equivalent)

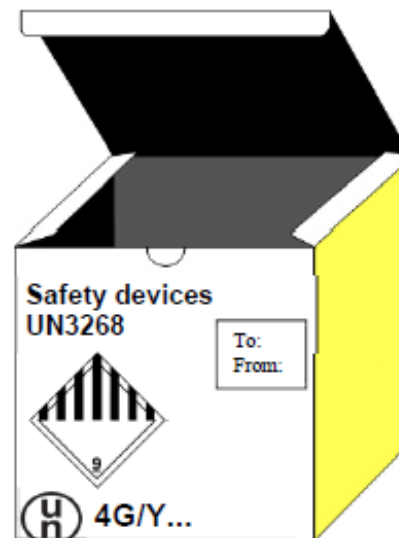
- **Note:** The Packing Group and the EX# are no longer required to be printed on the HAZMAT bill of lading.
- **Package example:**

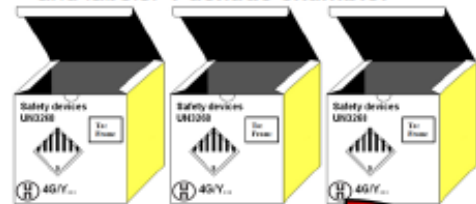
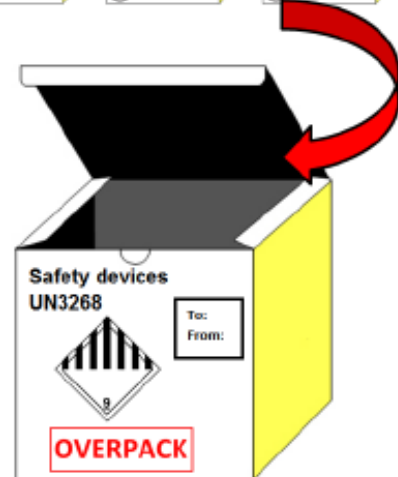
- Package each airbag in a separate UN spec box prepared with the labels/markings described above.
- Place each individual airbag box inside a larger non-UN spec box to keep the shipment together.
- This larger box is called an "OVERPACK."

- The OVERPACK must have the identical markings and label as the boxes contained inside.
- The OVERPACK must have the "OVERPACK" statement on the same face as the hazard markings and labels. **Package example:**
