Campaign No. 2020100005, October 2020

SUBJECT: **Model X204****Model Years 2013-2015****Replace Front Passenger-side Airbag**

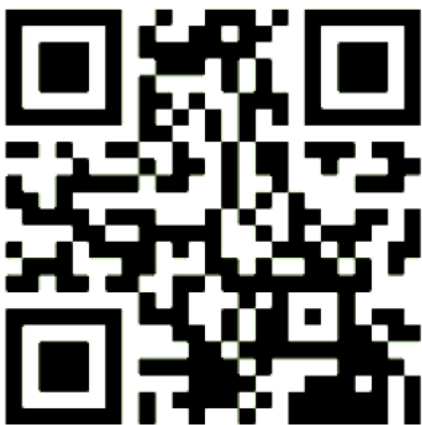
Figure 1

- Download app from Apple® store for iPhone® or Google® play for Android® (same as any other app download) then scan the QR code below (Figure 1) to continue download (follow on-screen instructions).

- To install and transmit the data a WiFi connection is required.
- After downloading the App, a one-time security authentication is required by means of encrypted QR code (Figure 1). Verification can be performed by scanning the QR code below (Figure 1), before using the application.

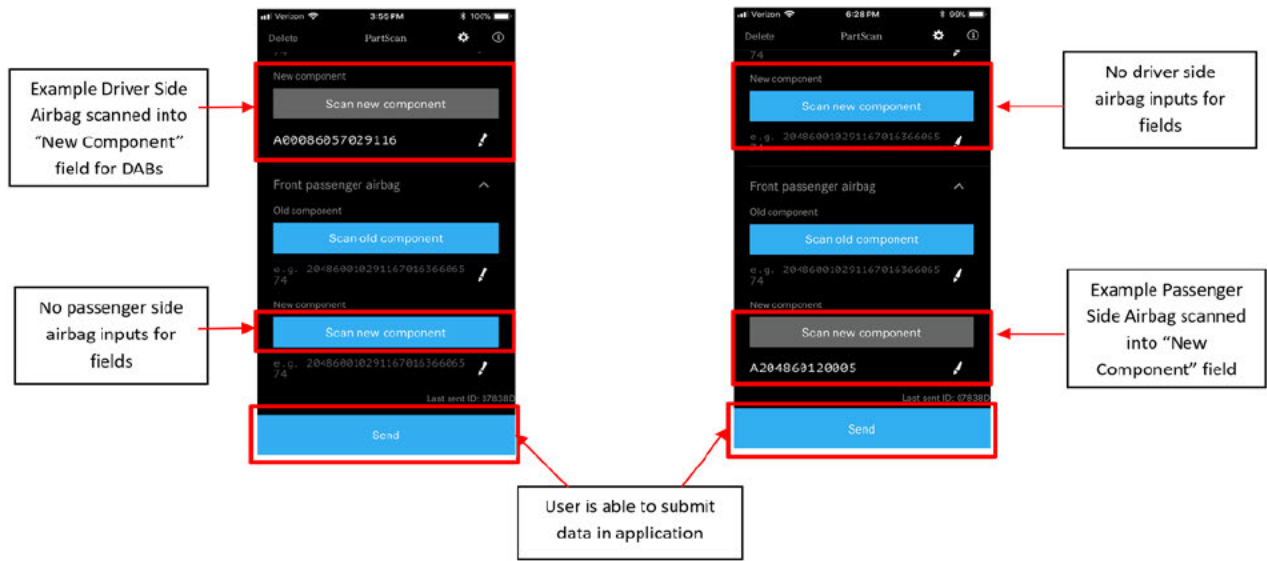
- The PartScan App must be utilized properly for every Takata airbag recall repair.
- If the VIN is missing, illegible or incomplete, it must be entered manually
- The airbag barcode scan may only be skipped if the barcode is missing, illegible or incomplete.
- **Never** scan a “dummy” barcode to skip the entry fields – See Example below
 - **When only the passenger airbag** replacement is required scan and only press “scan old component” under the “Front passenger airbag” section.
- Always make sure the proper airbag is scanned in the respective entry field in the App (driver airbag for driver-side, passenger airbag for passenger-side)
- Part Scan Examples: Driver-side airbag only and Passenger-side airbag only scans

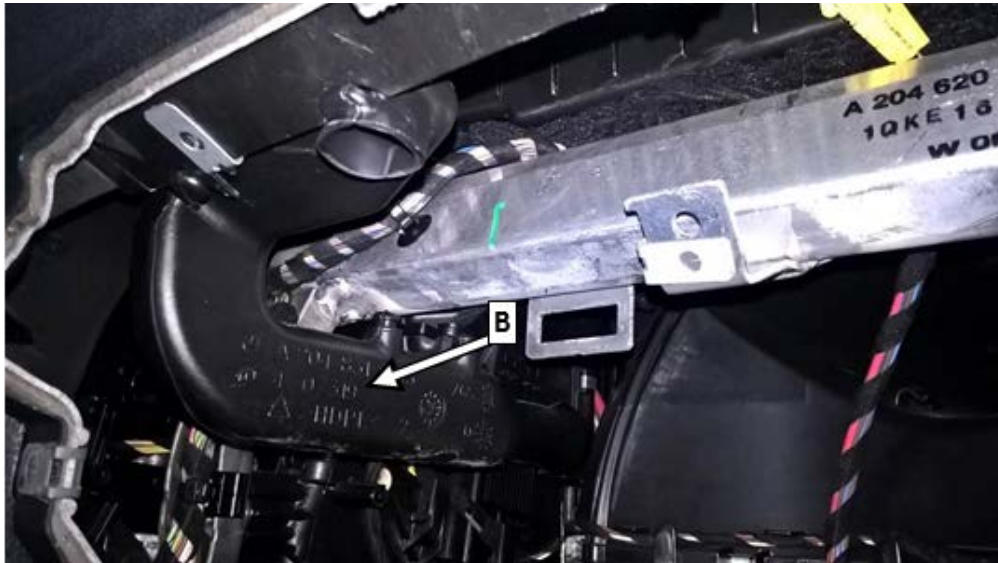
Figure 2

1. Disconnect ground line from the on-board electrical system battery.
2. Remove glove compartment housing (AR68.10-P-1200CY).
3. Remove air duct (B, figure 2) above the glove compartment.

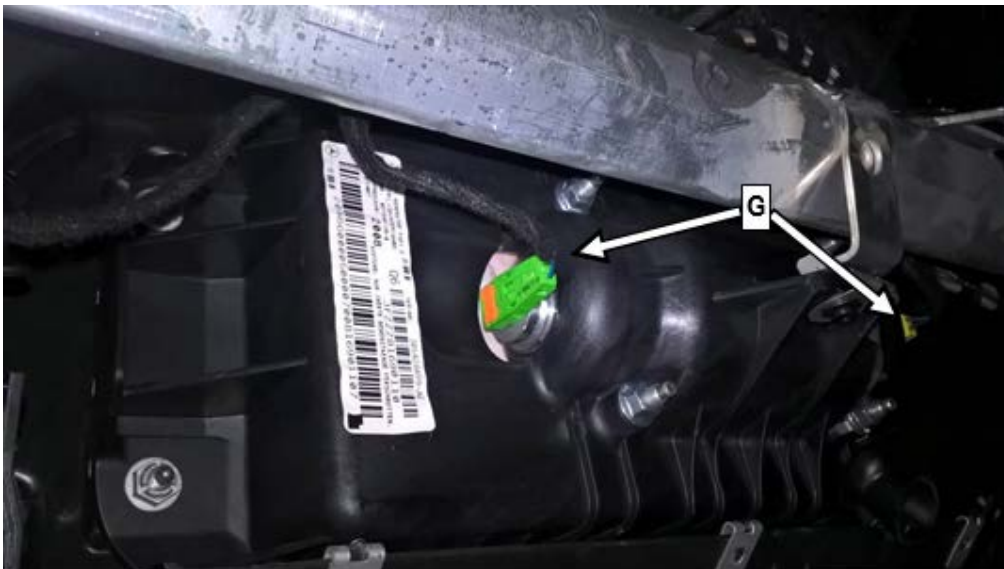
Figure 3

4. Disconnect electrical contacts (G, figure 3) at the front passenger airbag.

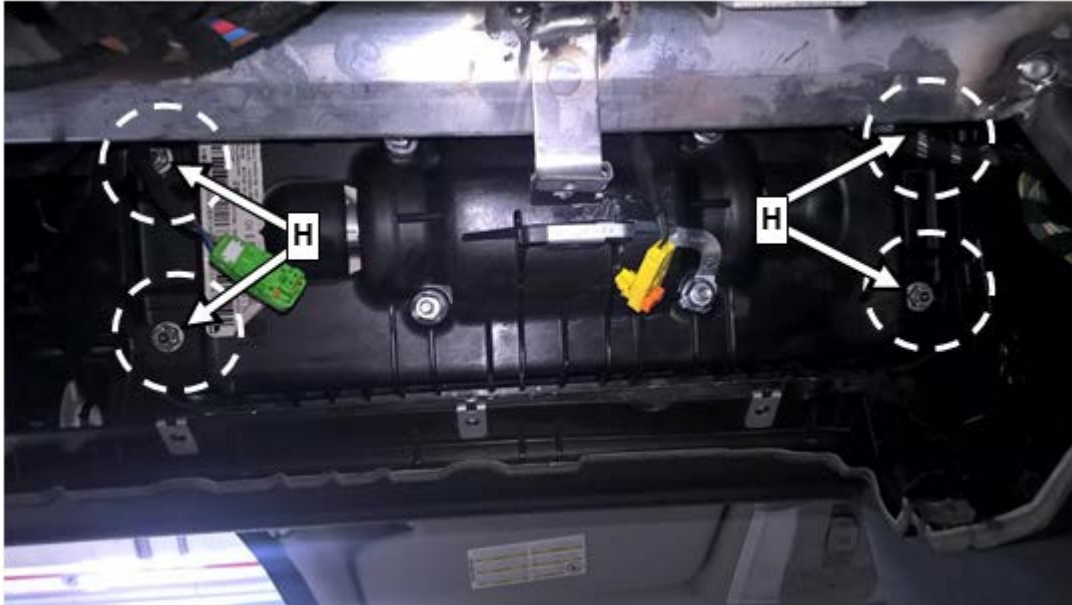
Figure 4

5. Remove threaded connections (**H**, figure 4) for the front the passenger airbag.

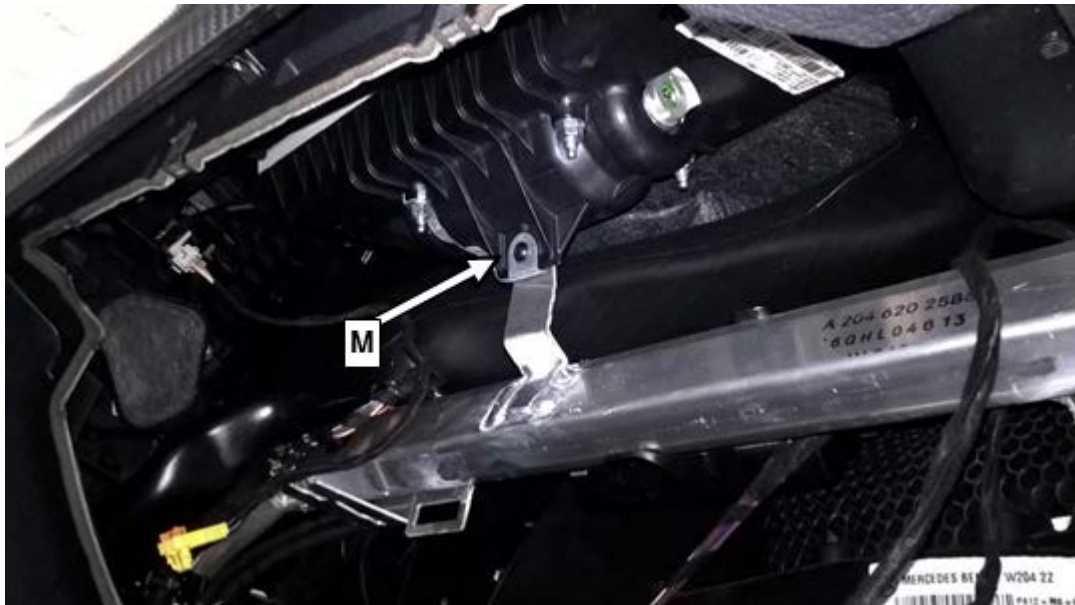
Figure 5

6. Remove Screw (**M**, figure 5) for the front passenger airbag.

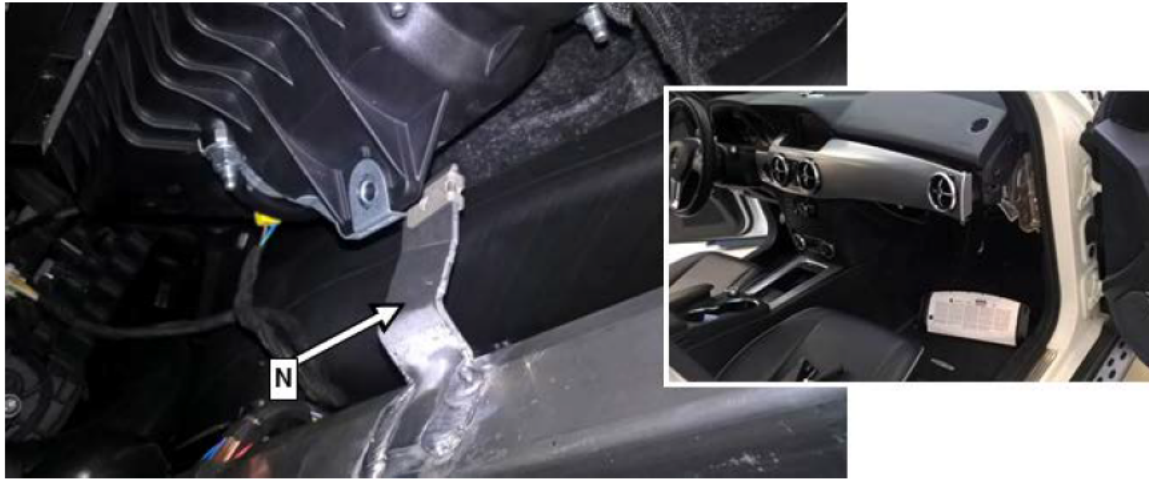
Figure 6

i To remove the front passenger airbag, slightly push the bracket (**N**, figure 6) forward.

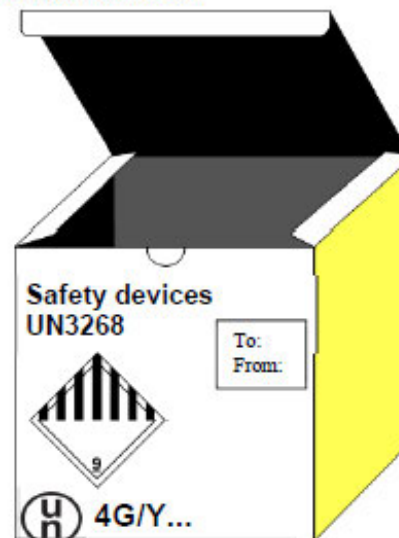
- Carefully open received box and remove new airbag. Keep box intact & save all contents!
- Place used airbag into replacement airbag box, re-using any packaging material (e.g., cardboard inserts) used for the new airbag. Package as the new airbag was packaged.
- Use plastic adhesive tape 50 mm wide to secure the box closed. Do not obscure labels or text on the box with the tape.
- Ensure that the 4G fiberboard box is not ripped or damaged.

- A Class 9 Miscellaneous label must be clearly visible on one side of the box.

- The following words ("marking") must also be clearly visible on the same side of the box as the Class 9 label:
Safety devices
UN3268 (font size must be $\geq \frac{1}{2}$ inch)
- Affix "To/From" address label to same or adjacent packaging face as the hazardous markings/labels.
- The UN 4G code preprinted near the bottom edge of the box must also be clearly visible.

- **Note:** The Packing Group and the EX# are no longer required to be printed on the HAZMAT bill of lading.
- **Package example:**
