Volvo Car Customer Service

QB Instruction R89910

Title	Inspection and replacement of "drive units", tailgate lift arms	Page:	1 (4)
Action

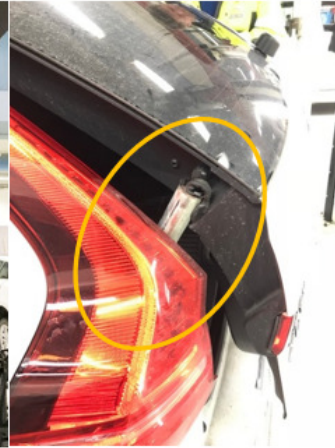
Condition 3, Not OK

Condition 3, Vehicles exhibiting the symptoms of a bent lifting arm(s) should be parked in a safe, isolated location, preferably with the tailgate facing a solid wall type structure:

DO NOT open or close the tailgate.

DO NOT attempt to repair the vehicle until Volvo Cars has released a safe handling/repair instruction.

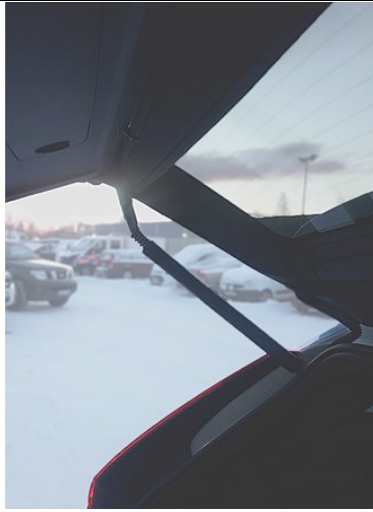
3.

**Condition 3**

Warning: If motor, power operated tailgate looks according to image, the tailgate must not be closed.

Warning: Do not operate the tailgate.

DO NOT attempt to repair the vehicle until Volvo Cars has released a safe handling/repair instruction.

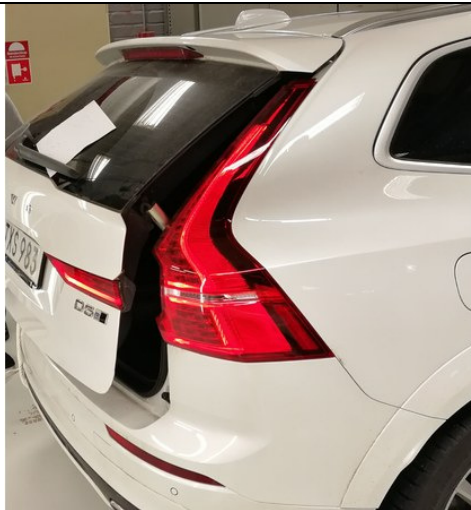
4.

**Condition 3**

Warning: Do not operate the tailgate.

DO NOT attempt to repair the vehicle until Volvo Cars has released a safe handling/repair instruction.
