January 25, 2019

Version 1

Safety Recall: 2017-19 Ridgeline Fuel Pump Cracks or Leak Inspection

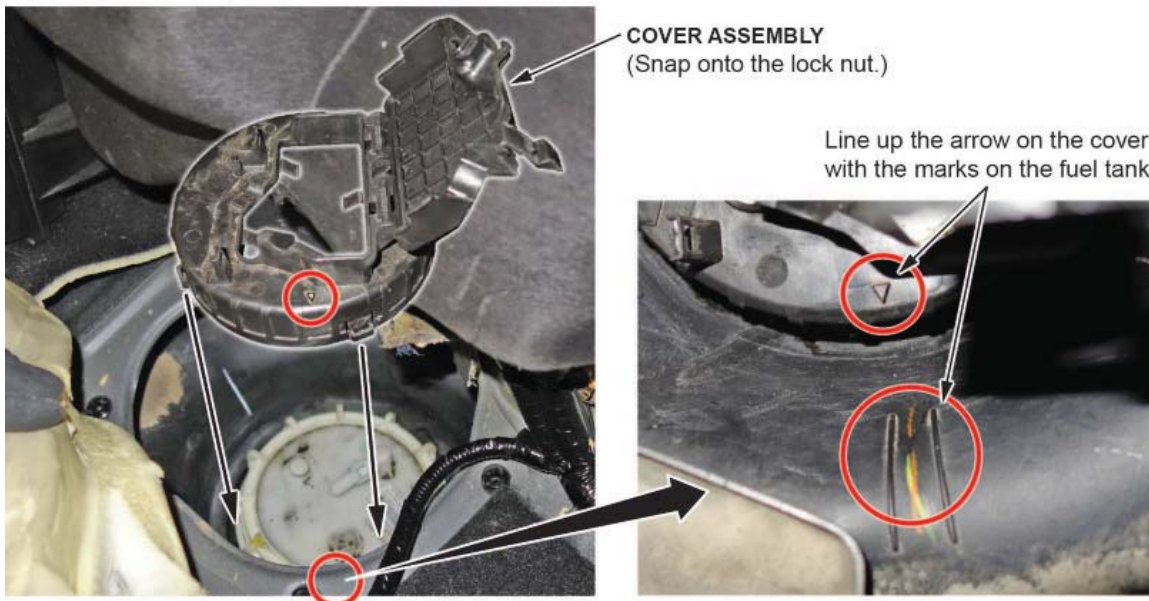
8. Install the cover assembly, and make sure the arrow on the cover lines up with the marks on the fuel tank and the cover assembly is fully snapped onto the lock nut.

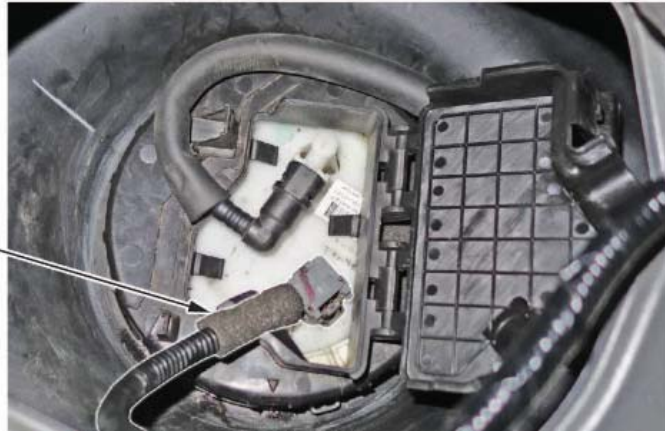
9. Connect the fuel line and the connector as shown.

Reconnect the connector and route across the cover as shown.

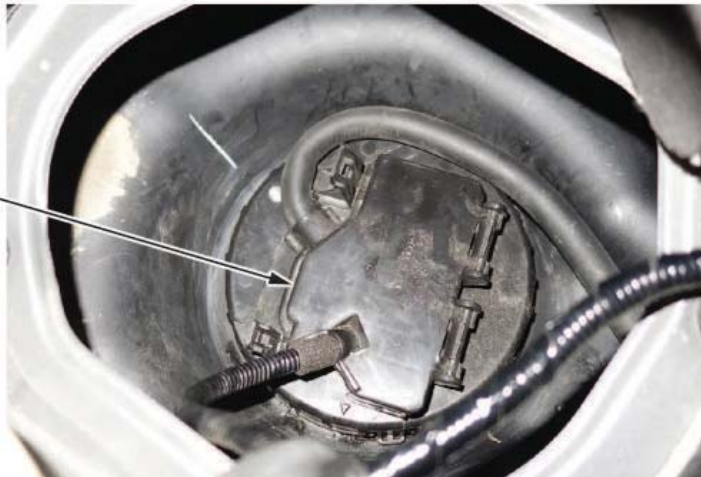
10. Close the lid on the cover assembly.

Close the cover lid.
