# Safety Recall

## Code: 42J5

**Subject** Rear Axle Coil Springs

**Affected Vehicles** **U.S.A. and Canada: Certain 2015-2019 MY Volkswagen Golf, 2017-2019 MY Golf SportWagen, 2019 MY Jetta and 2018-2019 MY Tiguan**

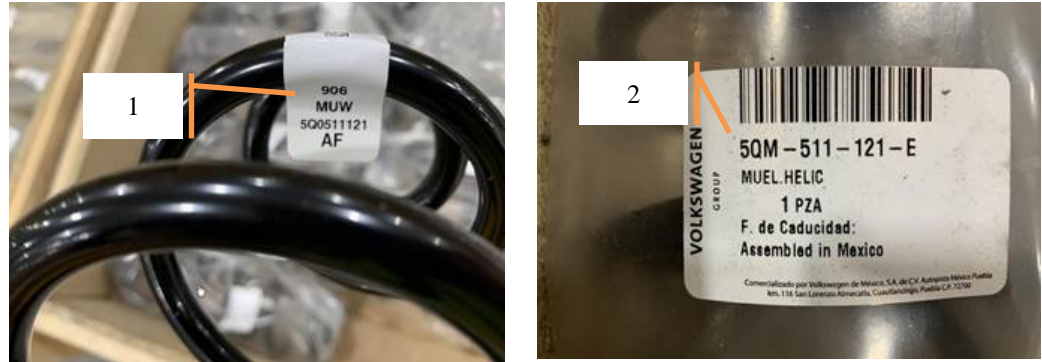
**42J5 Coil Spring Part Tag Guide**

Several part numbers used in Safety Recall 42J5 were consolidated under one (1) part number. Before filing a factory mis-box claim, and to help avoid repair delays, please refer to the table below to identify an acceptable coil spring part tag.

**Coil spring tag (1) does not match the packaging label (2).**

**This is OK.**

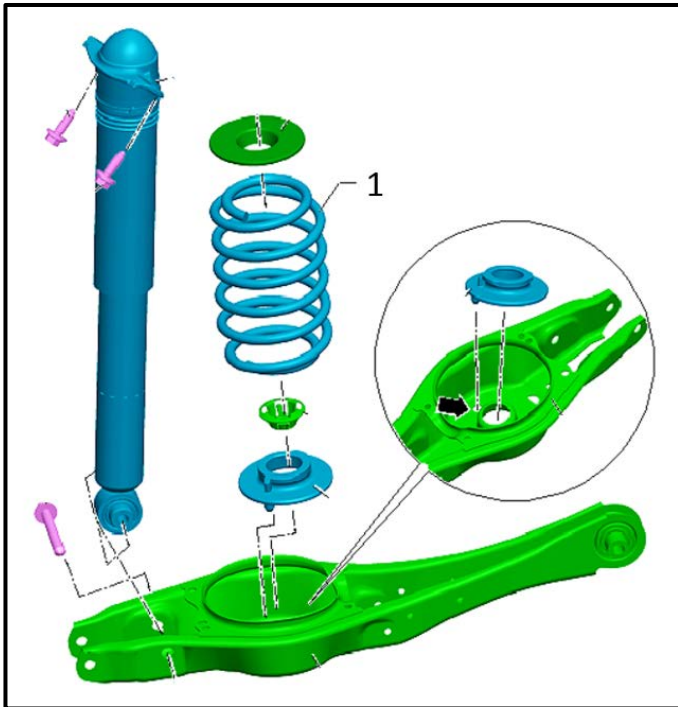
- Replace rear coil springs <1>.

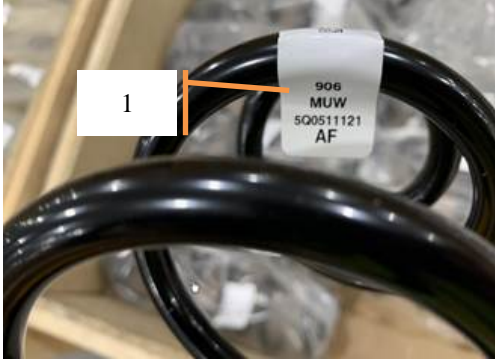
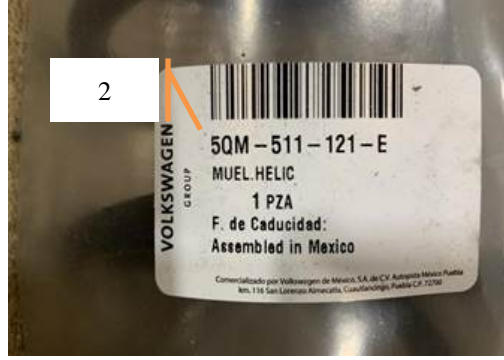
**42J5 Coil Spring Part Tag Guide**

Several part numbers used in Safety Recall 42J5 were consolidated under one (1) part number.

Before filing a factory mis-box claim, and to help avoid repair delays, please refer to the table below to identify an acceptable coil spring part tag.

**Coil spring tag (1) does not match the packaging label (2).**

This is **OK**.

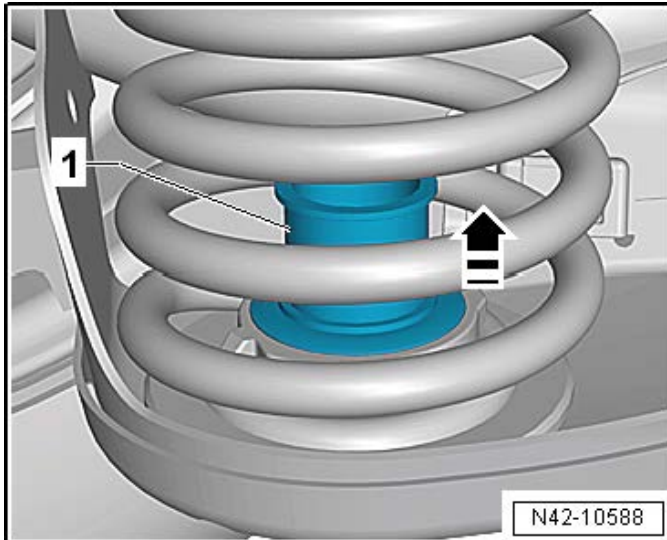
- Raise vehicle on hoist.
- Remove the clip <1> in the direction of <arrow> until stop.

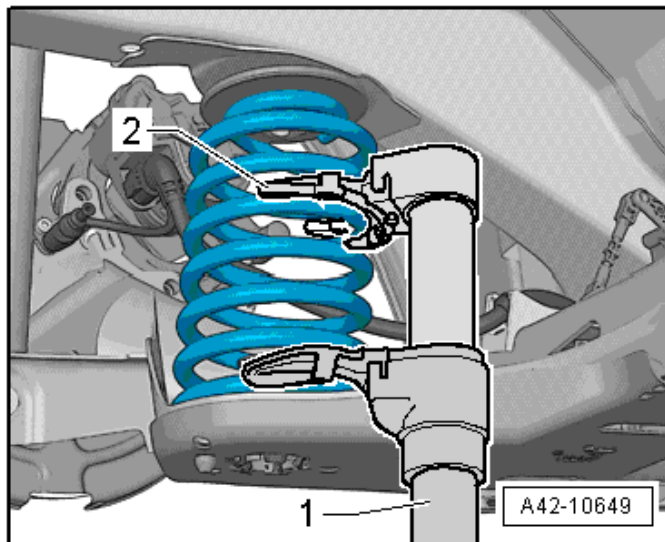
- Install Spring Tensioner -VAG1752/1- with Spring Retainer -VAG1752/3A- onto rear spring.

Make sure the coil spring is seated correctly in the -VAG1752/3A- <2>.

- Tension the coil spring and remove it.

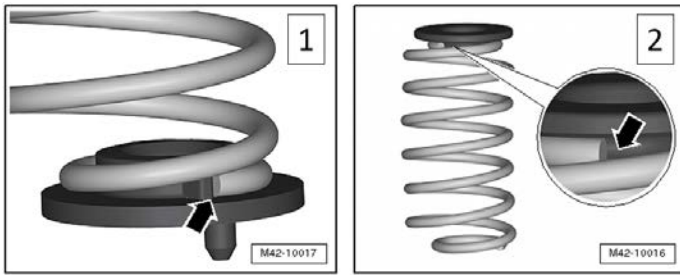
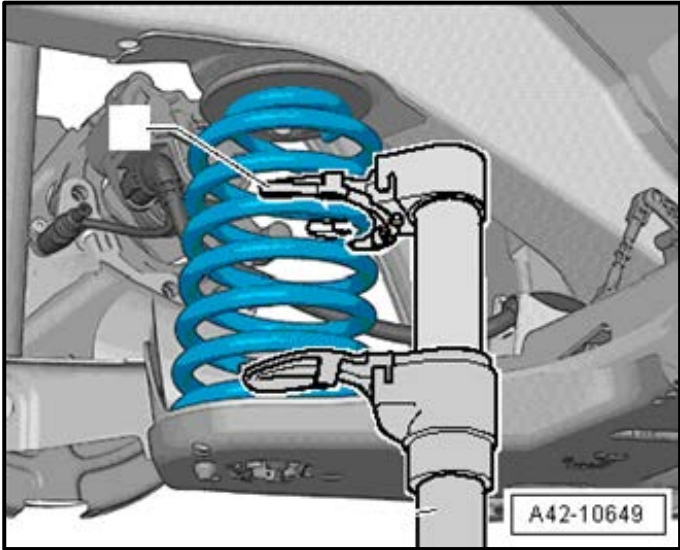
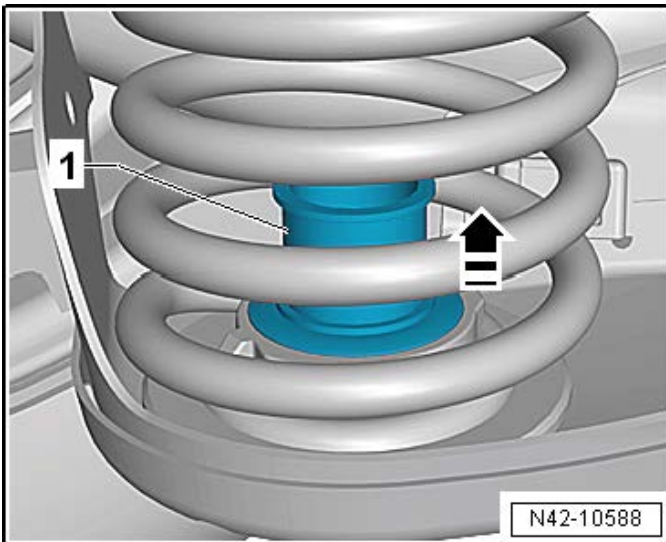
- Transfer the upper and lower spring supports to the new spring.
- Note the following when installing the new spring:
  1. The end of the spring coil <arrow> must rest against the stop on the lower spring support.
  2. The upper spring support must be fully seated on the upper spring coil <arrow>.
  3. The lower spring support pin must go through the hole in the lower control arm.
- Tension new spring with Spring Tensioner -VAG1752/1- with Spring Retainer -VAG1752/3A-, install into vehicle and slowly release tension.

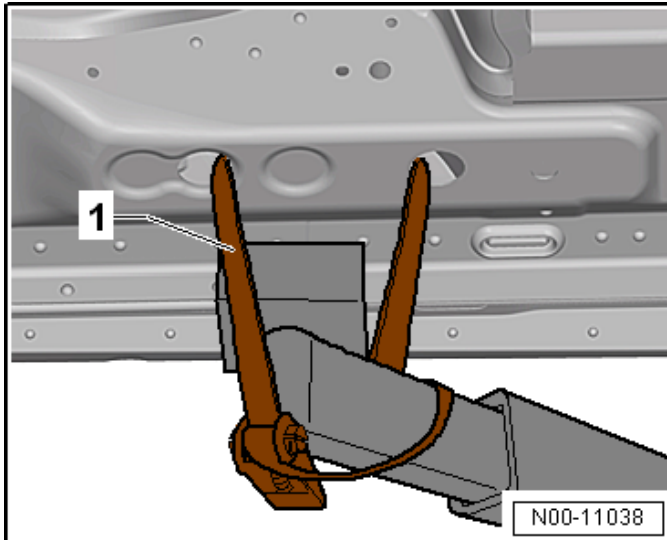
- Secure vehicle so it does not tip off the hoist using -T10038- or equivalent.

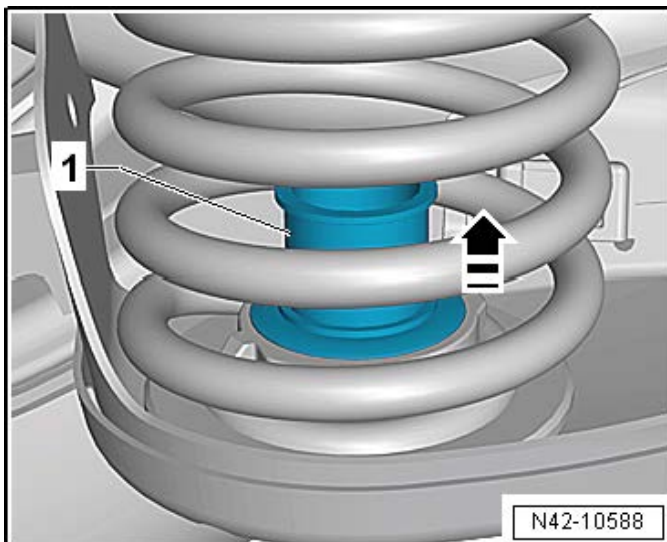
- Raise vehicle on hoist and remove rear wheels.
- Remove the clip <1> in the direction of <arrow> until stop.

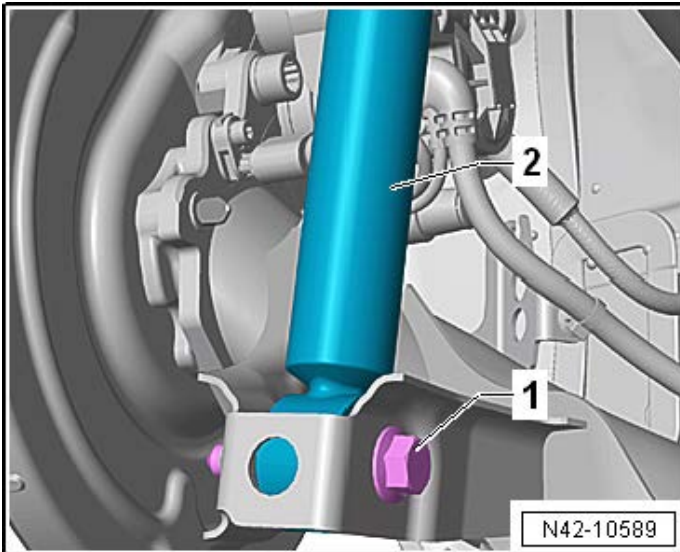
- Position the -VAS6931- with Engine/Gearbox Jack - Gearbox Support -T10337- under the spring pocket on the left side of the torsion beam axle and apply slight upward pressure.
- Remove left side lower shock bolt <1>.
- Lower the Engine and Gearbox Jack -VAS6931- and free up the shock.
- Repeat the same procedure to remove the right side lower shock bolt.

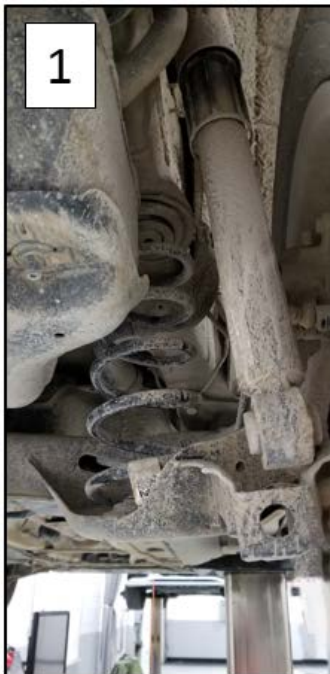
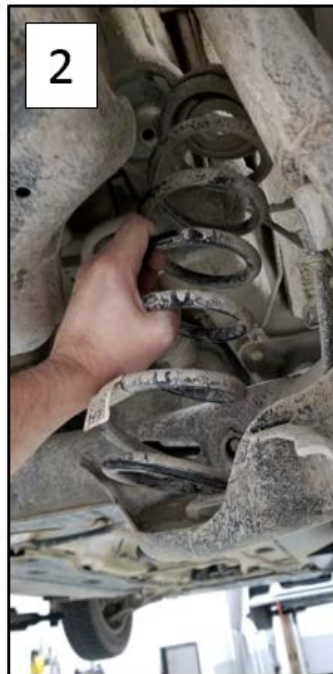
- Remove the engine and gearbox jack from under the vehicle.
- Pull down gently on the torsion beam axle and unseat the shock from the axle <image 1>.
- Unseat the coil spring from the upper pocket first, then the lower pocket <image 2>.

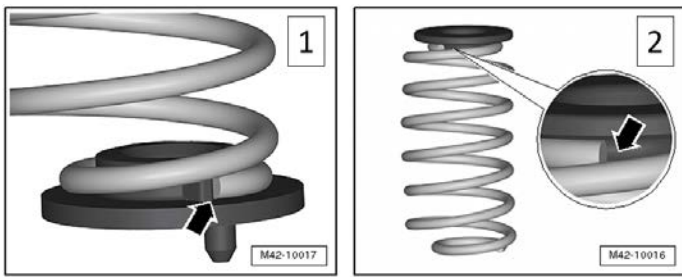
- Transfer the upper and lower spring supports to the new spring.
- Slowly raise the suspension with the -VAS6931- and guide the spring so it is seated on the upper and lower spring mounts.
- Note the following when installing the new spring:
  1. The end of the spring coil <arrow> must rest against the stop on the lower spring support.
  2. The upper spring support must be fully seated on the upper spring coil <arrow>.
  3. The lower spring support pin must go through the hole in the lower control arm.

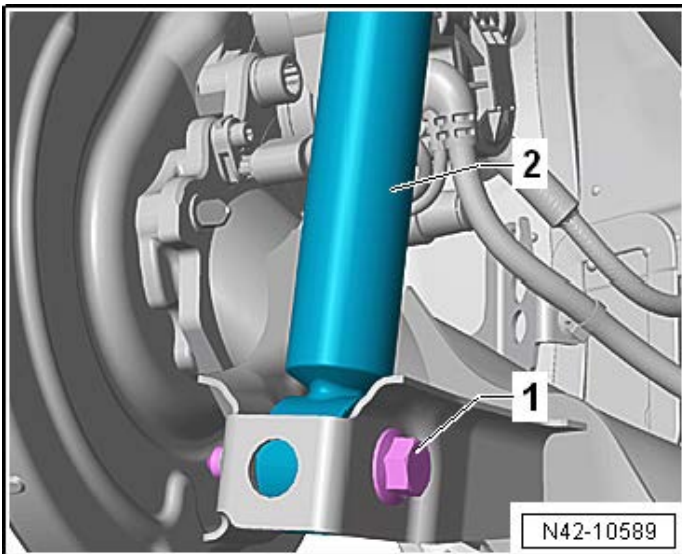
- Lift torsion beam axle on one side.
- Position shock <2> so the bolt holes on the shock and the axle line up.
- Start new lower shock bolt <1> by hand, but do not tighten.

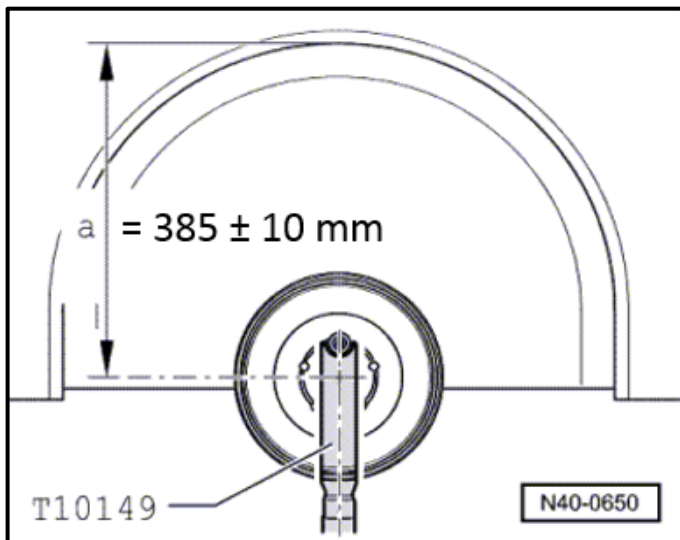
- Turn the wheel hub until one of the holes for the wheel bolts is on top.
- Install the -T10149- with a wheel bolt.
- Raise the suspension with the -VAS6931- until dimension <a> is achieved.
  - Dimension <a> = 385 ± 10 mm.

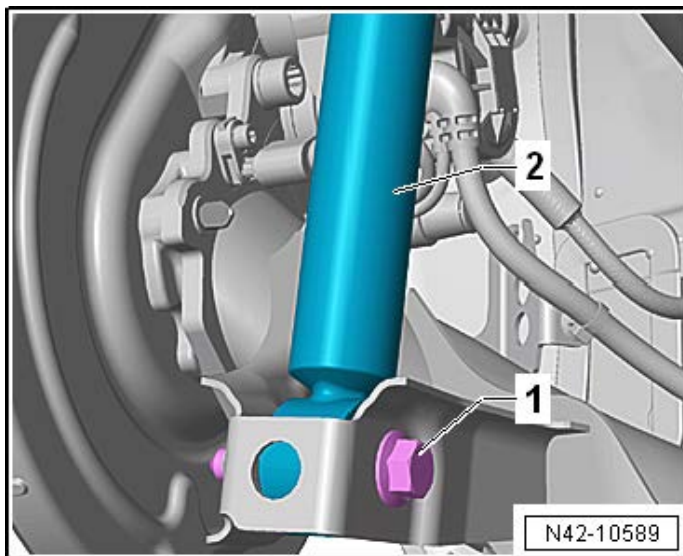
- Torque lower shock bolt <1> to 70 Nm + 180°.
- Install rear wheels and torque to 120 Nm.
- Remove any tools that were used to secure the vehicle on the hoist.
- Remove tools from under the vehicle.
