## RECALL CAMPAIGN BULLETIN

BR19-002

### VOLUNTARY SAFETY RECALL CAMPAIGN BRAKE PEDAL INSPECTION

**CAMPAIGN ID #:** PC691  
**APPLIED VEHICLES:** 2019 Altima (L34)

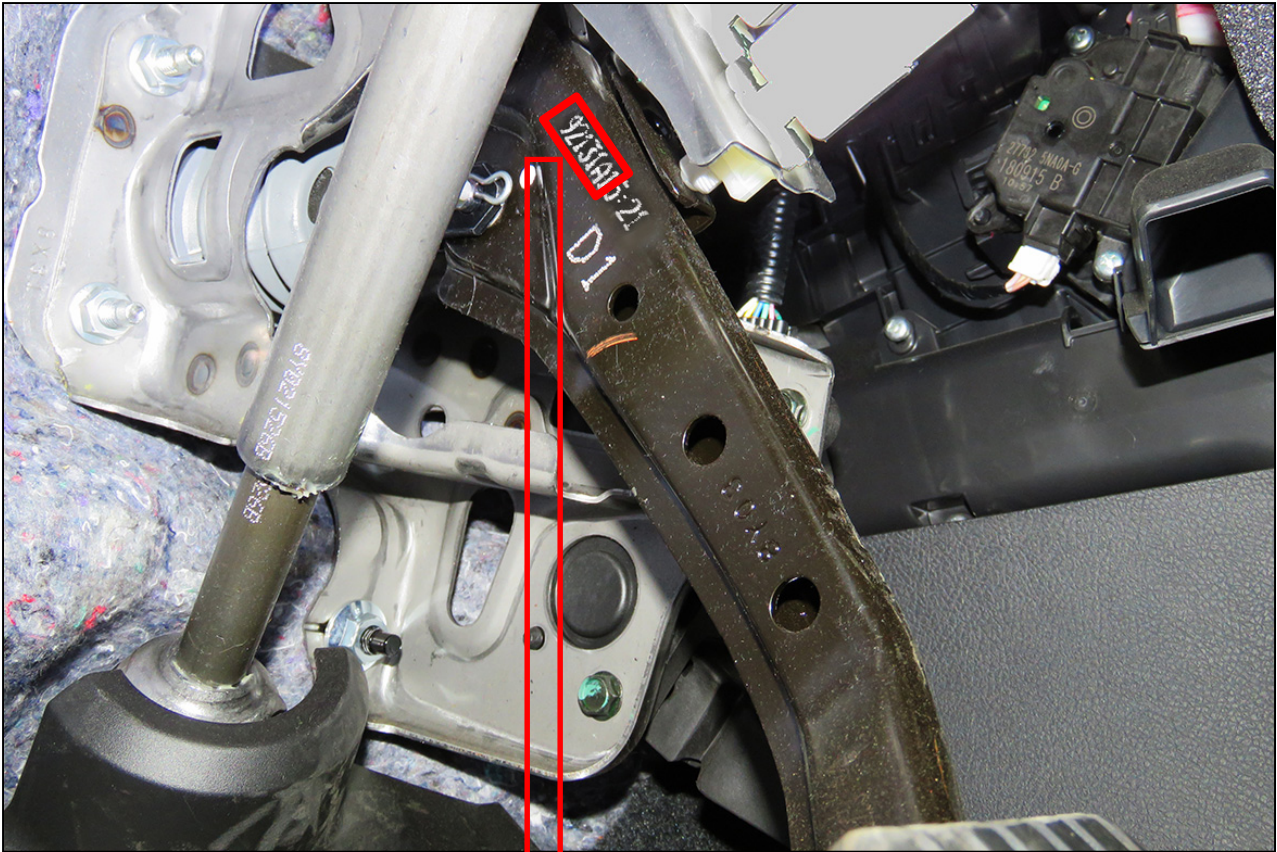
1. Write down the first six (6) digits of the lot number located on the brake pedal arm as shown in Figure 1 and Figure 2.

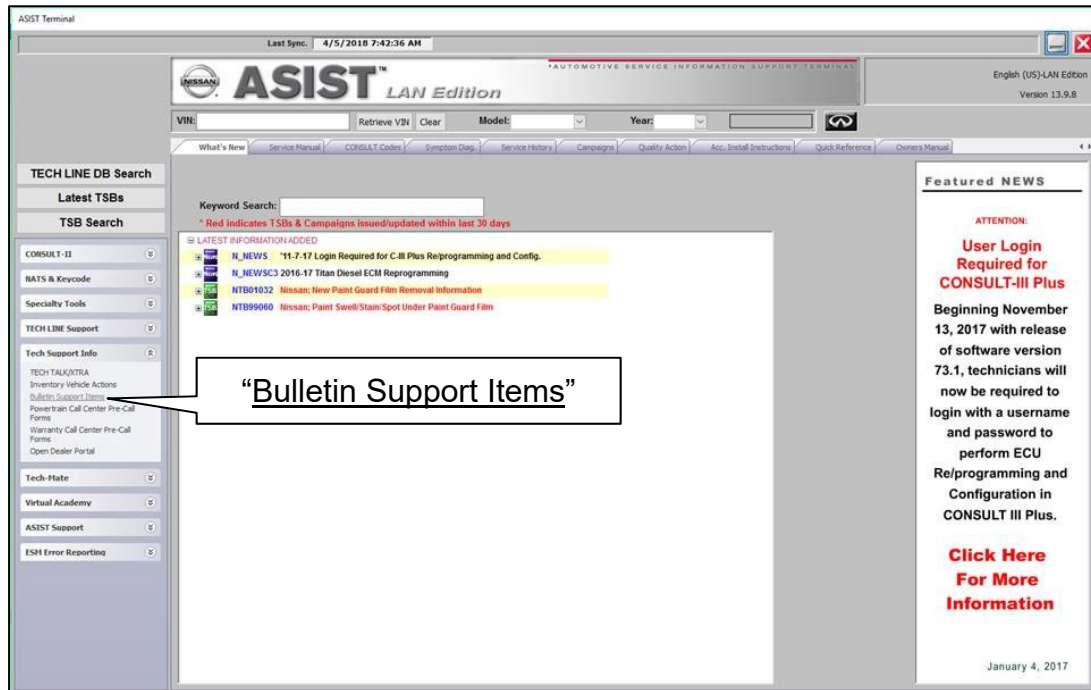
Figure 3

2. Open ASIST.
3. Select the “Tech Support Info” tab on the left side of the ASIST screen.
4. Select “Bulletin Support Items.”

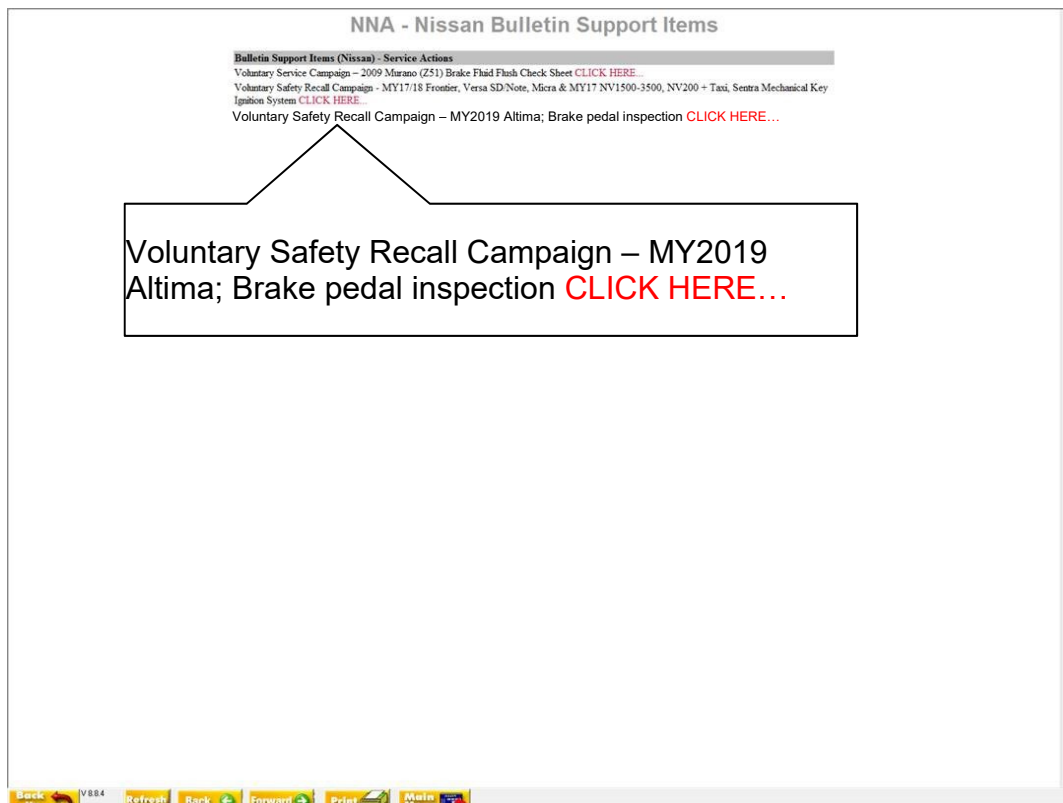
Figure 4

5. Select “Voluntary Safety Recall Campaign – MY2019 Altima; Brake pedal inspection [CLICK HERE...](#)”
