April 2019

Safety Recall V35 / NHTSA 19V-246

Sun Visors Label

2019 (LD) Dodge Charger

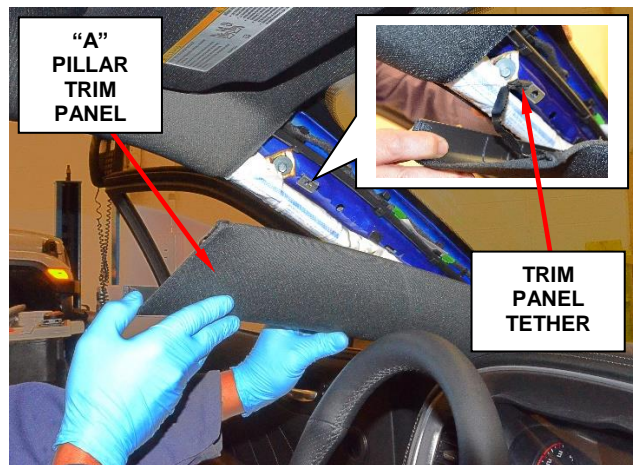
Figure 1 – “A” Pillar Trim

2. Remove the “A” pillar trim panels from both sides (Figure 1).

NOTE: Release the trim panel tether from the “A” post body retainer (Figure 1).

18. Repeat the procedure on both sun visors.
19. Gently push the sun visor retainers into the roof panel.
20. Install the overhead console screw (Figure 2).
21. Secure the sun visor screws and install the visor arm cover (Figure 4).
22. Install the sun visor clips and secure the screws and install the cover (Figure 3).
23. Install the grab handle and secure the screws (Figure 5).
24. Install the “B” pillar trim panels and secure the screws (Figure 6).
25. Install the front and rear sill plate covers.
26. Install the “A” pillar trim panels (Figure 1).

NOTE: Secure the “A” trim panels tether to the body

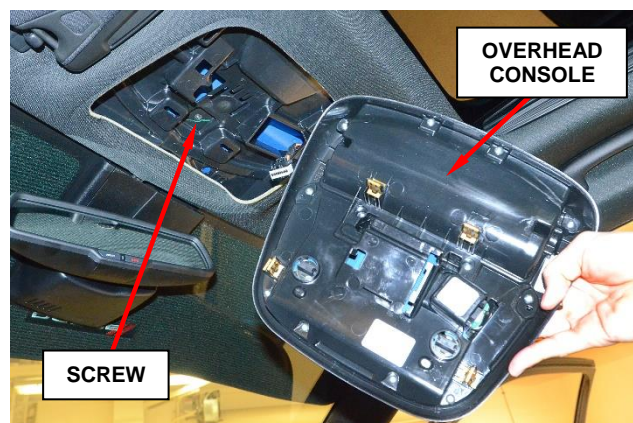
Figure 2 – Overhead Console

3. Lower the overhead console and disconnect the electrical connector (Figure 2).

4. Remove the overhead console screw (Figure 2).

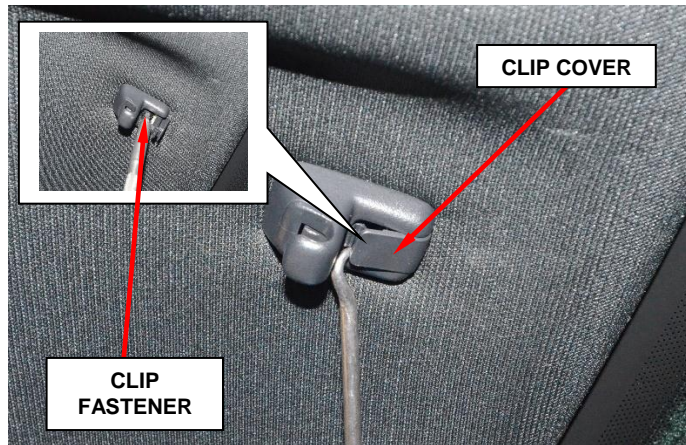
Figure 3 – Visor Clip

5. Remove both visor clip covers to gain access to the fastener then remove the visor clips (Figure 3).

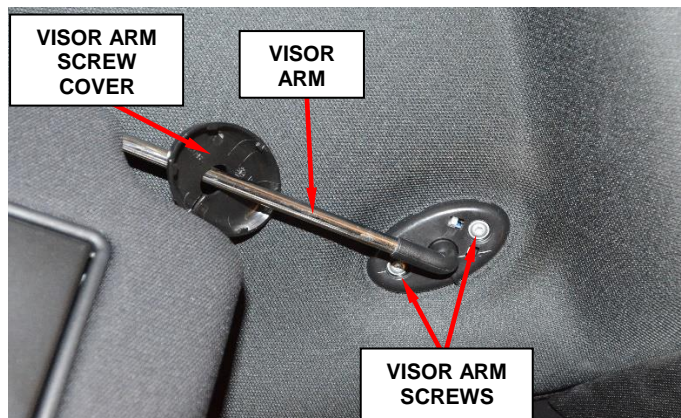
Figure 4 – Visor Arm

6. Remove the visor arm screw covers from both sides (Figure 4).

7. Remove the visor arm screws and allow the sun visor to hang (Figure 4).
8. Remove both grab handles screws and then remove the handle (Figure 5).

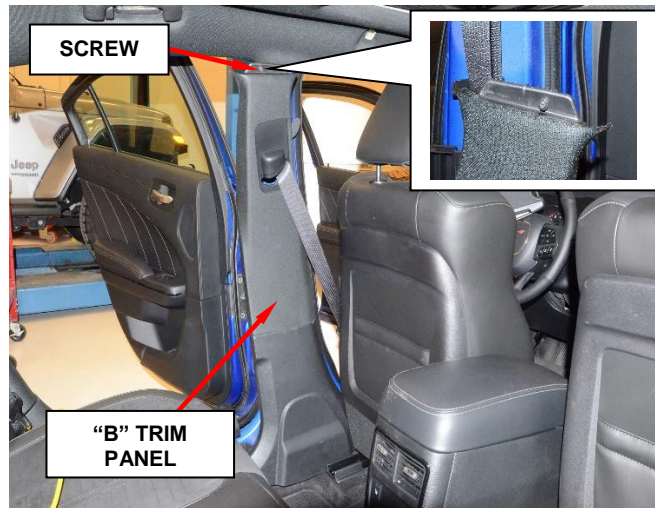
Figure 6 – “B” Pillar Trim Panel

9. Partially remove the front and rear sill plate covers.
10. Remove the “B” pillar trim panels screws from both sides (Figure 6).
11. Grasp the “B” trim panel and pull the trim panel away from the body on both sides.

NOTE: “B” Trim panel is a one-piece panel

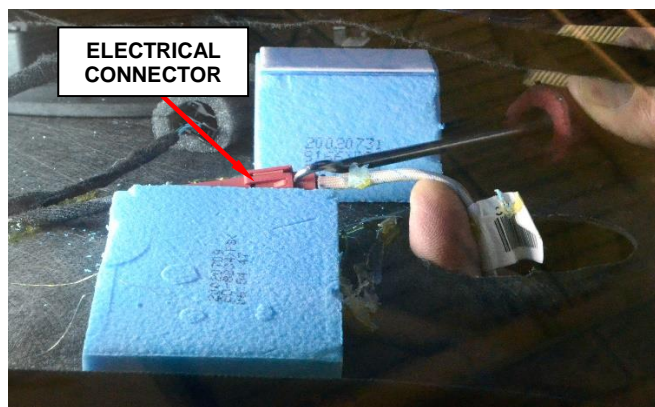
Figure 7 – Electrical Connector

12. Carefully pull down on the front headliner to gain access to the sun visor electrical connector and disconnect the electrical connector (Figure 7).

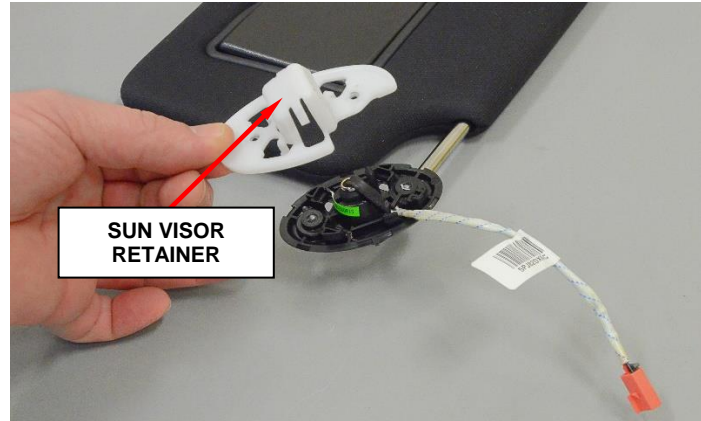
Figure 8 - Retainer

13. Remove the sun visor arm retainer from the vehicle body (Figure 8).

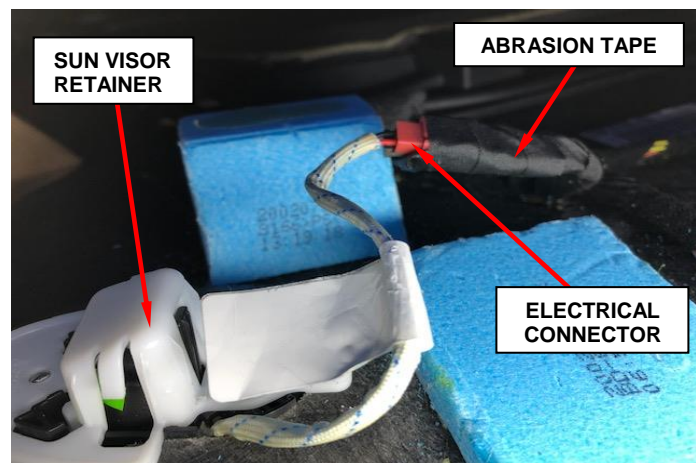
Figure 9 – Electrical Connector

14. Route the **NEW** sun visor electrical connector through the headliner and the visor retainer, and connect the electrical connector to the headliner electrical harness.
15. Wrap the **NEW** sun visor electrical connector on the headliner harness side with abrasion tape (Figure 9).
16. Align the **NEW** sun visor arm to the headliner opening and attach the sun visor retainer to the back of the headliner to hold the visor to the headliner (Figure 10).

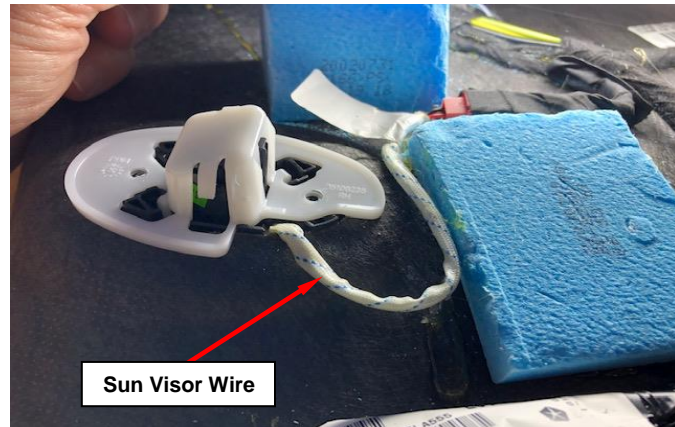
Figure 10 – Wire Routing

17. Route the sun visor wire along the blue pad as illustrated (Figure 10).
