Safety Recall: 2014-19 MDX Inner Taillights

BACKGROUND

An uneven sealing surface allows moisture to enter the inner taillight(s), causing one or all of the taillights not to work.

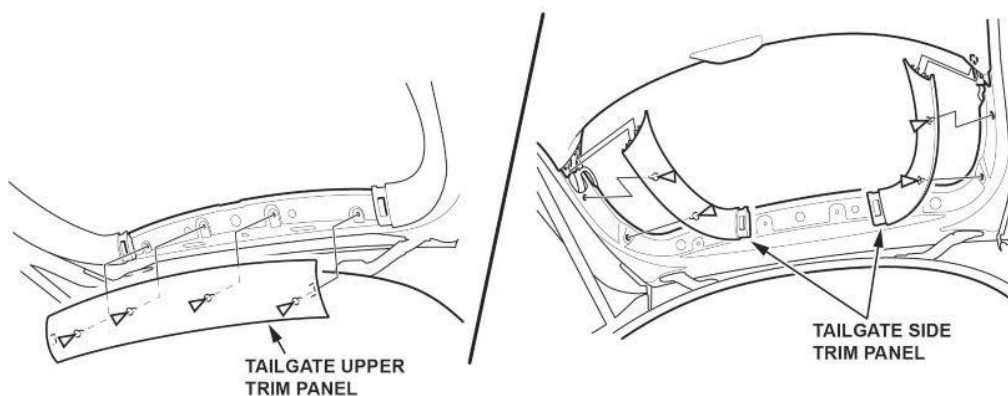
2. Remove the tailgate upper trim panel, then remove the side trim panels.

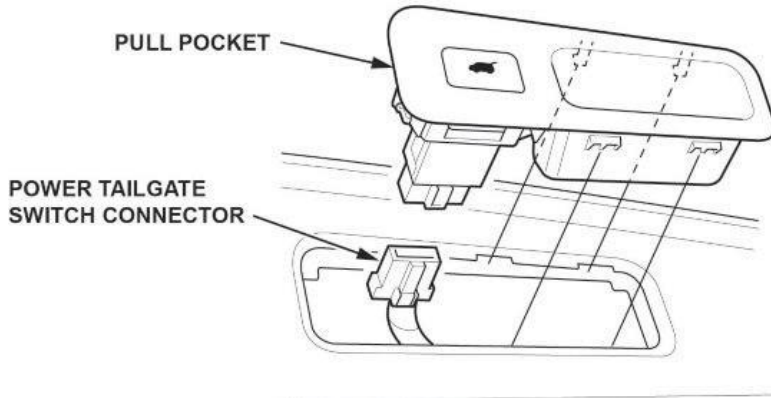
3. Remove the pull pocket and disconnect the power tailgate switch connector.

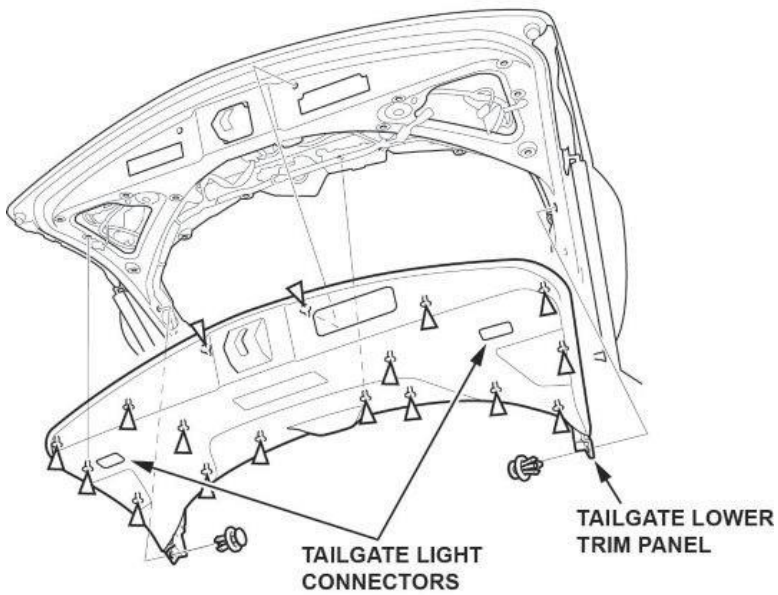
4. Remove the tailgate lower trim panel, then disconnect the tailgate light connectors.

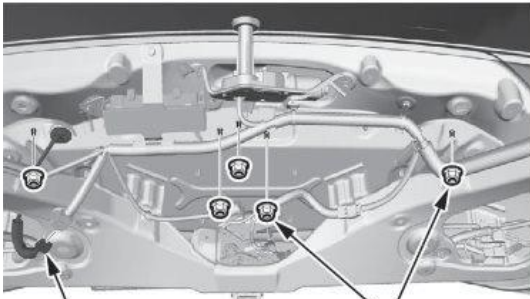
INSIDE THE TAILGATE

5. Disconnect the license sub harness connector, remove the five nuts, release the pins from the clips, then remove the rear license trim.

LICENSE SUBHARNESS CONNECTOR

4.9 N-m (3.6 lb-ft)

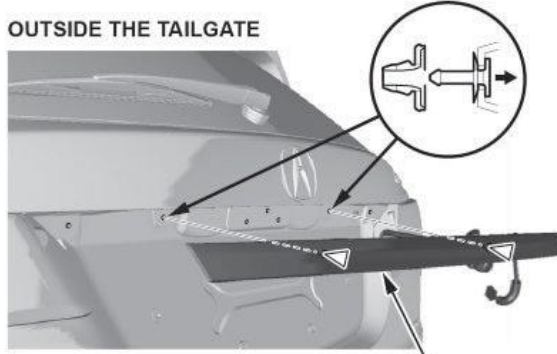
OUTSIDE THE TAILGATE

REAR LICENSE TRIM

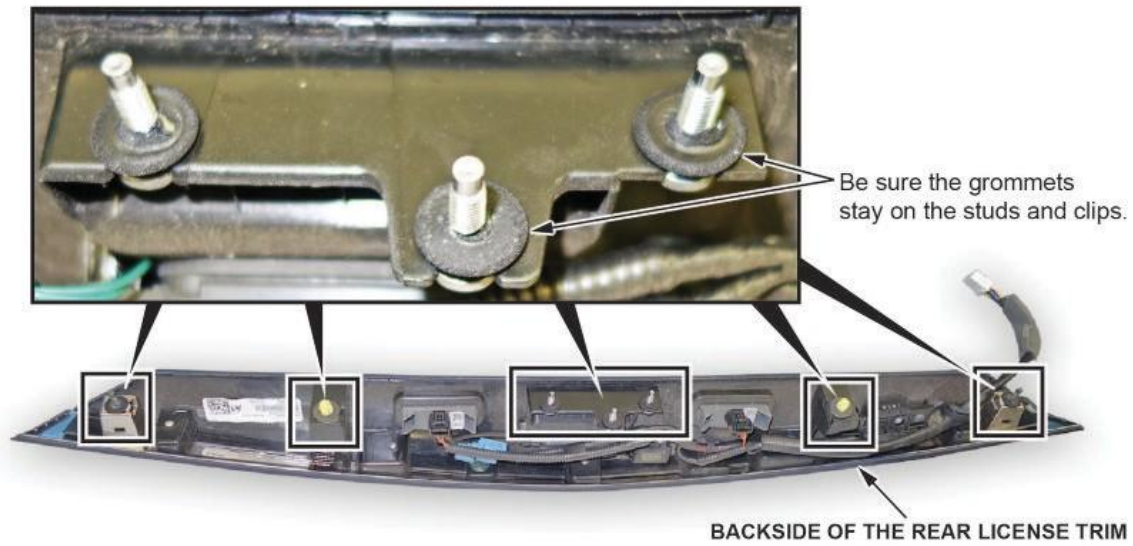
BACKSIDE OF THE REAR LICENSE TRIM

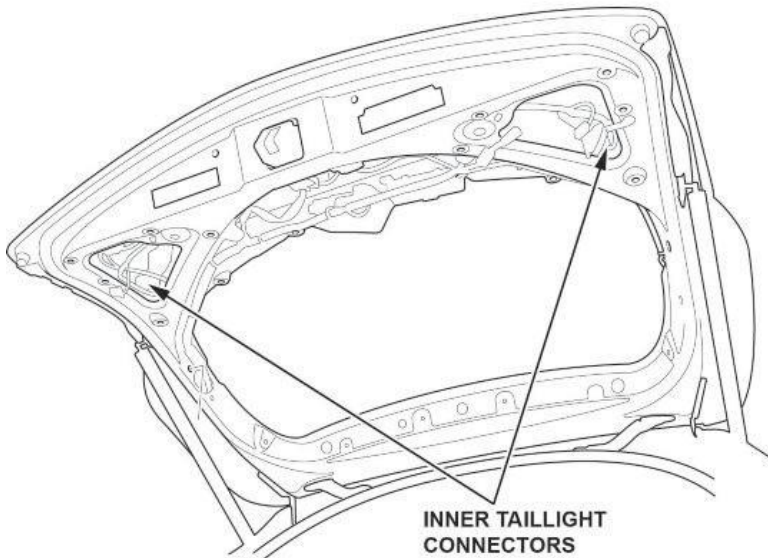
6. Disconnect both inner taillight connectors.

INNER TAILLIGHT CONNECTORS

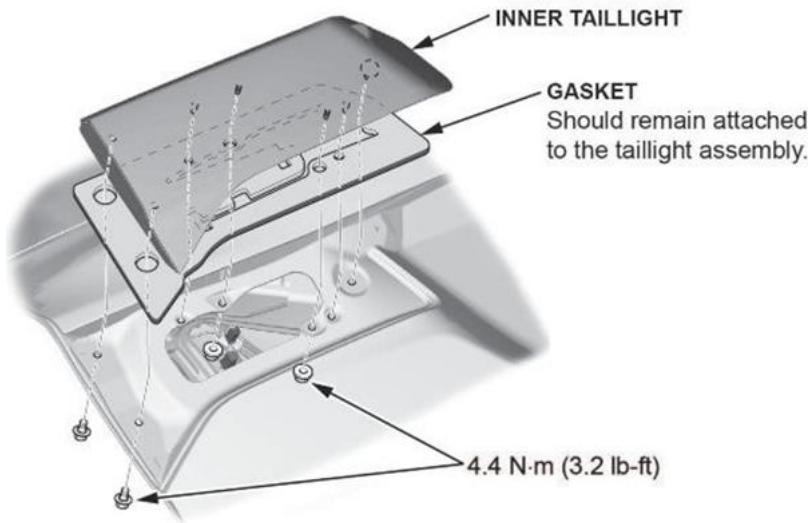
7. Remove the two bolts and two nuts behind each inner taillight, then remove the inner taillights.
NOTE: Be sure to completely remove the old inner taillight gasket.

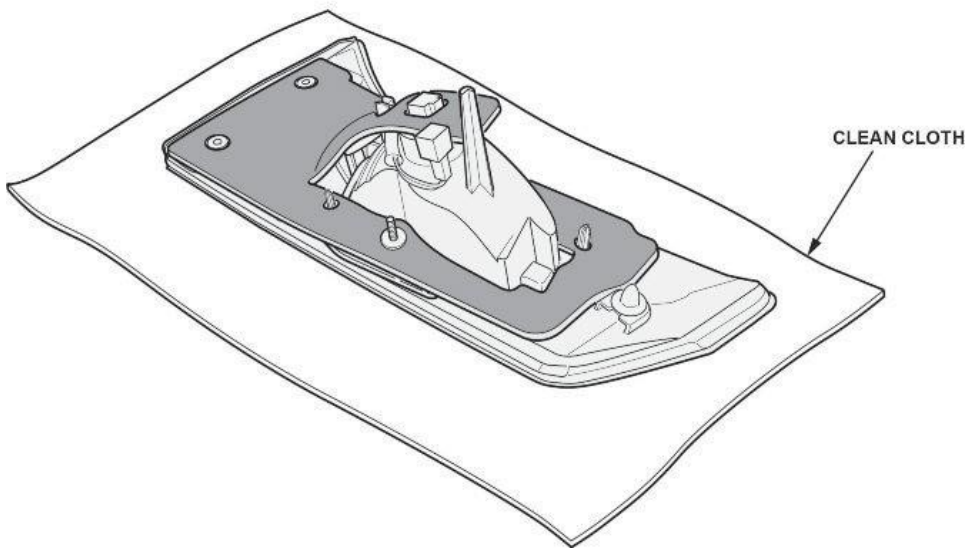
8. Place the inner taillight on a soft, clean cloth to prevent lens damage.

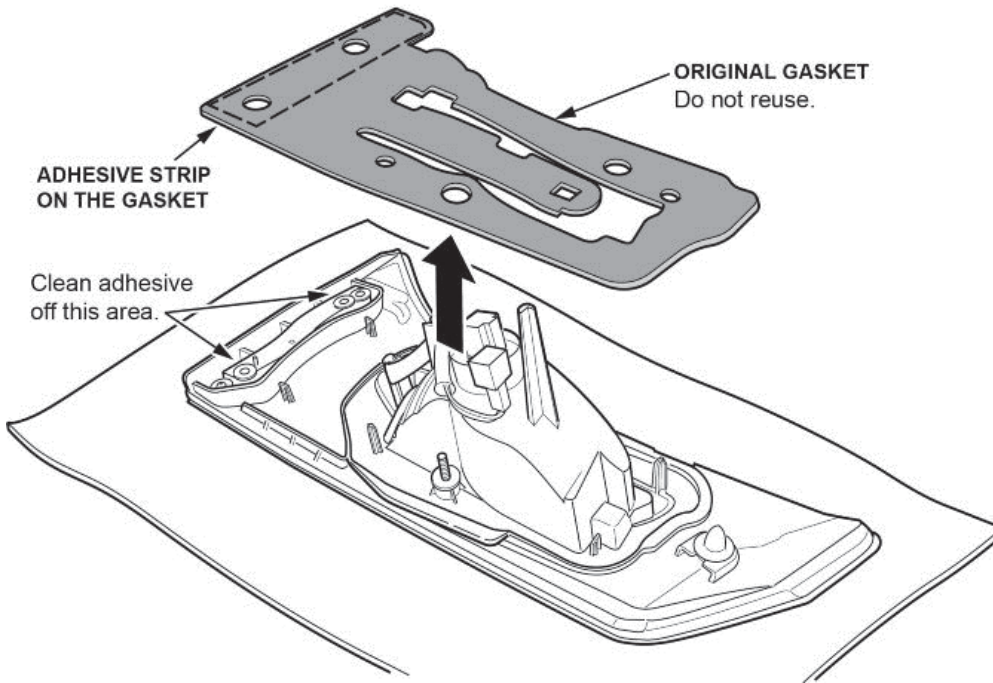
9. Remove the original gasket from the inner taillight and remove any remaining gasket material/adhesive.
NOTE: Do not use commercial adhesive removing chemicals, they could damage the plastic light body.

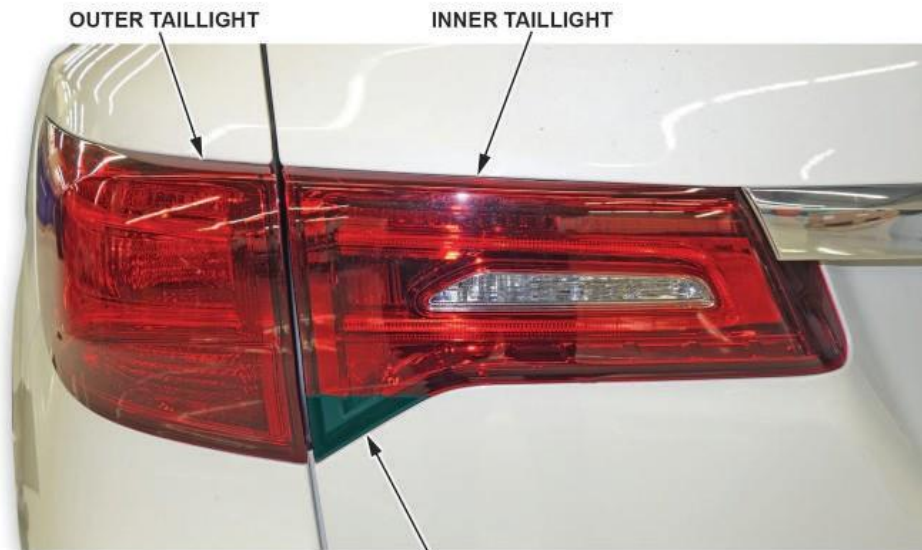
10. Hold the inner taillight upright, and check for trapped water.

WATER TRAPPED IN INNER TAILLIGHT

If there is trapped water, remove the top screw and turn the light upside down to drain it. Then, install the screw.

NOTE: Remove as much water as possible, any remaining moisture will eventually evaporate.

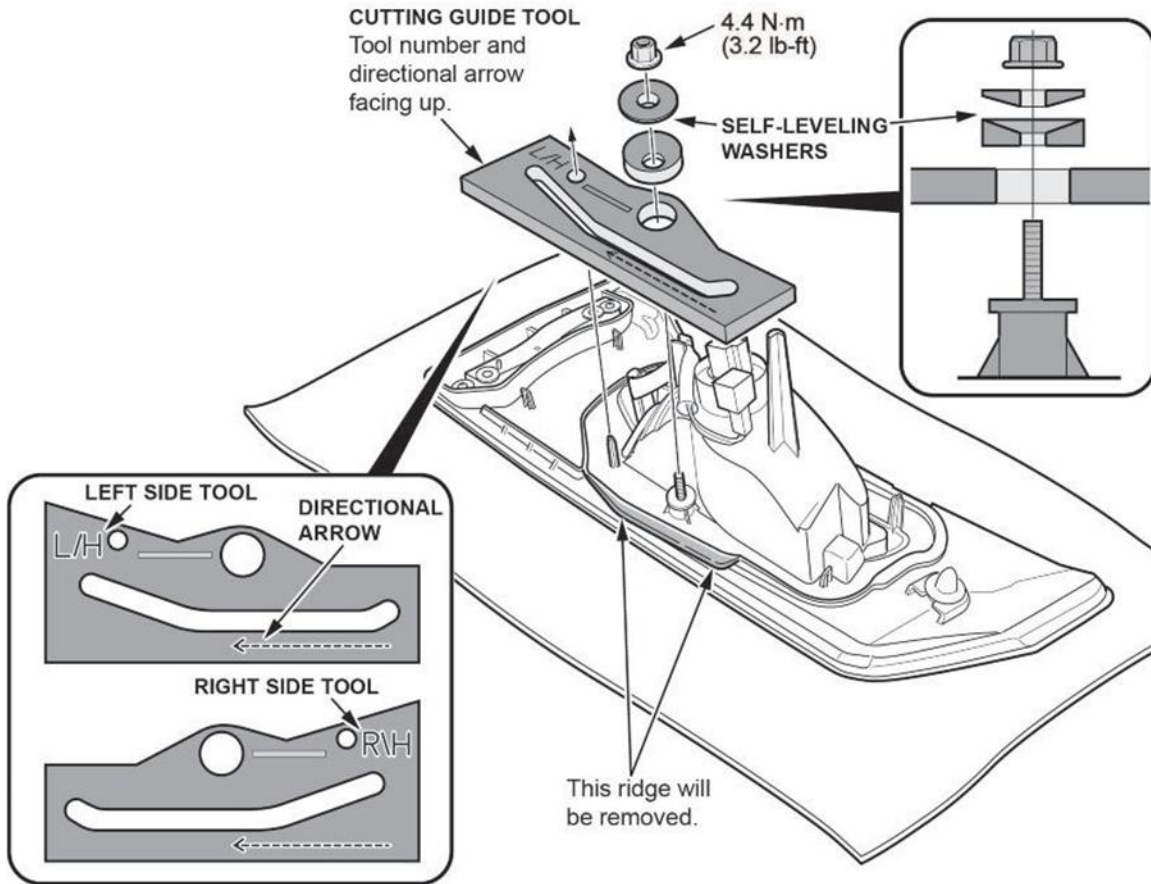
12. Using the flush cut bit attached to a commercially available right-angle grinder or similar tool, remove the excess material from the inner taillight housing. Make sure the cutter depth is set to **6 mm**. If needed, loosen the set screw and adjust the height and tighten.

NOTE: Not all of the ridge will be removed, a very small portion should remain.

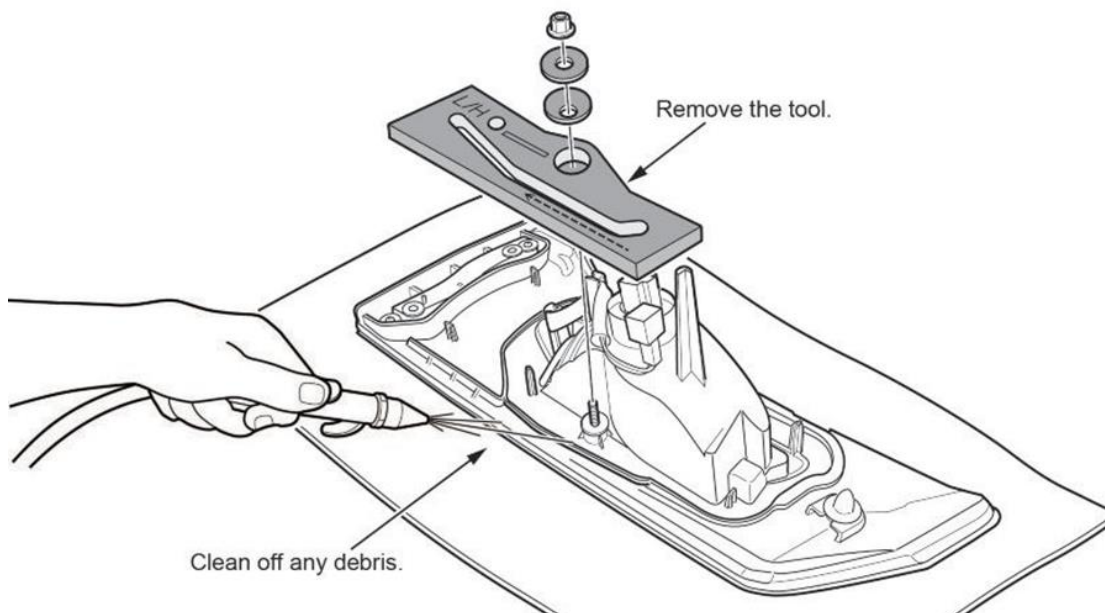
14. Clean inner taillight mating surface with isopropyl alcohol and install the new light gasket. Remove the adhesive tape backing and attach it to the taillight.

NOTE: The gaskets are marked **L** for left and **R** for right. Make sure to use the correct side.

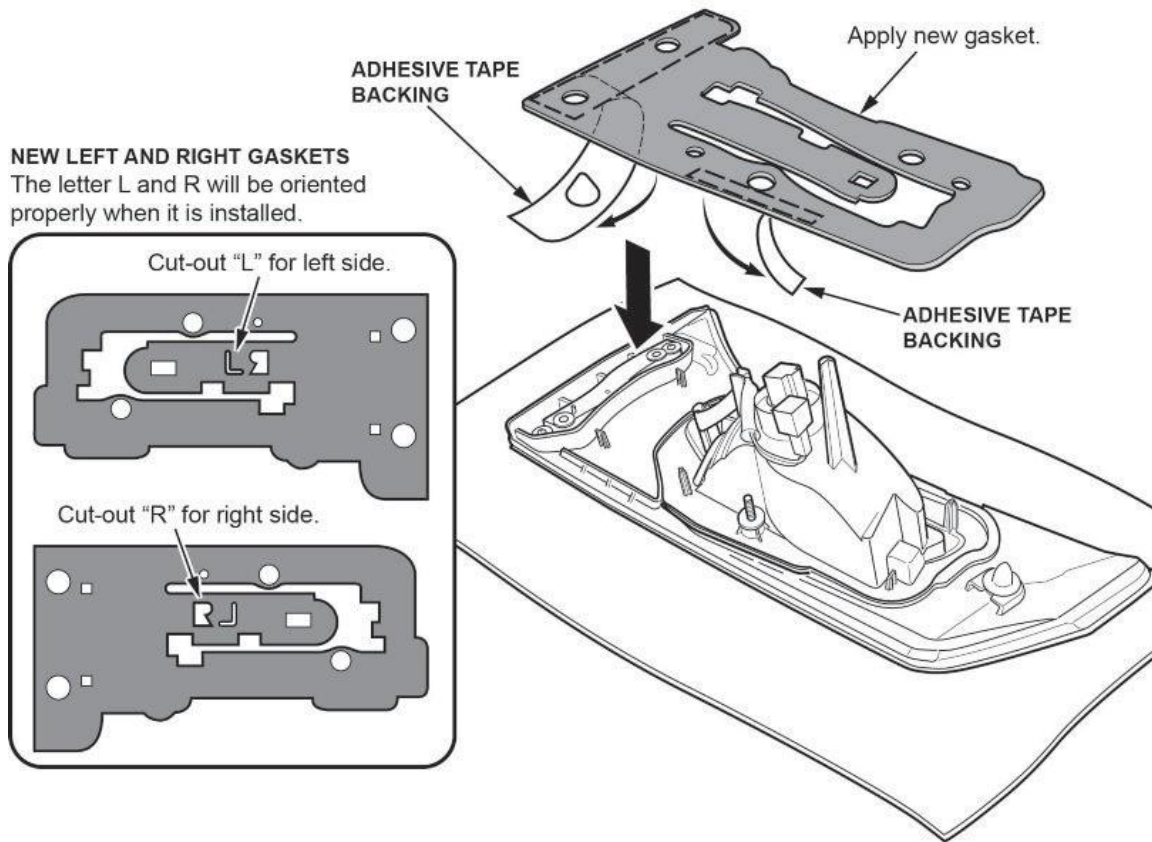
16. Install the inner taillights and torque the nuts and bolts to **4.4 N-m (3.2 lb-ft)**.

NOTE: Make sure the gasket is properly attached to the inner taillight.

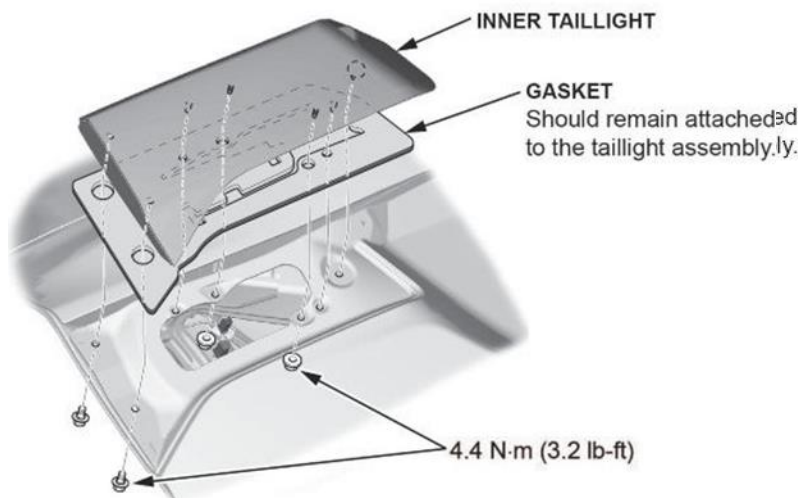
17. Install the rear license plate trim. Make sure the grommets are attached to the studs and clips then connect the connector and torque the nuts to 4.9 N-m (3.6 lb-ft).

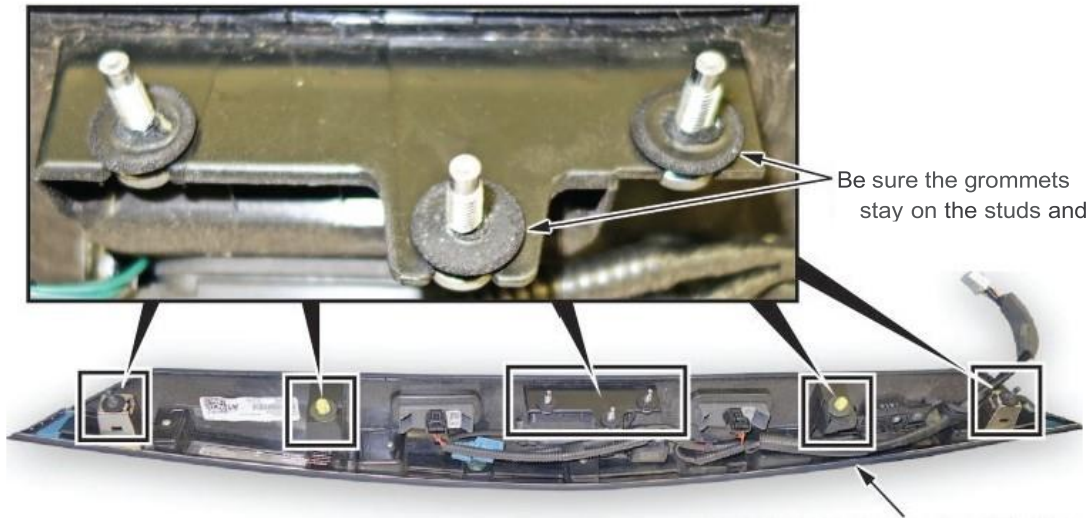
BACKSIDE OF THE REAR LICENSE TRIM

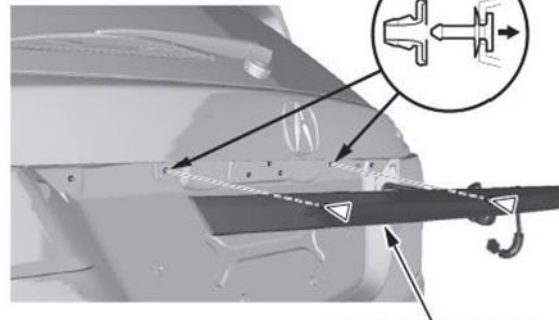
OUTSIDE THE TAILGATE

18. Install and route the new inner taillight sub harness (included in the service kit) to the existing tailgate harness as shown.

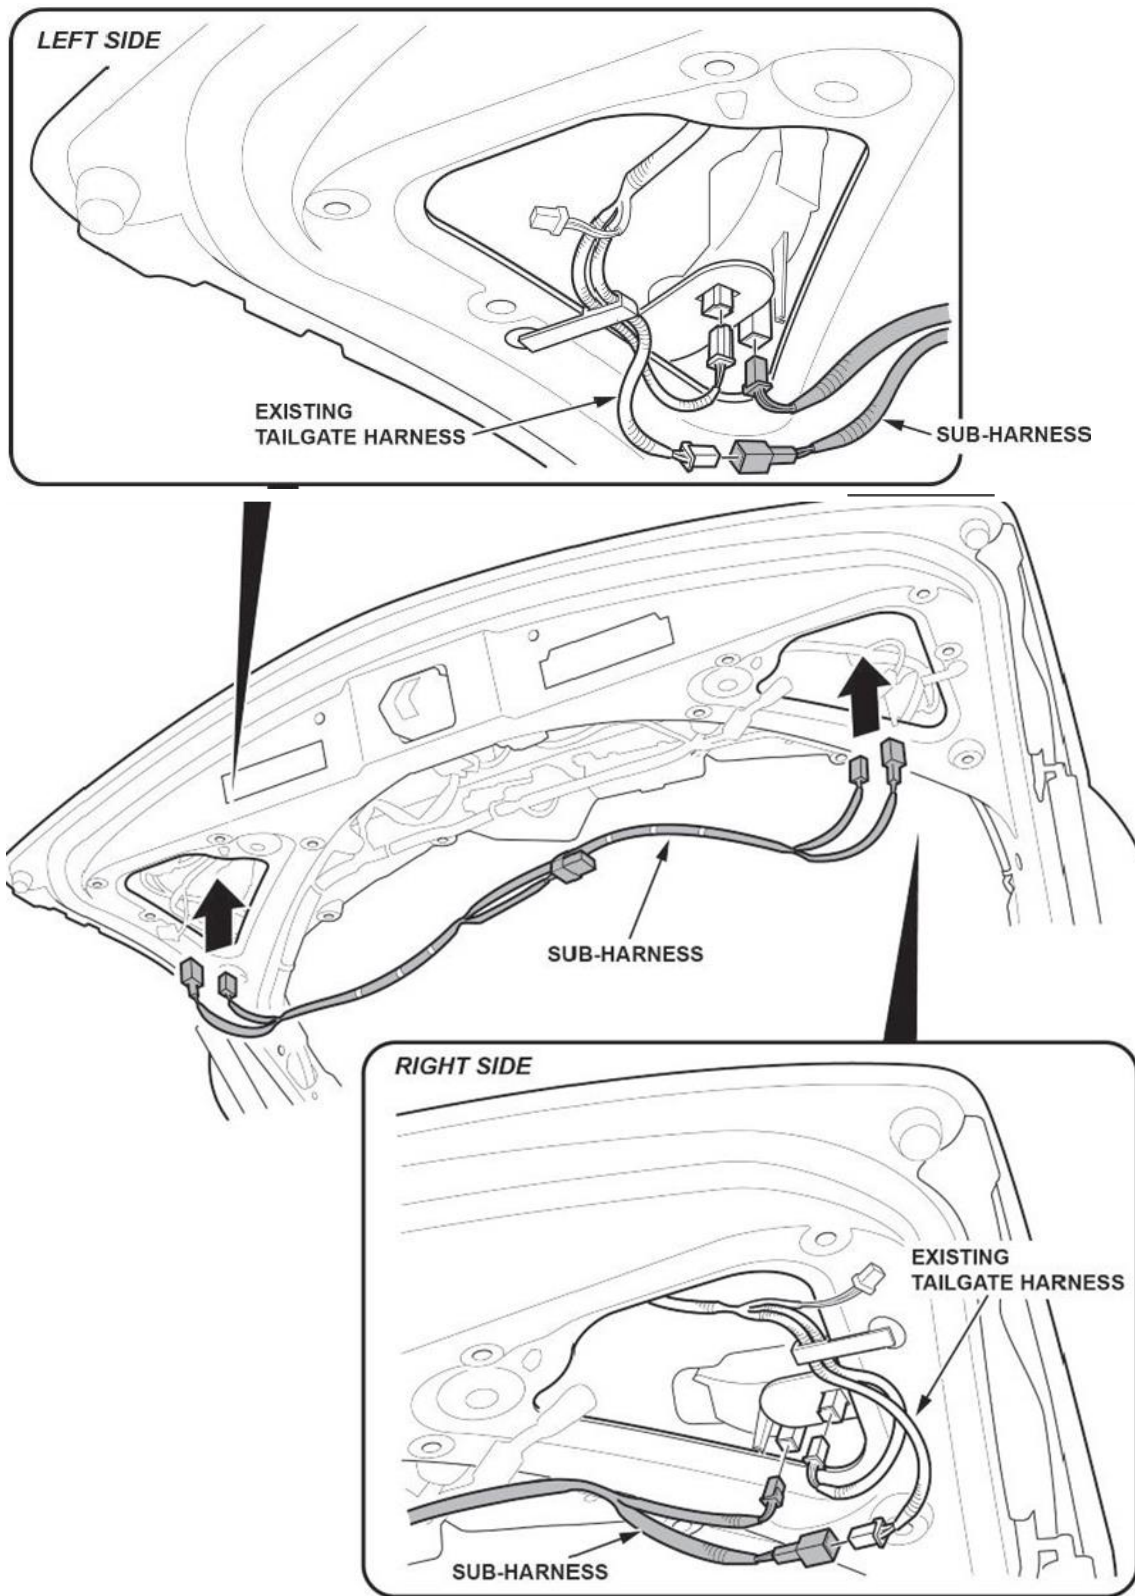
19. Secure the new inner taillight sub harness. Use the supplied wire ties on each of the white pieces of tape found on the new harness, starting from the center and moving out toward the connectors as shown.

NOTE: Trim any excess from the wire ties.

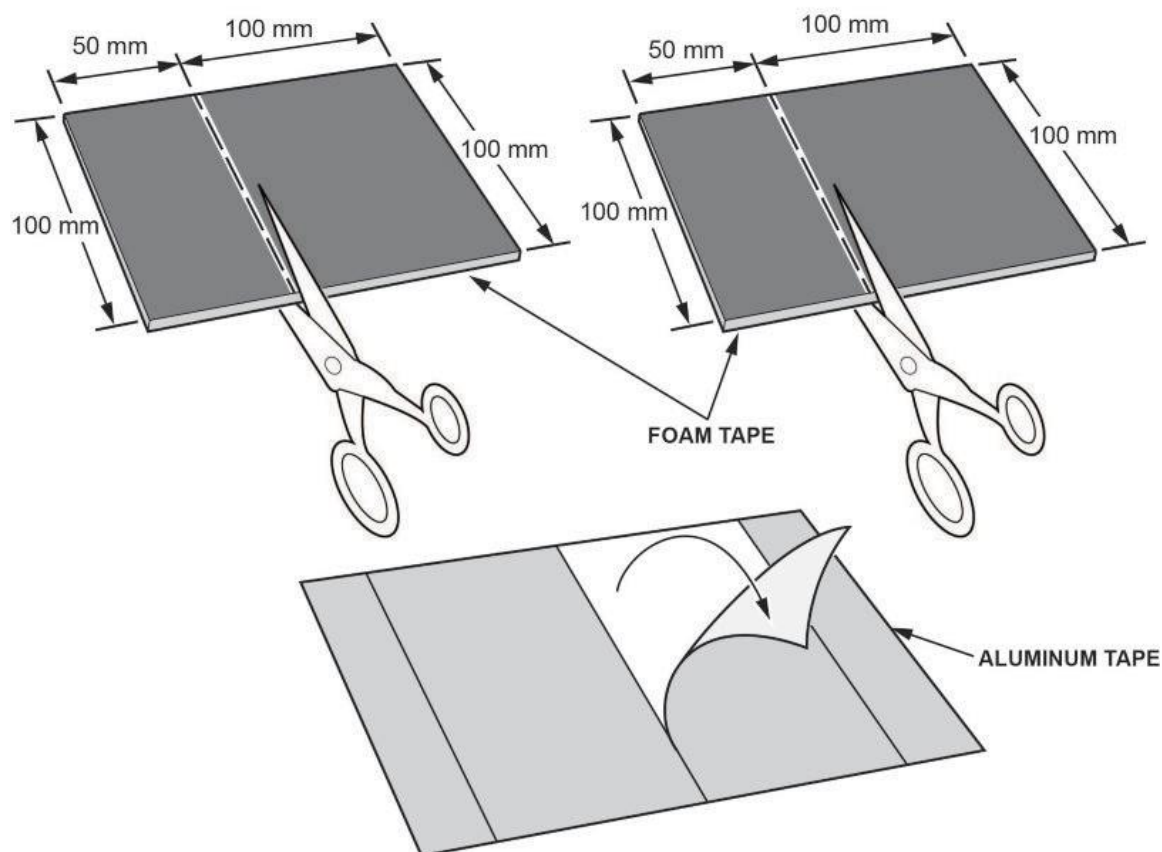
21. Clean the areas shown below with isopropyl alcohol and attach the foam tape pieces. Then, secure the harness and connectors to the body with aluminum tape as shown.

NOTE: To prevent water intrusion, make sure the foam tape covers the entire connector. The aluminum tape should wrap around the foam wrapped connector to the back side of the metal, this will prevent rattles.

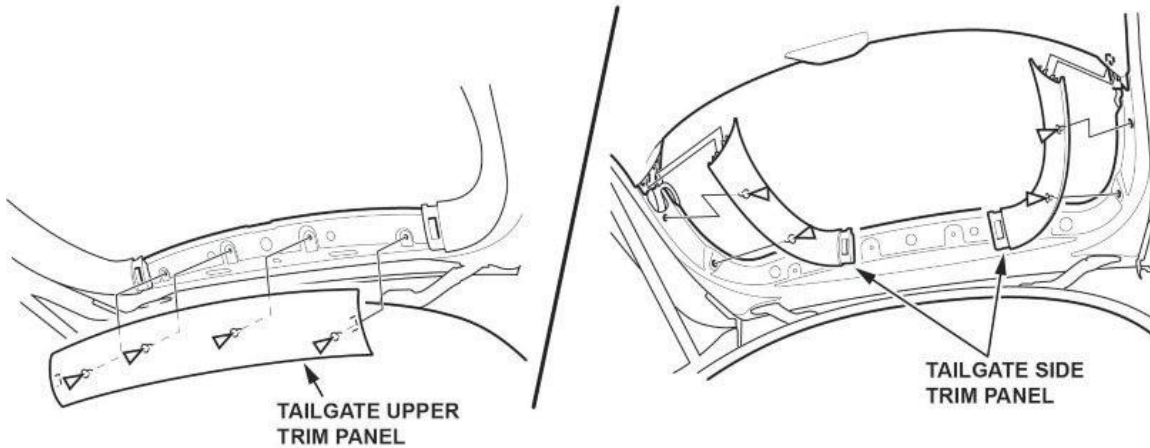
2. Remove the tailgate upper trim panel, then remove the side trim panels.

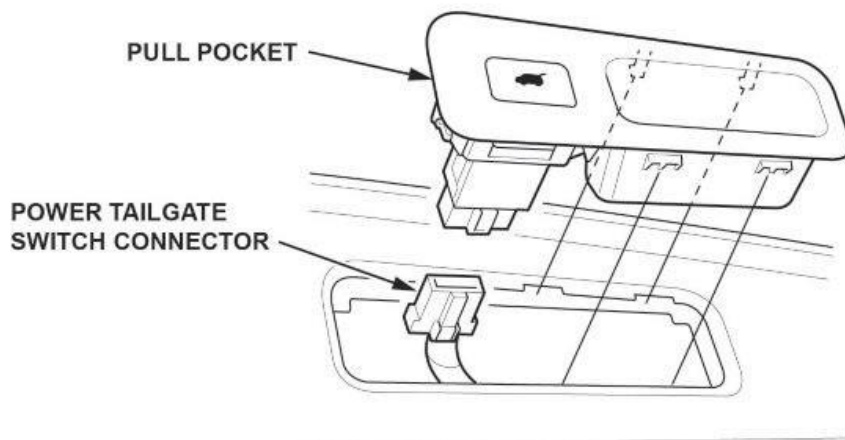
3. Remove the pull pocket and disconnect the power tailgate switch connector.

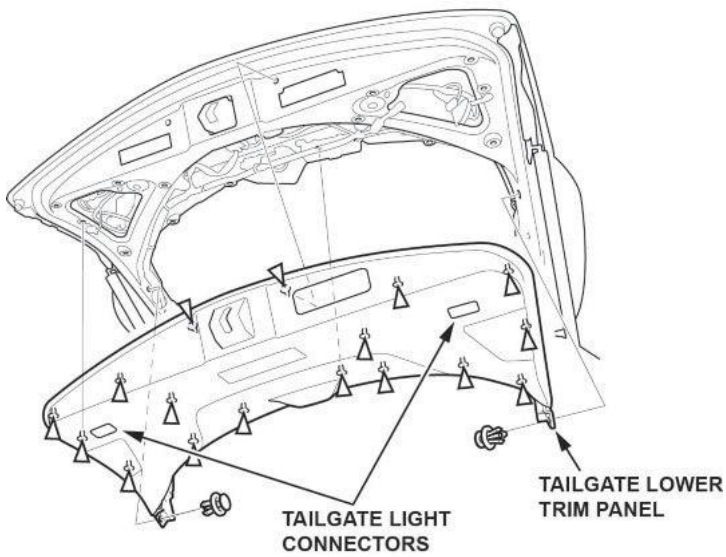
4. Remove the tailgate lower trim panel, then disconnect the tailgate light connectors.

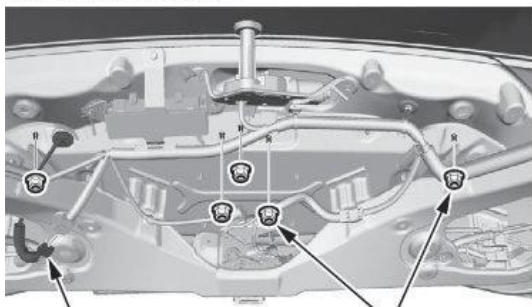
INSIDE THE TAILGATE

5. Disconnect the license sub harness connector, remove the five nuts, release the pins from the clips, then remove the rear license plate trim.

LICENSE SUBHARNESSE CONNECTOR

4.9 N·m (3.6 lb-ft)

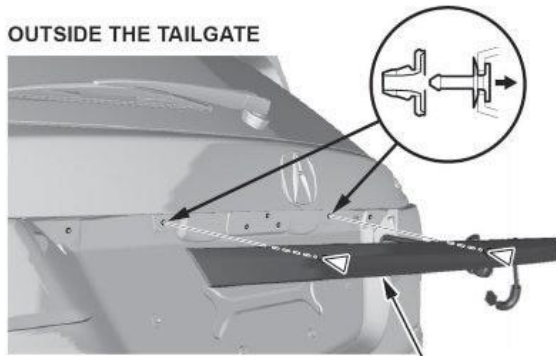
OUTSIDE THE TAILGATE

REAR LICENSE TRIM

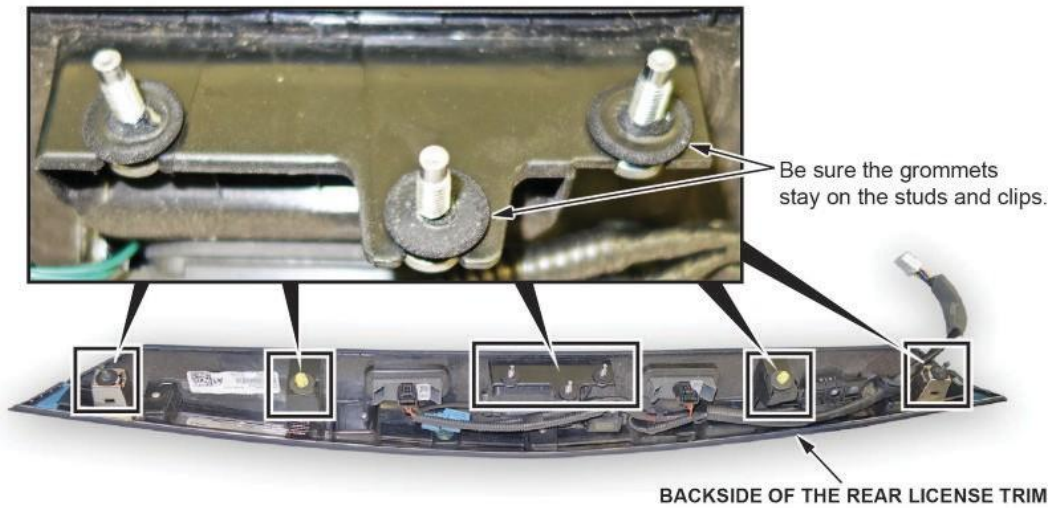
BACKSIDE OF THE REAR LICENSE TRIM

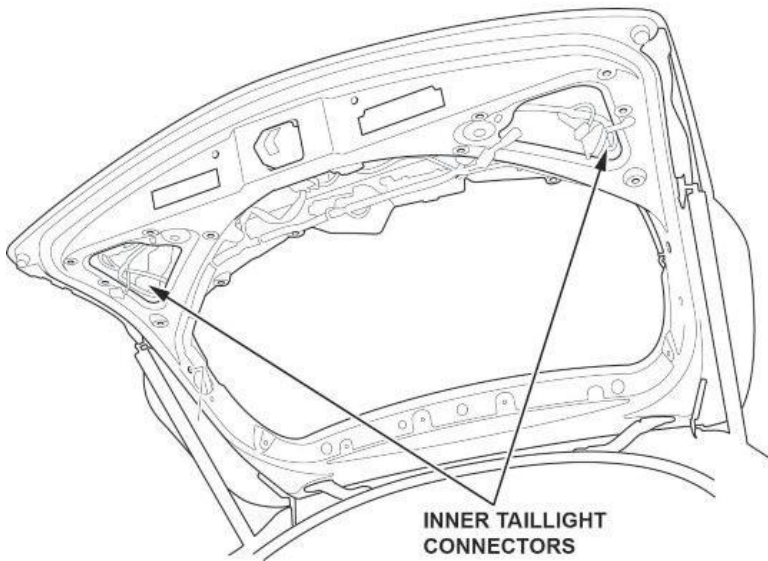
6. Disconnect both inner taillight connectors.

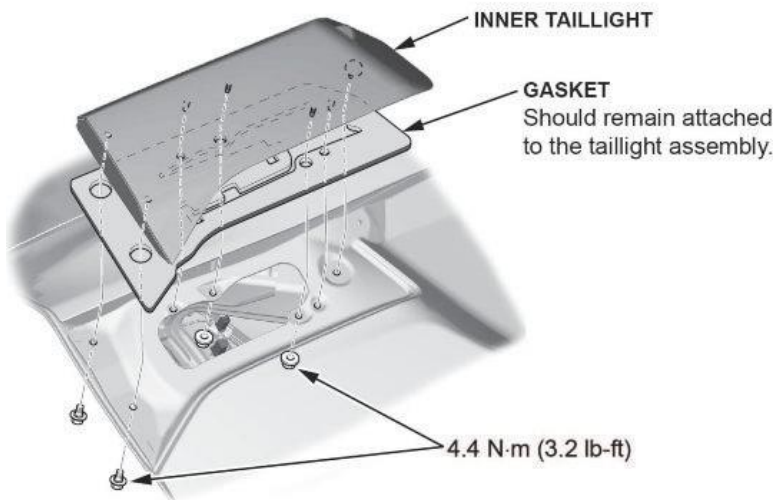
7. Remove the two bolts and two nuts behind each inner taillight, then replace both inner taillights and torque the nuts and bolts to **4.4 N-m (3.2 lb-ft)**

NOTE: Be sure to completely remove the old inner taillight gasket. The new inner taillight will come with a new gasket installed.

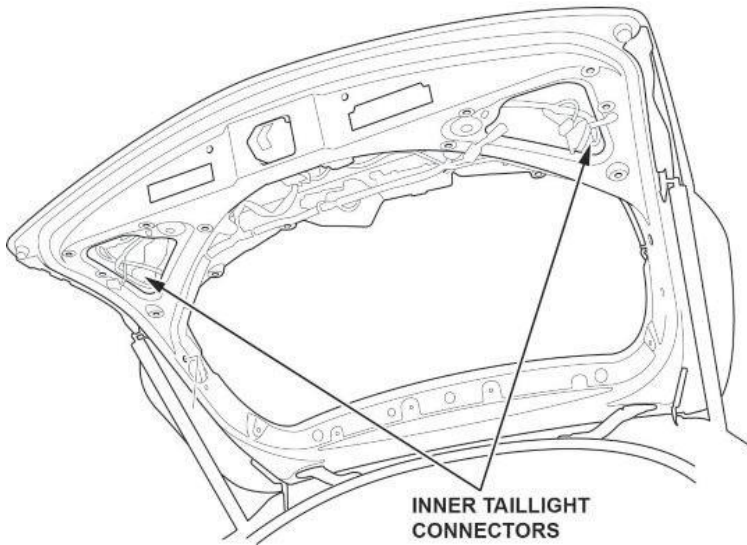
8. Connect the inner taillight connectors.

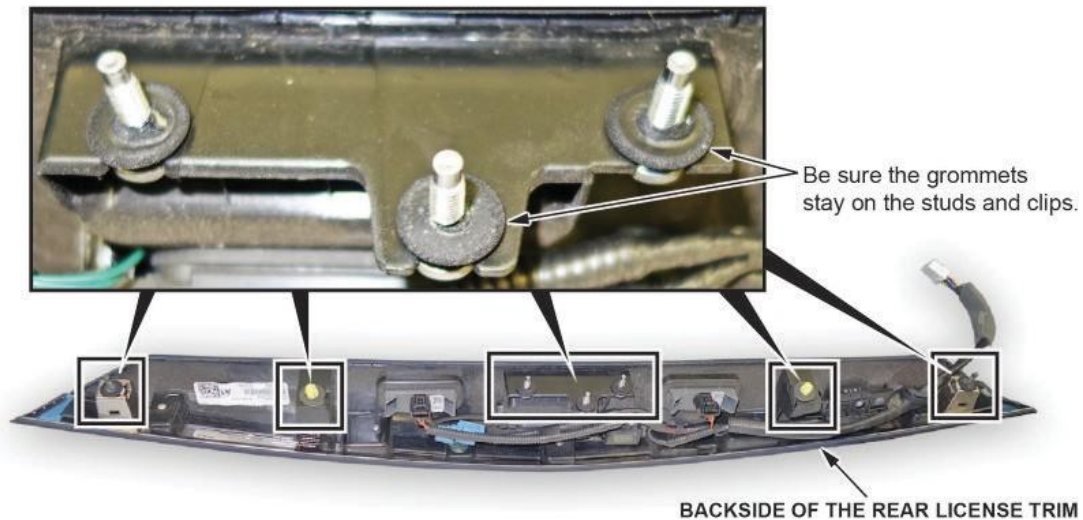
9. Install the rear license trim. Make sure the grommets are attached to the studs and clips, then connect the connector, and torque the nuts to **4.9 N-m (3.6 lb-ft)**.

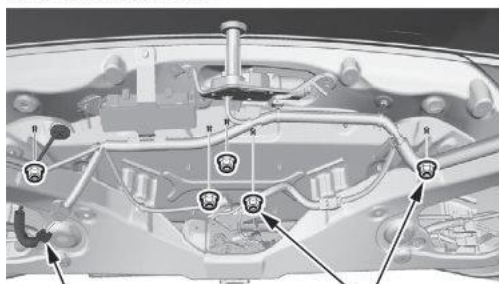
INSIDE THE TAILGATE

LICENSE SUBHARNESS CONNECTOR

4.9 N-m (3.6 lb-ft)

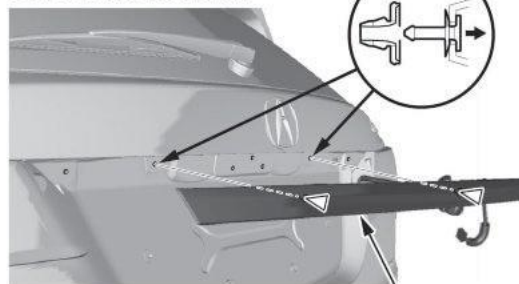
OUTSIDE THE TAILGATE

REAR LICENSE TRIM
