Blower Motor Fuse Replacement

Bulletin Type:	Safety Recall	Publication Date:	April 2019
Bulletin #(s):	Jayco 19V-265 2019-166 Entegra 19V-270 2019-167	Make(s):	Jayco / Entegra
Job Code(s):	9903432	Model(s):	Precept / Alante Precept Prestige Vision / Emblem
Flat Rate(s):	.3 hour	Model Year(s):	2014-2019

Incident:	Inadequate overcurrent protection to dash blower motor.
Affected Units:	Please reference listing on last page of Instructions
Parts Kit:	Parts Kit #: 19V-265/270
	Parts Kit Contents: 1 - Fuse 25A Maxi 1 - Label
Misc. Tools & Supplies:	Isopropyl alcohol and clean rag

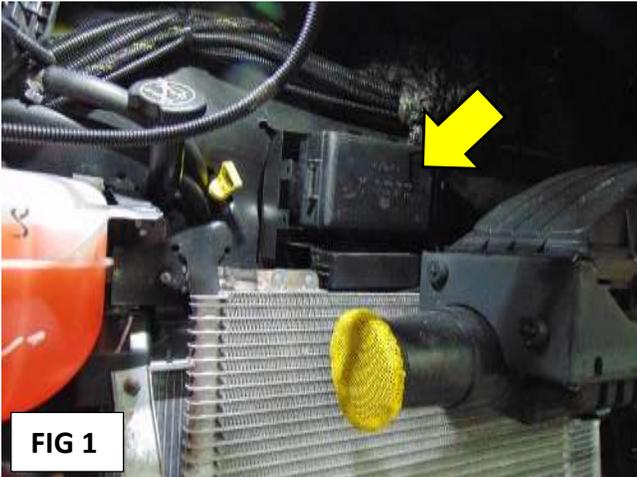
FIG 1

FIG 1:

- Open the engine compartment door on the front of the vehicle.
- Fuse box mounted to the firewall (arrow).

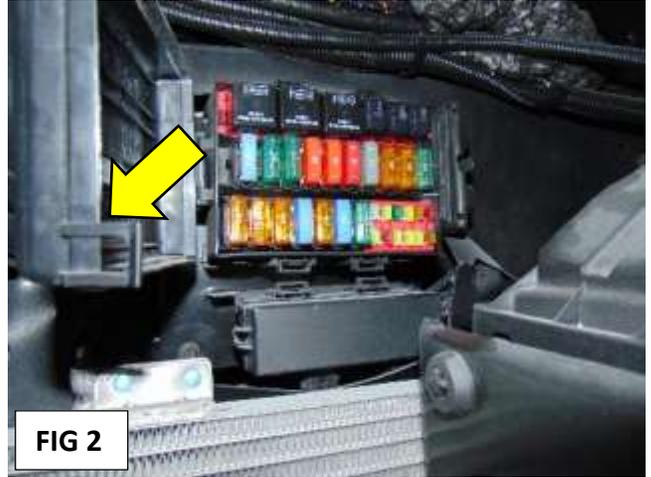
FIG 2

FIG 2:

- Open the fuse box by disengaging the locking tab in the lower right front corner of the box (arrow).

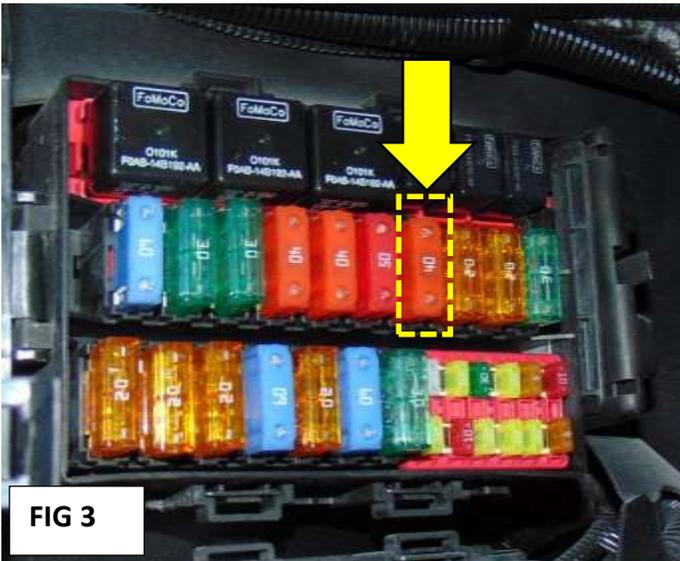
FIG 3

FIG 3:

- 40 Amp red fuse. (4th fuse from the right side).
- This is fuse position #23 as indicated on the fuse box lid (arrow and dashed box in Figure 4).
- Remove the 40A fuse in position #23.
- Save the 40A fuse as a spare as there are other 40A fuses in the box.

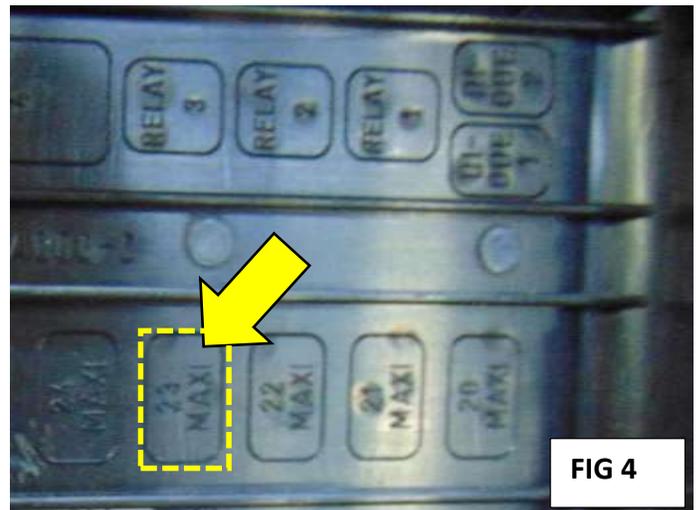
FIG 4

FIG 4:

- Fuse box lid showing fuse position #23 (arrow).

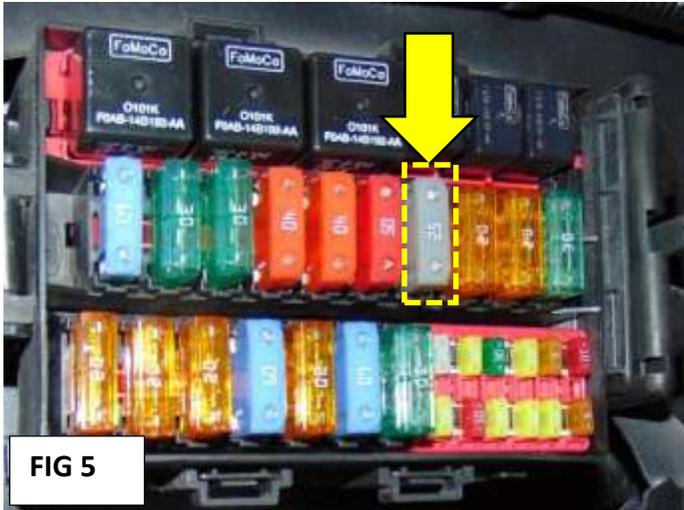
FIG 5:

- Install the 25A Maxi fuse from the kit in place of the 40A fuse in position #23 in fuse box (arrow and dashed box).

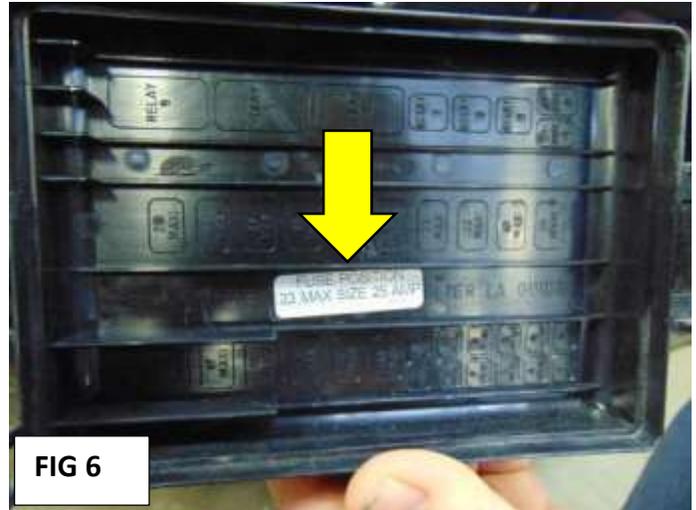
FIG 6:

- **Clean the area where the label will go using isopropyl alcohol and clean rag. Let dry 30 seconds.**
- **Place the label (from the kit) in the location shown (arrow).**
- Do not place the label where it will cover up any of the other fuse location callouts.
