RECALL BULLETIN:
190412REV

Fleetwood Flair Model 32 S only
Manufactured 6/20/2018 through 2/22/2019

Holiday Rambler Model 32 S only
Admiral
Manufactured 6/29/2018 through 3/22/2019

Inspection / Correction of Generator Exhaust Pipe Routing

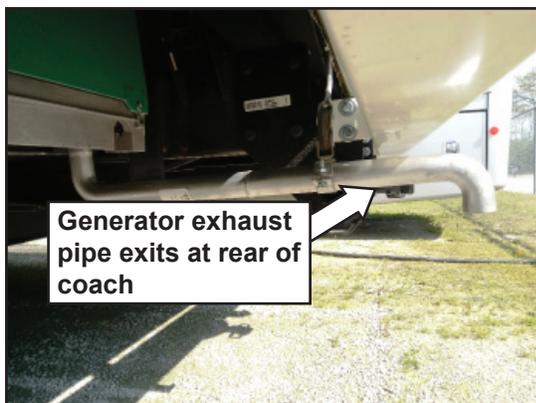
Figure 1 – Correct Installation

3. Block wheels to prevent movement.
4. At the driver's side, rear of the coach, locate the generator exhaust pipe and determine whether it exits on the side of the motorhome or out the rear, under the bumper. See Figures 1 & 2 for both examples of exhaust pipe routing.

- a) If the generator exhaust pipe exits the motorhome at the rear of the coach under the bumper, take several clear photos (see Photo Requirements on Page 3) and submit a claim using code 6080-11, "Inspected/Not Defective"; no more work is required.

For Non-Defective Units: Take photos that clearly show that the generator exhaust pipe has been properly routed. Submit the photos with an authorization request for Inspected/Not Defective. See Figure 1 (Page 2) for an exemplar photo.

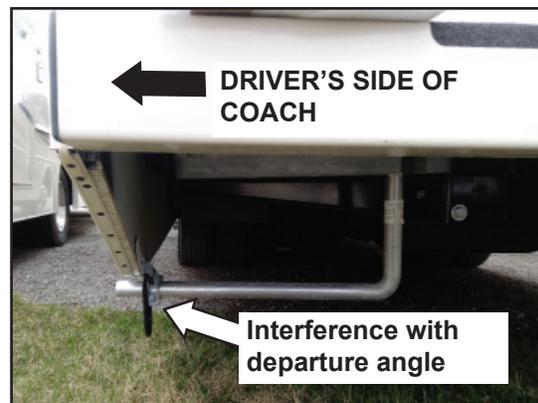
Figure 2 - Repair Needed

On motorhomes affected by this recall, the generator exhaust pipe may be routed in a manner that causes it to intrude into the departure angle of the coach. This improper mounting location could cause the generator exhaust pipe to become damaged or sheared off when the vehicle is driven on an incline, potentially allowing carbon monoxide from generator exhaust emissions to enter the vehicle, which could result in illness or death.

- b) If the generator exhaust pipe exits on the side of the motorhome, take several clear photos (see Photo Requirements on Page 3) and then proceed to the Repair Procedure beginning at Step 5.

- Before beginning repairs, take several photos clearly showing the generator exhaust misrouted out the side of the motorhome. See Figure 2 (Page 2) for an exemplar photo.
- After completing repairs, take several photos that clearly display the corrected routing of the generator exhaust out the rear of the coach, under the bumper. See Figure 1 (Page 2) for an exemplar photo. Submit both sets of photos with an authorization request for Inspected/Defective/Repaired.
