AKA7 - Checking Control Unit for Air-Conditioning Blower and Replacing it if Necessary (Recall Campaign)

Model Line: **Panamera (970)**

Subject: **Control unit for air-conditioning blower**

Concern: **There is a possibility that moisture can get into the control unit for the air-conditioning blower on the affected vehicles and cause short circuits there.**

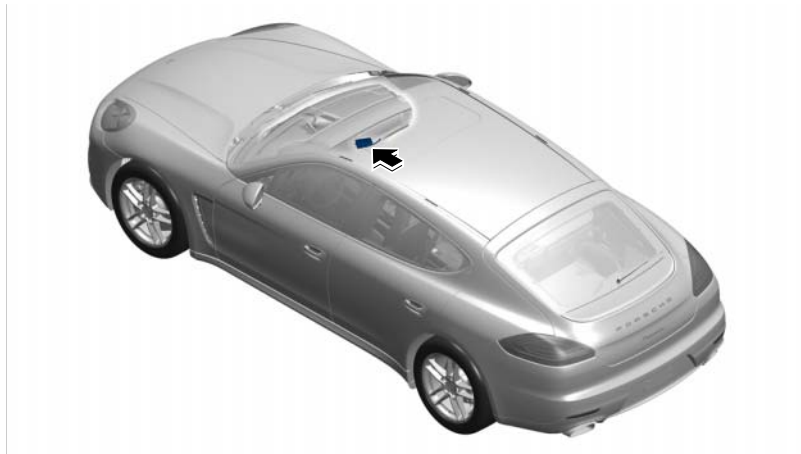
Installation position of control unit for air-conditioning blower

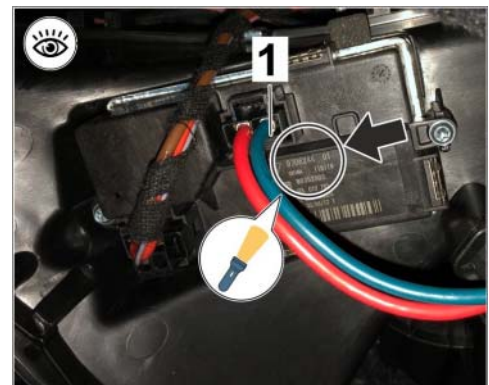
- 1.1 Remove cover in the footwell on the passenger's side ⇒ *Workshop Manual '702219 Removing and installing cover under dashboard'*.
- 1.2 Remove footwell outlet vent on passenger's side ⇒ *Workshop Manual '805519 Removing and installing front footwell outlet vent'*.
- 2 Illuminate control unit for air-conditioning blower ⇒ *Reading off part number -1-* using a hand lamp so that the part number is visible.

Reading off part number

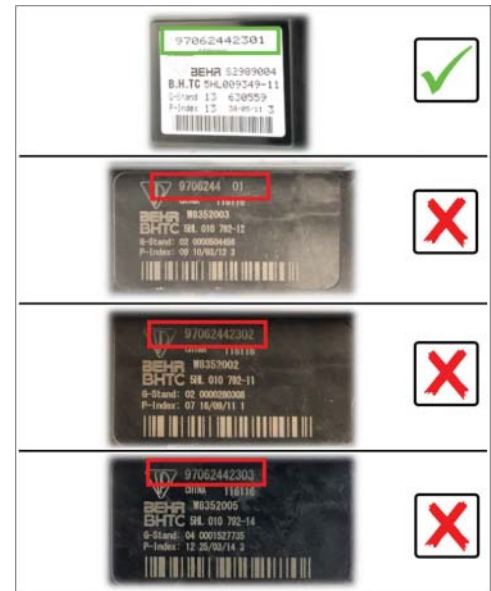
Comparing part number

Part number that was read off	Next steps
97062442301	Control unit for air-conditioning blower does not have to be replaced. -End of action required- Continue with Step 4.
9706244 01 or 97062442302 or 97062442303	Control unit for air-conditioning blower must be replaced. To do this, continue with Step 3.

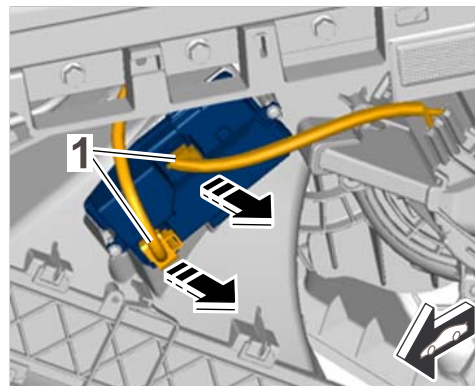
3.1.1 Release and disconnect electric plug connections ⇒ *Disconnecting plug connection on fan control-1-* on the blower regulator ⇒ *Disconnecting plug connection on fan control-arrow-*.

Disconnecting plug connection on fan control

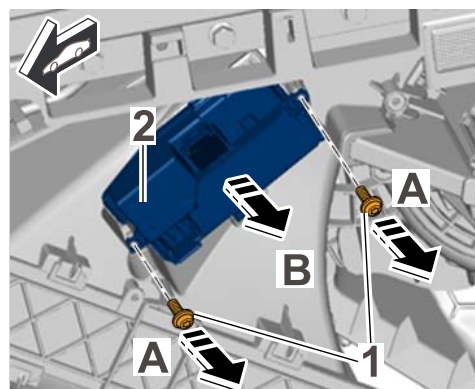
3.1.2 Unscrew fastening screws ⇒ *Pulling out fan control-1-* (⇒ *Pulling out fan control-arrows A-*) and pull out blower regulator ⇒ *Pulling out fan control-2-* (⇒ *Pulling out fan control-arrow B-*).

Pulling out fan control

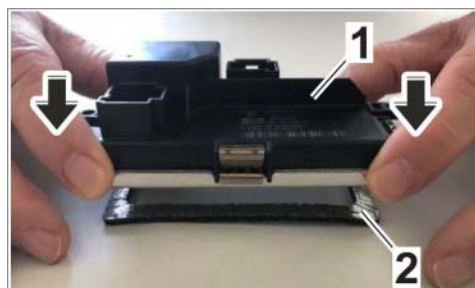
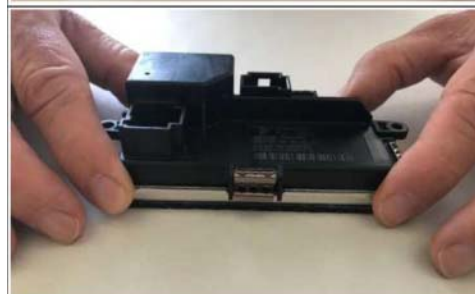
3.2.2 Place seal ⇒ *Fitting seal-2-* with bonding surface facing up on the work area, pull off protective paper and align the seal evenly

3.2.3 Hold the blower regulator ⇒ *Fitting seal-1-* upside down over the seal and align it with the bonding surface without making contact.

Fitting seal

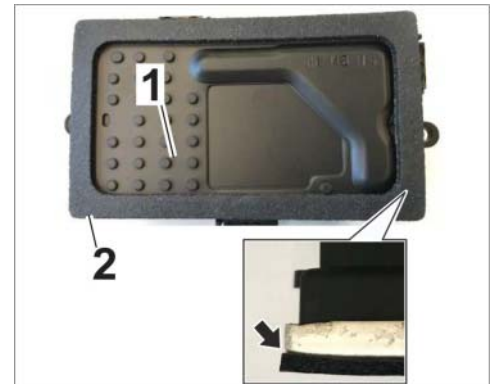
- 3.2.4 Lower the regulator straight onto the seal, check its position and then press it on ⇒ *Fitting seal -Arrows-*.
 ⇒ Inner contour of seal ⇒ *Fitting seal-2-* is aligned with inner contour of blower regulator ⇒ *Fitting seal-1-*.
 ⇒ It must not project by more than 1 mm at the sides all the way around ⇒ *Fitting seal-arrow-*.

Fitting seal

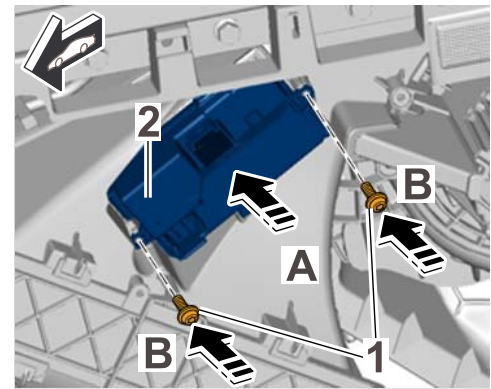
- 3.2.5 Position blower regulator ⇒ *Installing blower regulator-2-* on the heating/fresh-air unit ⇒ *Installing blower regulator -arrow A-* and screw in screws ⇒ *Installing blower regulator-1-* (⇒ *Installing blower regulator -arrows B-*).

Installing blower regulator

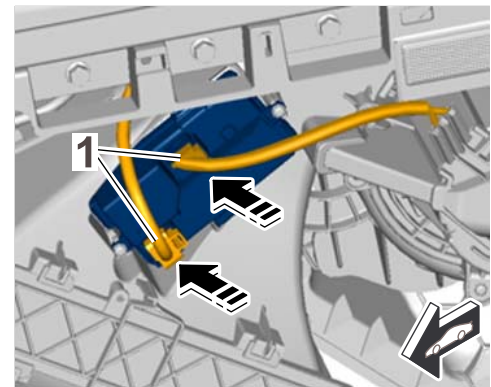
- 3.2.6 Plug in electric plug connections ⇒ *Inserting connector-1-* on the blower regulator until they engage securely ⇒ *Inserting connector -Arrows-*.

Inserting connector

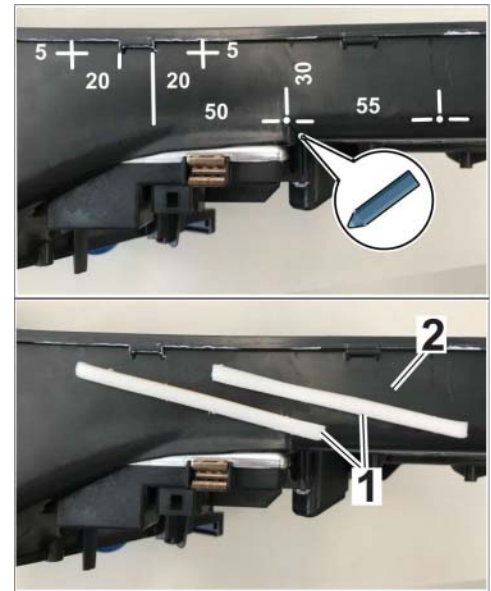
- 3.2.7 Mark upper guide points for drain strips at 20 mm to the left and right of the clip point above the blower regulator and 5 mm below the lower groove contour ⇒ *Fitting drain strips*.
- 3.2.8 Mark lower guide points as shown ⇒ *Fitting drain strips*.
- 3.2.9 Remove protective film.
- 3.2.10 Position drain strips with the top left corner on the respective top guide points and with the lower edge on the respective bottom guide point and press them on.

Fitting drain strips

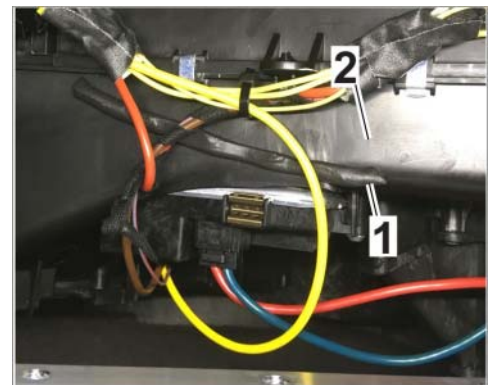
- 2.1 Pull off sealing strip (butyl cord) ⇒ *Removing sealing strip -1-* on the heating/fresh-air unit ⇒ *Removing sealing strip -2-*.
- 2.2 Remove residues of the butyl cord on the heating/fresh-air unit and clean with cleaning solution (isopropanol).

Removing sealing strip

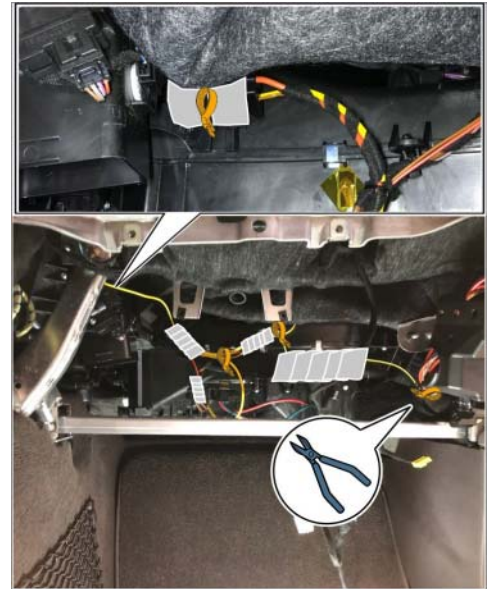
2.3.1 Remove tie-wraps that were fitted to secure the repair kit.

Loosening wire harness

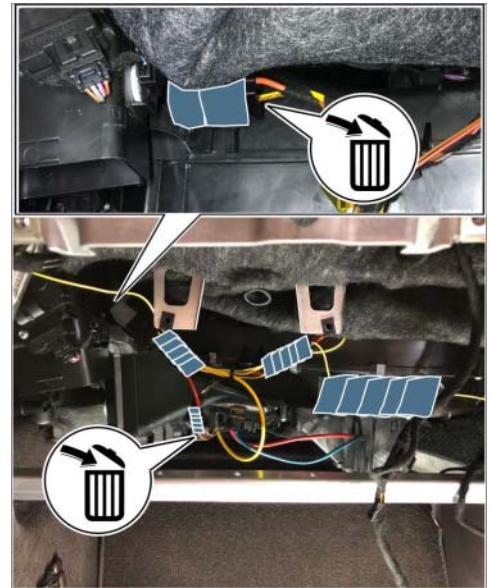
2.3.2 Remove strips of adhesive tape that were affixed.

Loosening wire harness

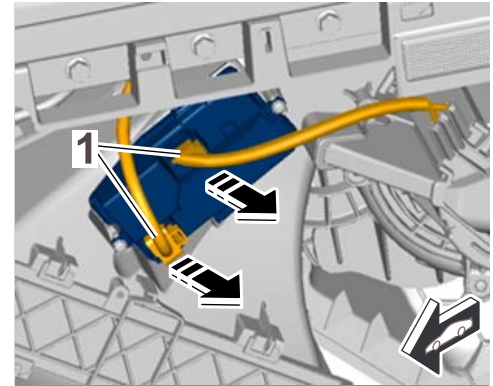
2.4.1 Release and disconnect electric plug connections ⇒ *Disconnecting plug connection on fan control-1-* on the blower regulator ⇒ *Disconnecting plug connection on fan control-arrow-*.

Disconnecting plug connection on fan control

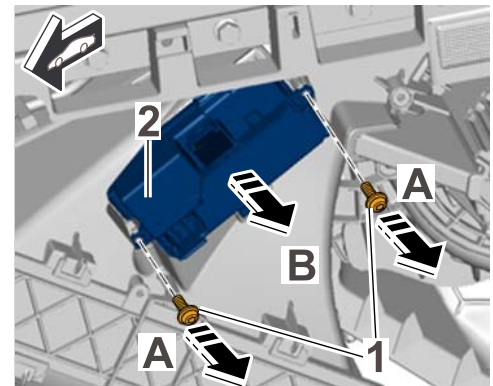
2.4.2 Unscrew screws ⇒ *Pulling out fan control-1-* (⇒ *Pulling out fan control-arrows A-*) and pull out blower regulator ⇒ *Pulling out fan control-2-* (⇒ *Pulling out fan control-arrow B-*).

Pulling out fan control

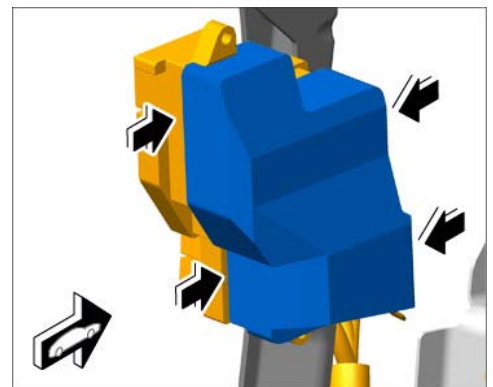
2.6.1 Unclip cover on the back of the fuse box ⇒ *Unclipping cover on fuse box-Arrows-*.

2.6.2 **Remove fuse** from slot 18.

Unclipping cover on fuse box

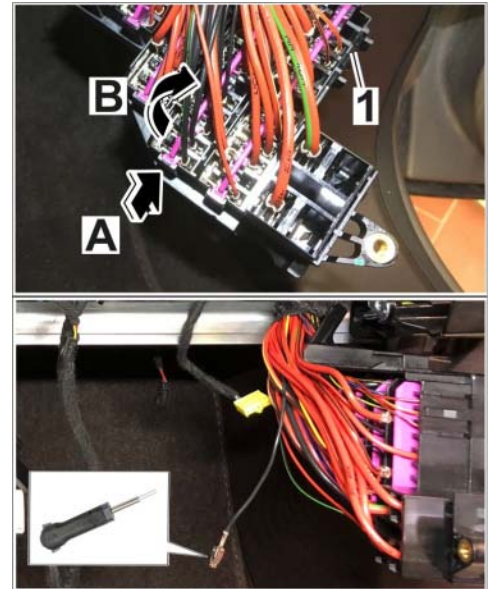
2.6.3 On the back of the fuse box ⇒ *Disconnecting terminal 15-1-*, release the locking element at the side of the second row ⇒ *Disconnecting terminal 15-arrow A-* and bend it up ⇒ *Disconnecting terminal 15-arrow B-*.

2.6.4 **Unpin black line** at slot 18 (**terminal 15**) using the release tool.

Disconnecting terminal 15

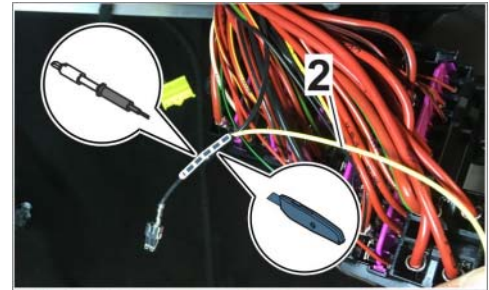
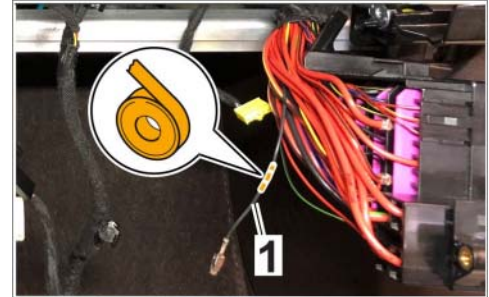
- 2.6.5 Carefully cut open protective sleeve (adhesive tape) on the black and yellow line ⇒ *Removing terminal 15-2-* lengthways using a suitable knife.

- 2.6.6 Disconnect soldered joint between both lines (black and yellow line). To do this, switch on the soldering iron and set it to **Temperature 662° F (350°C)**.

- 2.6.7 Wrap adhesive tape around the **black line** ⇒ *Removing terminal 15-1-* until the protective sleeve is fully restored.

Removing terminal 15

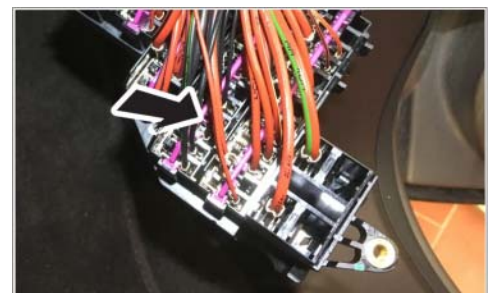
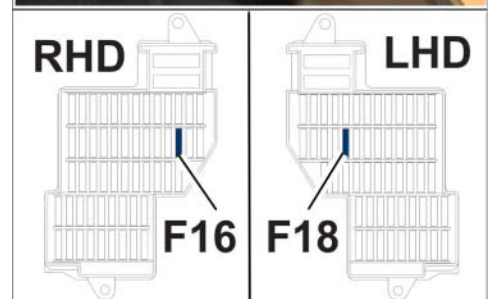
- 2.6.8 **Insert black line** at slot 18 and secure again with the locking element.

F18 – Left-hand drive (LHD) = front right fuse carrier

Terminal 15 slot

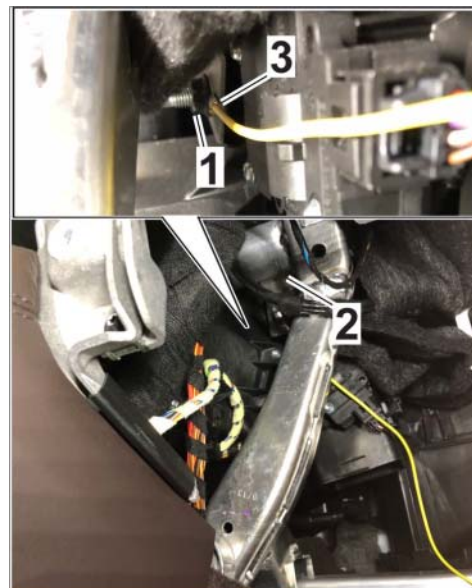
2.7 **Disconnect yellow 1 mm² line from relay repair kit, PIN 2** (ground point) at the dashboard bracket ⇒ *Disconnecting ground point.*

2.7.1 Loosen fastening screw ⇒ *Disconnecting ground point -1-* on the dashboard bracket ⇒ *Disconnecting ground point -2-.*

2.7.2 Remove ground line (**yellow 1 mm line with eyelet**) ⇒ *Pulling out fan control -3-* and screw in the fastening nut again.

Disconnecting ground point

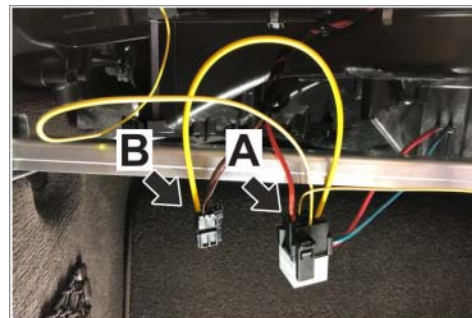
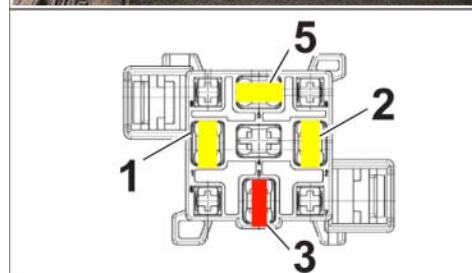
2.8 Disconnect **terminal 30** on the vehicle side of the wire harness for the blower regulator at the relay ⇒ *Connecting terminal 30.*

2.8.1 Unpin red line on the vehicle side at **PIN 3 of the relay socket** using the release tool ⇒ *Connecting terminal 30 -arrow A-.*

2.8.2 **Unpin yellow 4 mm² line from relay repair kit, PIN 5** at the connector for the blower regulator using the release tool ⇒ *Connecting terminal 30 -arrow B-.*

Connecting terminal 30

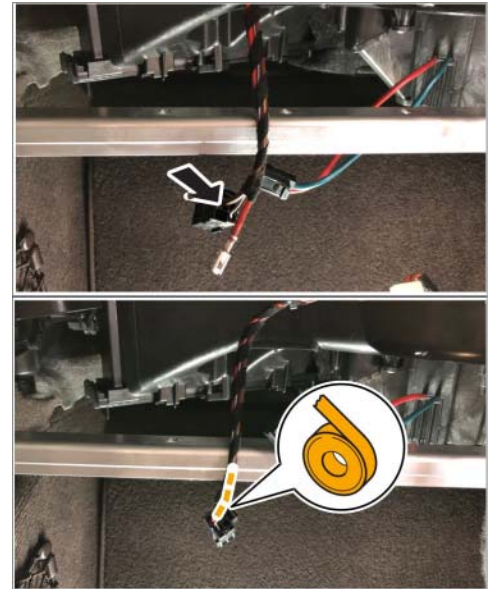
- 2.8.3 **Insert red line on the vehicle side** at the same slot as the previously disconnected yellow 4 mm² line from the repair kit on the connector for the blower regulator ⇒ *Connecting terminal 15 -arrow-*.
- 2.8.4 Wrap fabric adhesive tape around the **red line** on the wire harness until the protective sleeve is fully restored.

Connecting terminal 15

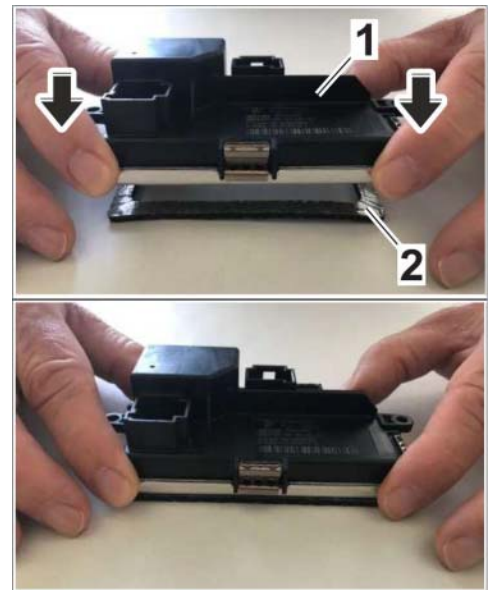
- 2.9 Install control unit for air-conditioning blower (blower regulator).
- 2.9.1 Place seal ⇒ *Fitting seal-2-* with bonding surface facing up on the work area, pull off protective paper and align the seal evenly
- 2.9.2 Hold the blower regulator ⇒ *Fitting seal-1-* upside down over the seal and align it with the bonding surface without making contact.

Fitting seal

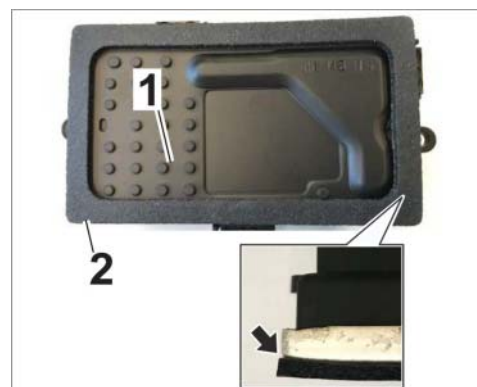
- 2.9.3 Lower the regulator straight onto the seal, check its position and then press it on ⇒ *Fitting seal -Arrows-*.
 ⇒ Inner contour of seal ⇒ *Fitting seal-2-* is aligned with inner contour of blower regulator ⇒ *Fitting seal-1-*.
 ⇒ It must not project by more than 1 mm at the sides all the way around ⇒ *Fitting seal-arrow-*.

Fitting seal

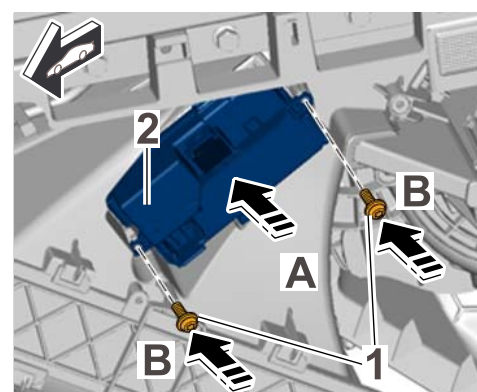
- 2.9.4 Position blower regulator ⇒ *Installing blower regulator-2-* on the heating/fresh-air unit ⇒ *Installing blower regulator -arrow A-* and screw in screws ⇒ *Installing blower regulator-1-* (⇒ *Installing blower regulator -arrows B-*).

Installing blower regulator

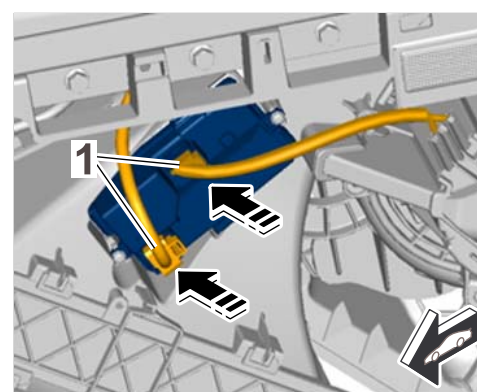
- 2.9.5 Plug in electric plug connections ⇒ *Inserting connector-1-* on the blower regulator until they engage securely ⇒ *Inserting connector -Arrows-*.

Inserting connector

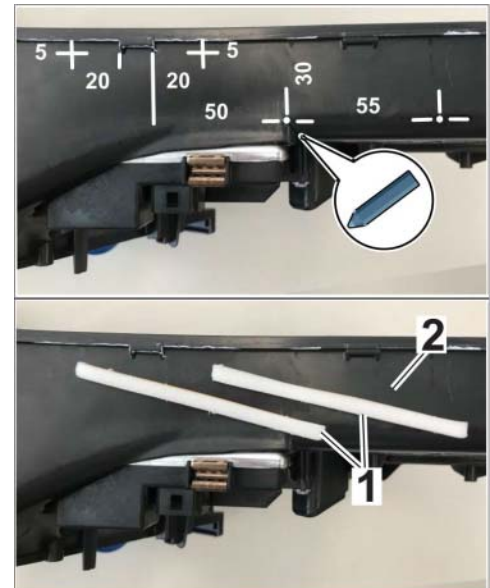
- 2.9.6 Mark upper guide points for drain strips at 20 mm to the left and right of the clip point above the blower regulator and 5 mm below the lower groove contour ⇒ *Fitting drain strips*.
- 2.9.7 Mark lower guide points as shown ⇒ *Fitting drain strips*.
- 2.9.8 Remove protective film.
- 2.9.9 Position drain strips with the top left corner on the respective top guide points and with the lower edge on the respective bottom guide point and press them on.

Fitting drain strips
