Volvo Car Customer Service

QB Instruction VCC-516904-1

Title	Track rod, Flange locknut inspection/replacement	Page	1 (4)
Action	Inspection/replacement	Operation number:	99921-2 99922-2

Model year	Model
2019	S60 (19-)

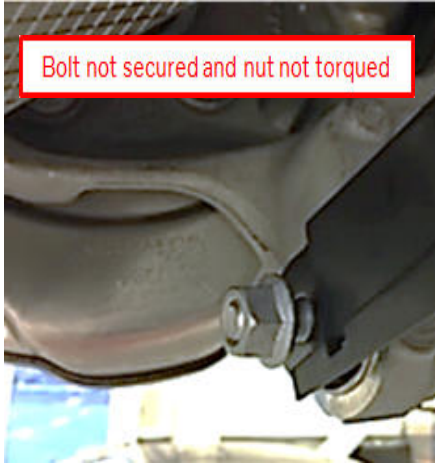
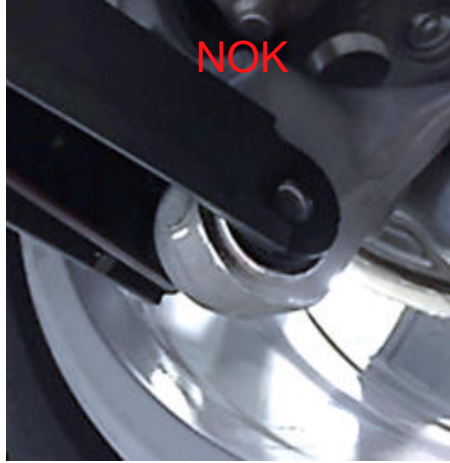
On both sides.

Perform inspection on both sides by torquing the flange lock nuts to 90 Nm. If movement is observed follow the steps below.

If the nut is missing or loose install new bolt and nut. Torque to specs.

- Stage 1 : Torque to 90Nm
- Stage 2 : Angle tighten 90°

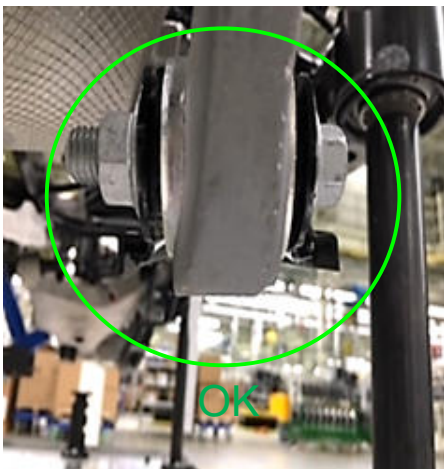
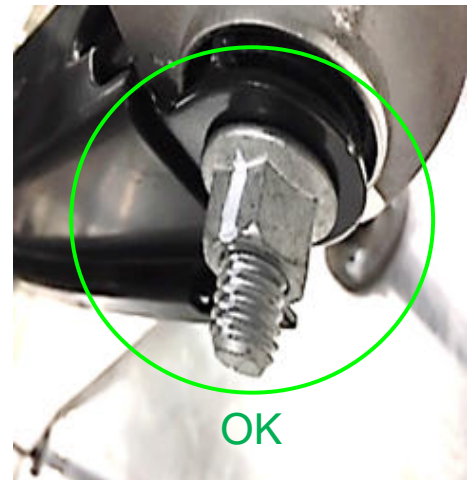
On both sides.
