IMPORTANT SAFETY RECALL

Airstream Travel Trailer

NHTSA Recall Number 19V-334

Transport Canada Recall Number 2019-268

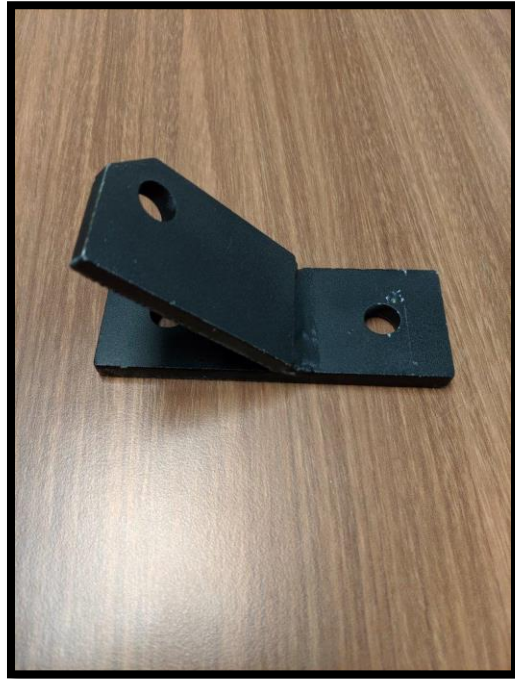
5/16" socket or wrench
Spare tire bracket (Part # **450414-02**)

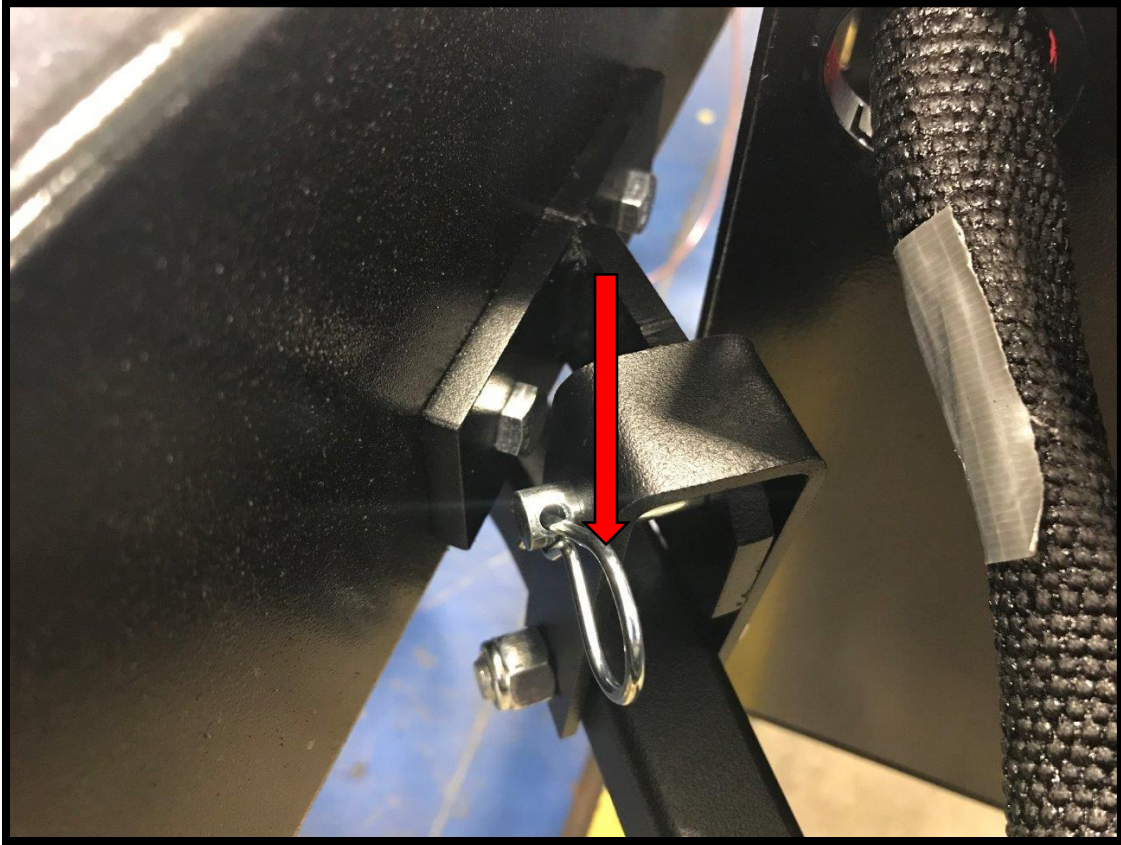
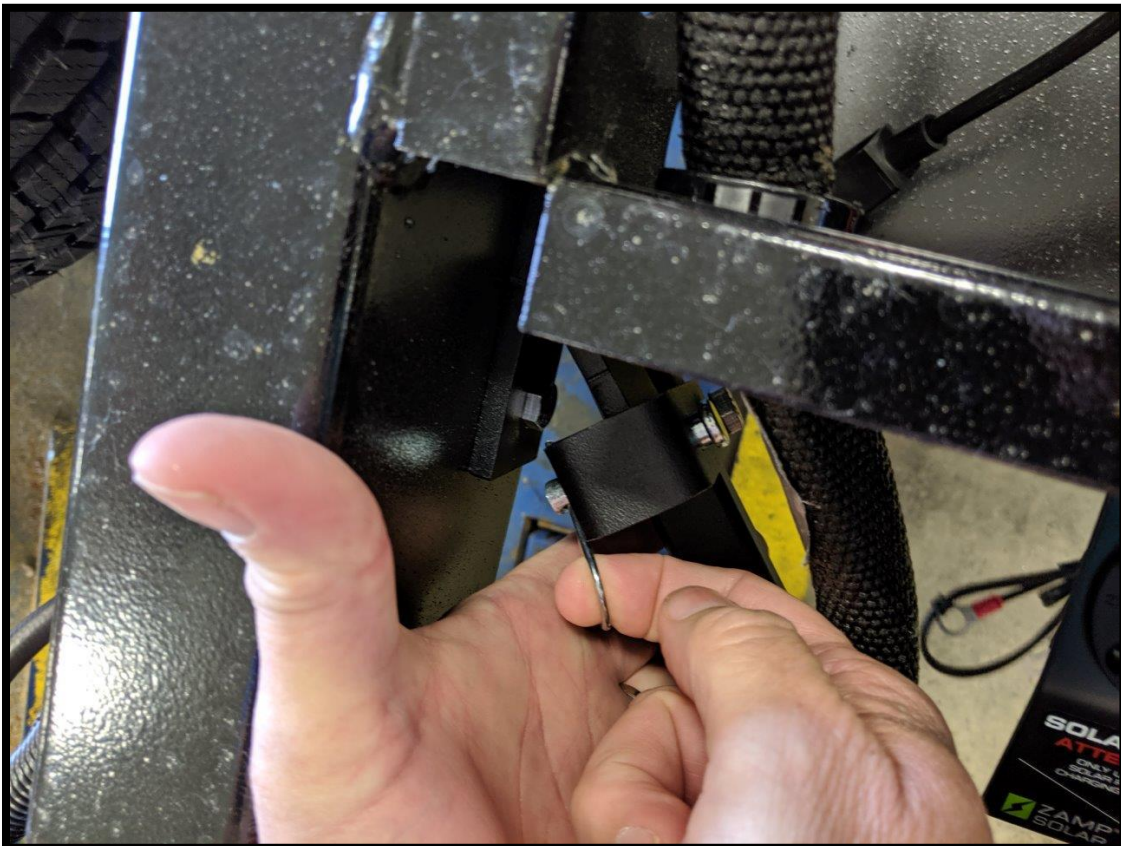
Step 1: Start by releasing the spare tire. Locate the cotter pin on the pivot arm bracket and remove the pin

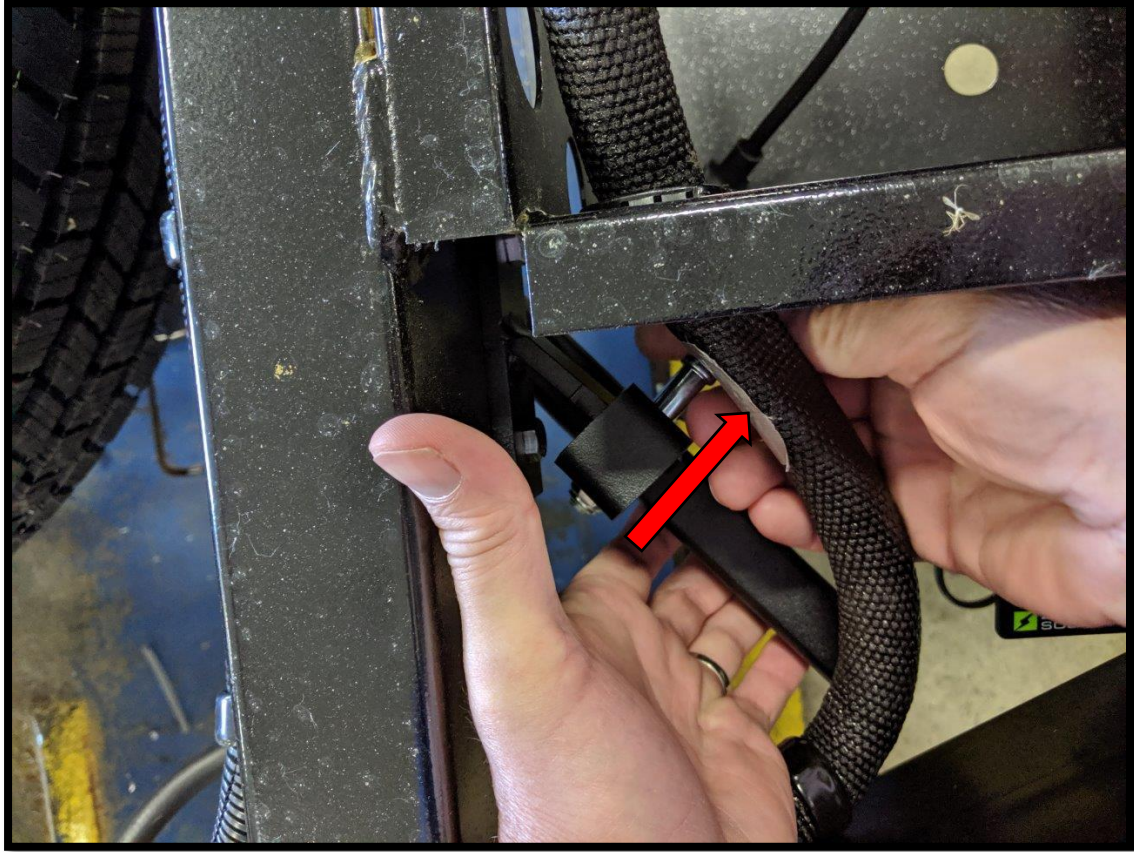
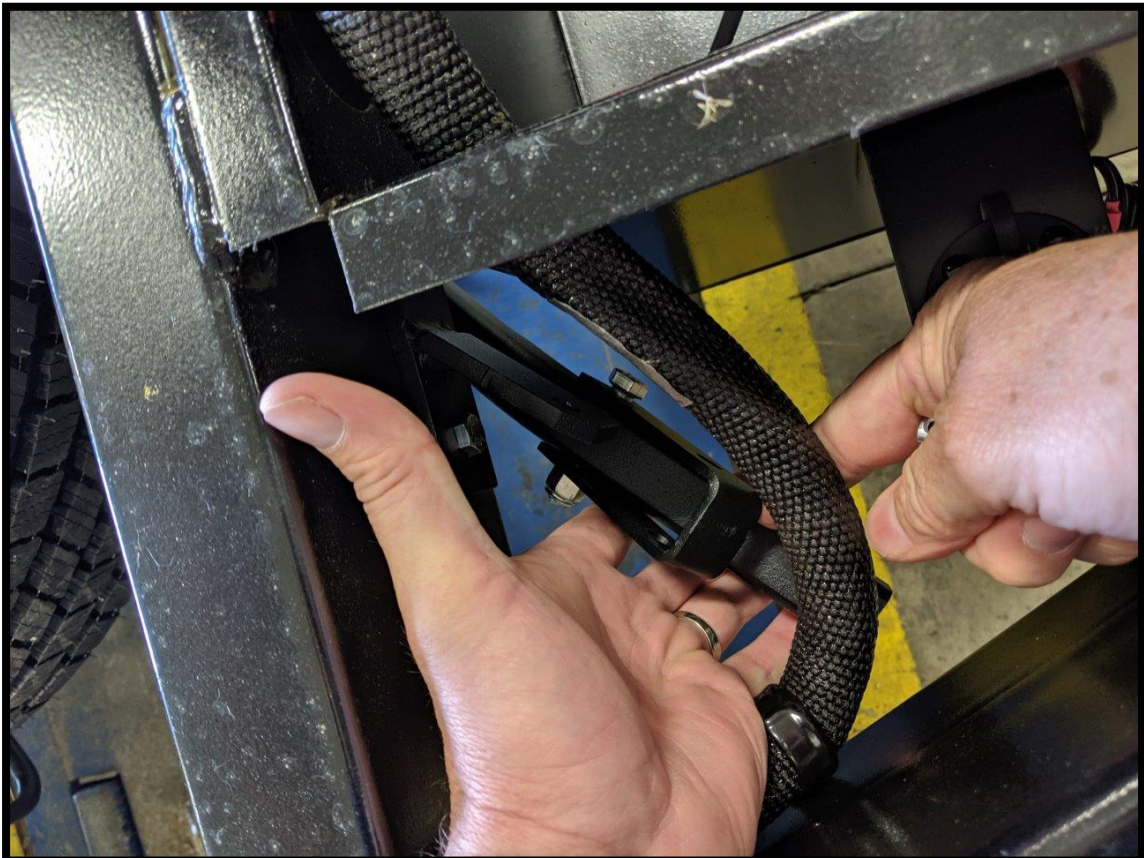
Step 2: Remove the pin from the bracket securing the pivot arm and lower the spare tire

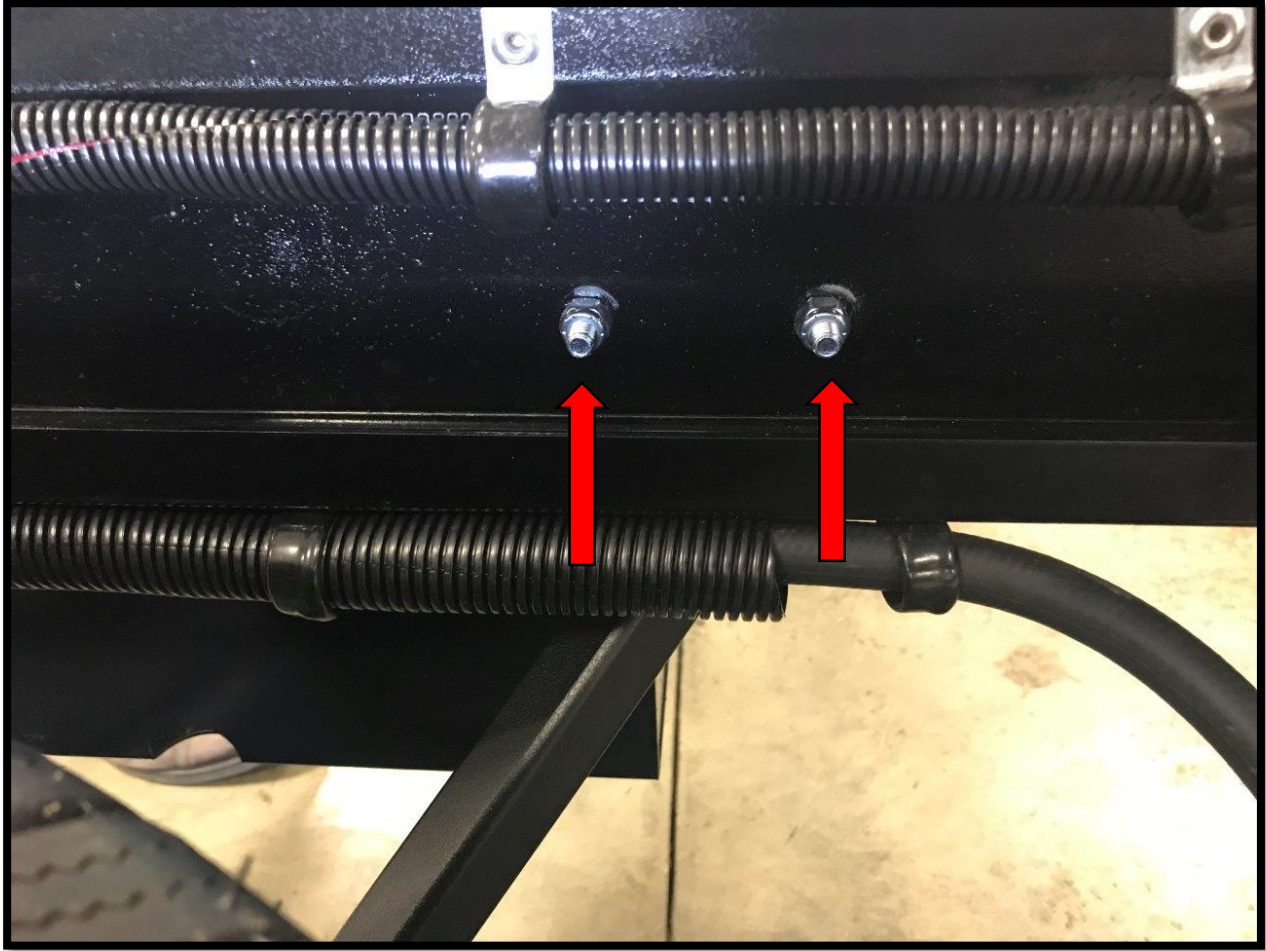
Step 3: After you have the spare tire lowered, locate the 5/16" nuts on the back side of the spare tire bracket. Remove the nuts and the bolts and remove the existing spare tire bracket.

Step 4: Using the nuts and bolts removed, attach the new spare tire bracket (Part # **450414-02**).

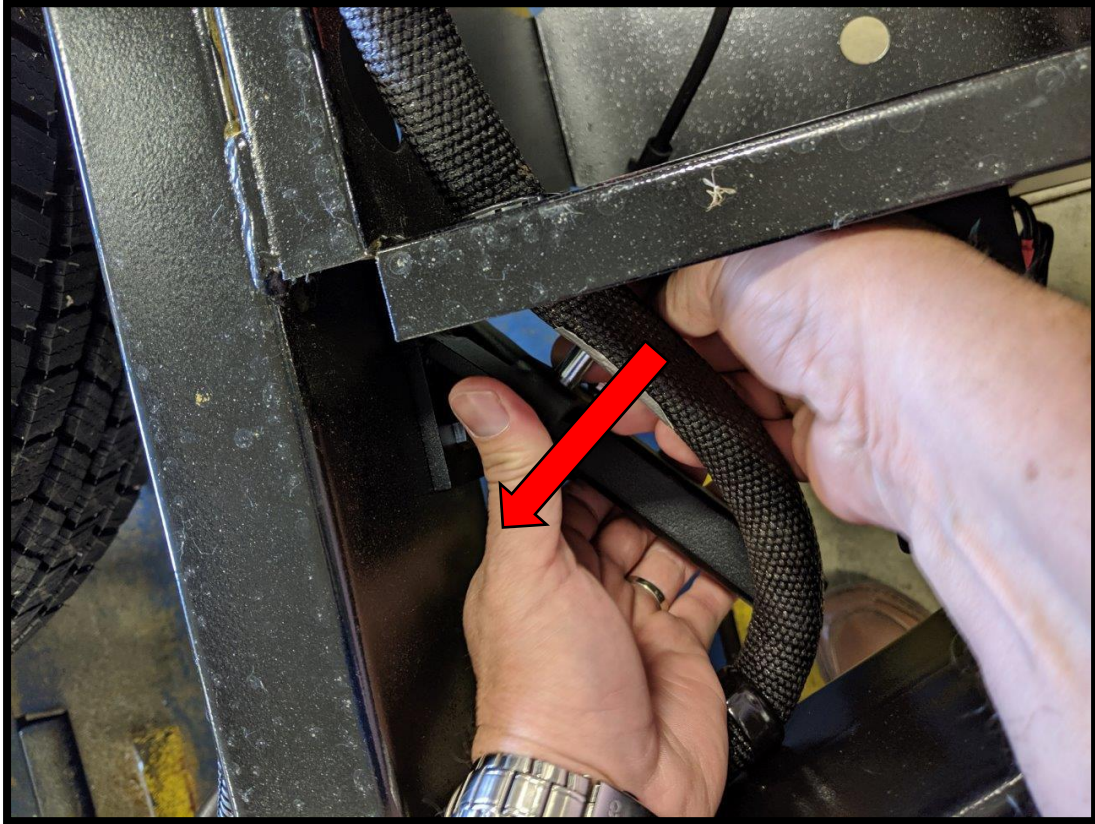
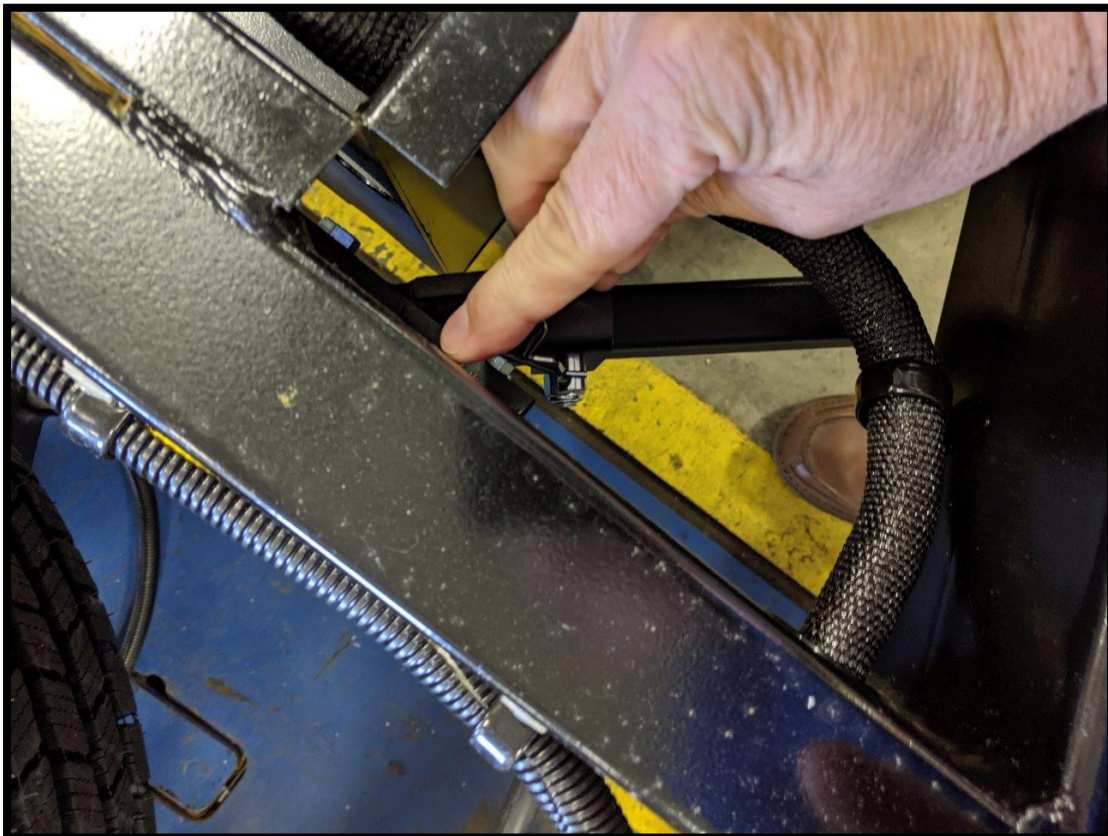
Step 5: Using the pivot arm, raise the spare tire, replace the pins.
