## **SAFETY RECALL CAMPAIGN 2A89**

### UH200A CVT Driven Face Replacement

- Affected Models:** 2018 - 2019 UH200A (Burgman 200)
- Affected Departments:** Management, Service, Sales, Warranty, Parts, Accessories
- Revision:** **New countermeasure part identification information** (page 3)

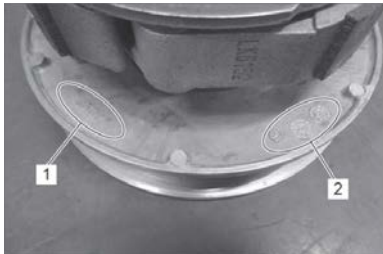
**Original production driven face set**  
*NO blue paint between the two casting impressions (1 and 2)*

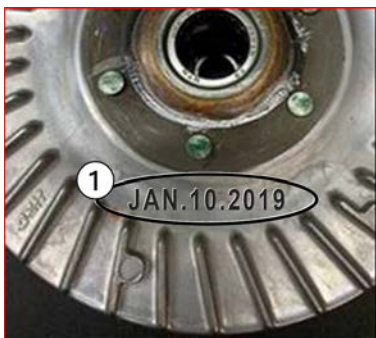
**Original production driven face set**  
① Date of manufacture before **JAN.10.2019**

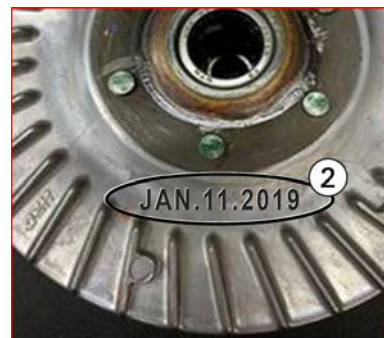
**Updated countermeasure driven face set**  
② Date of manufacture after **JAN.11.2019**

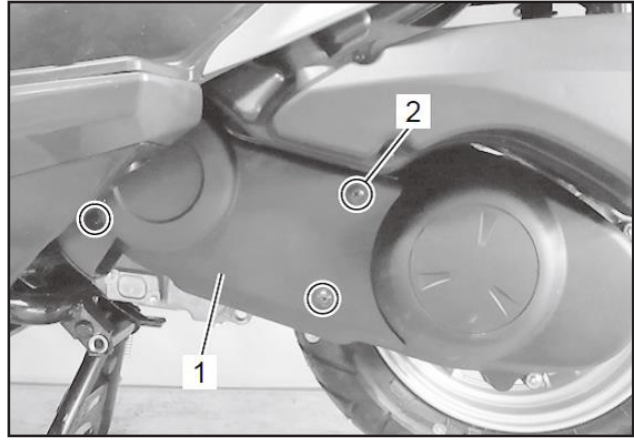
1. Remove the cooling fan (1) by removing the screws (2).
