October 26, 2019

Version 4

Safety Recall: 2019 CR-V Cable Reel and Sub-Wire Harness

Supersedes 19-062, dated June 21, 2019, to revise the information highlighted in **yellow**.

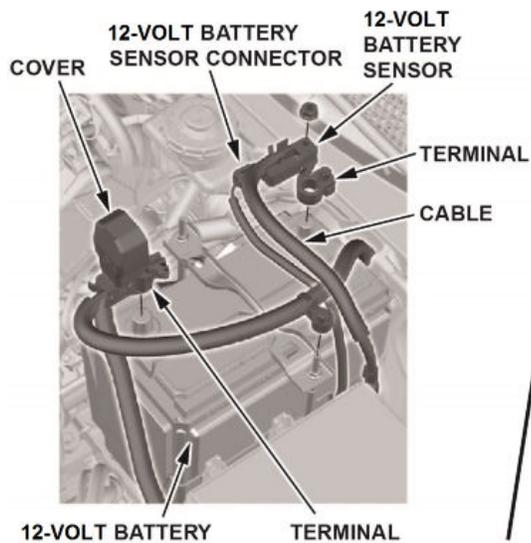
TYPE A

1. Set the steering wheel and front wheels in the straight-ahead position.
2. Turn the ignition to OFF.
3. Disconnect and isolate the negative battery cable with the battery sensor from the battery.

- Always disconnect the negative side first.
- To protect the battery sensor connector from damage, do not hold it when removing the terminal.
- Do not disconnect the battery sensor from the negative cable.

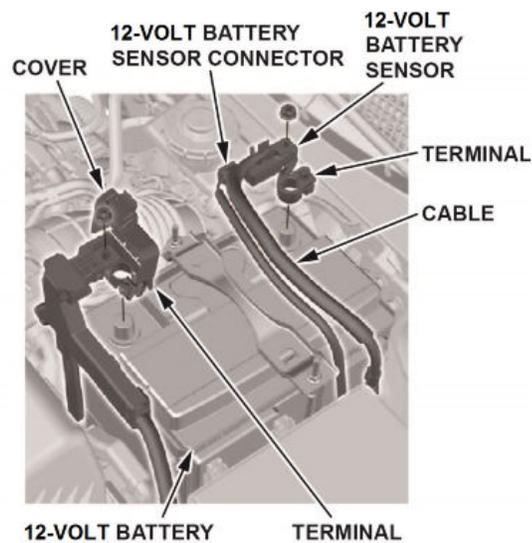
TYPE B

4. *Type A only:* Open the cover.
5. Disconnect the positive terminal from the battery.

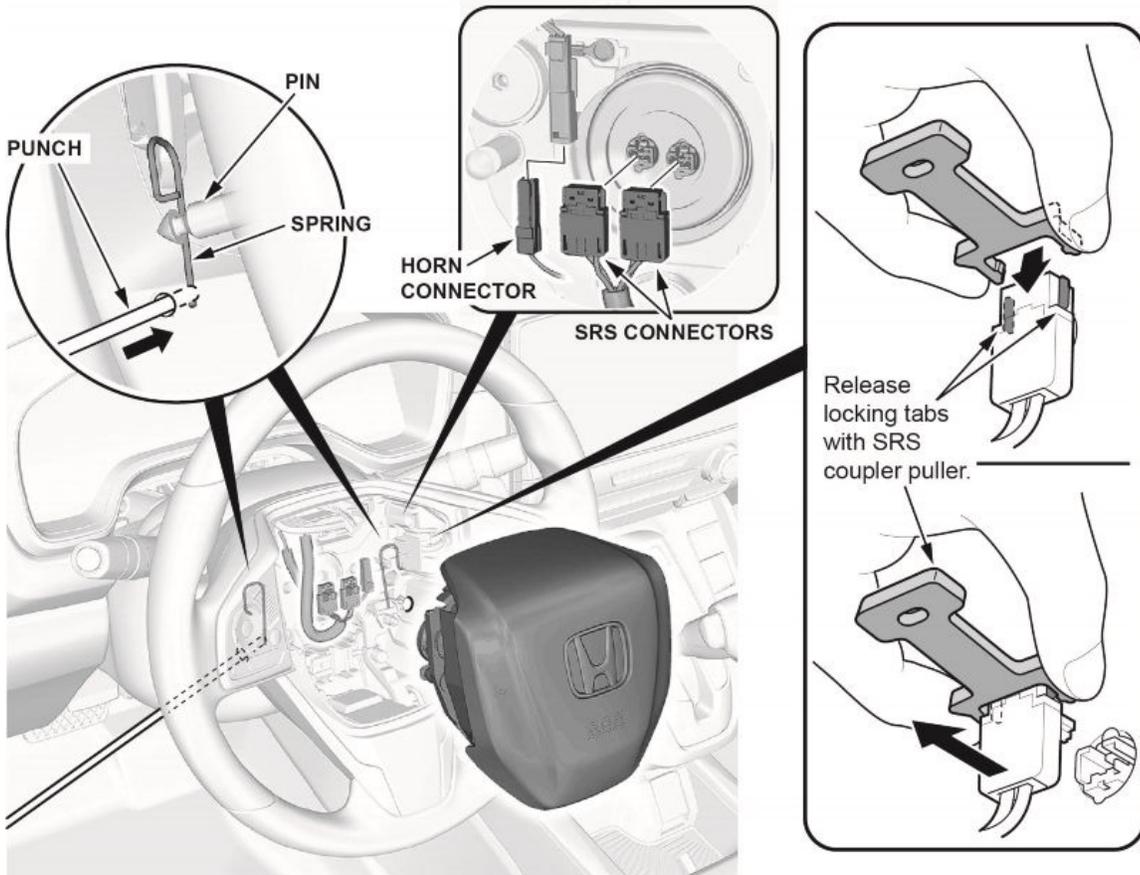
6. Insert a 5.5 mm-diameter punch through the left hole in the steering wheel cover. Then, push the retainer spring to release the left side airbag module pin while lightly pulling out the module.

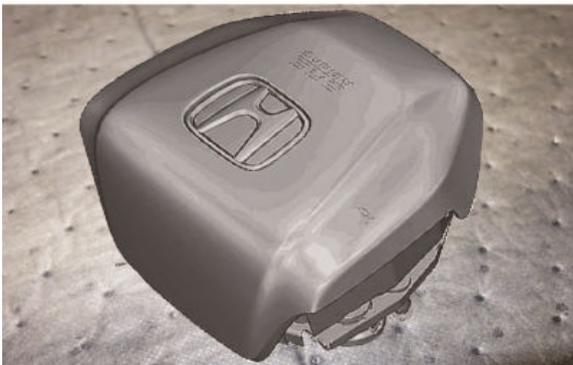
9. Disconnect the horn connector, and remove the airbag module. Set it facing up on a shop towel to avoid damaging the surface.

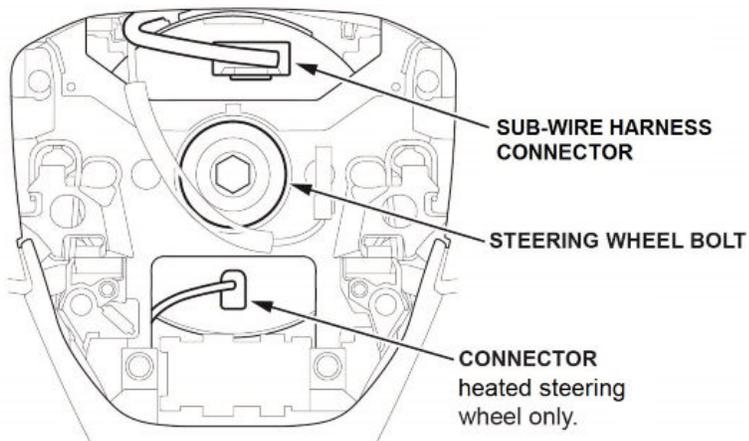
10. Disconnect the sub-wire harness connector from the cable reel.

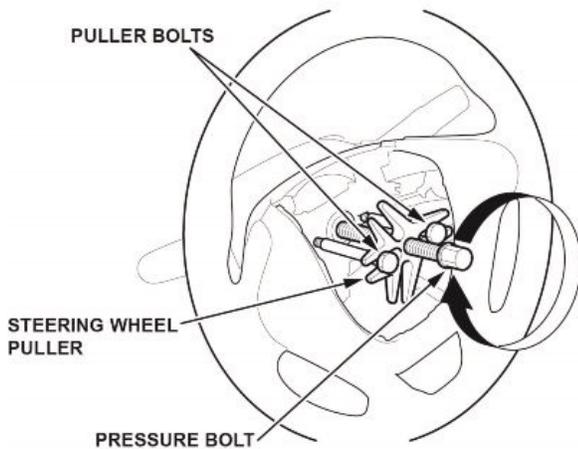
13. Install a commercially available steering wheel puller on the steering wheel.

- Do not tap on the steering wheel or the steering column shaft when removing the steering wheel.
- If you thread the puller bolts into the wheel hub more than five threads, they will hit the cable reel and damage it. To prevent this, install a pair of jam nuts five threads up on each puller bolt.

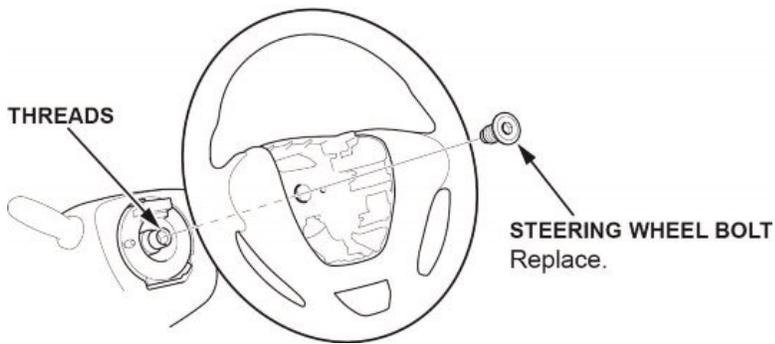
17. Remove the steering wheel.

Remove the old sealant from the column shaft threads.

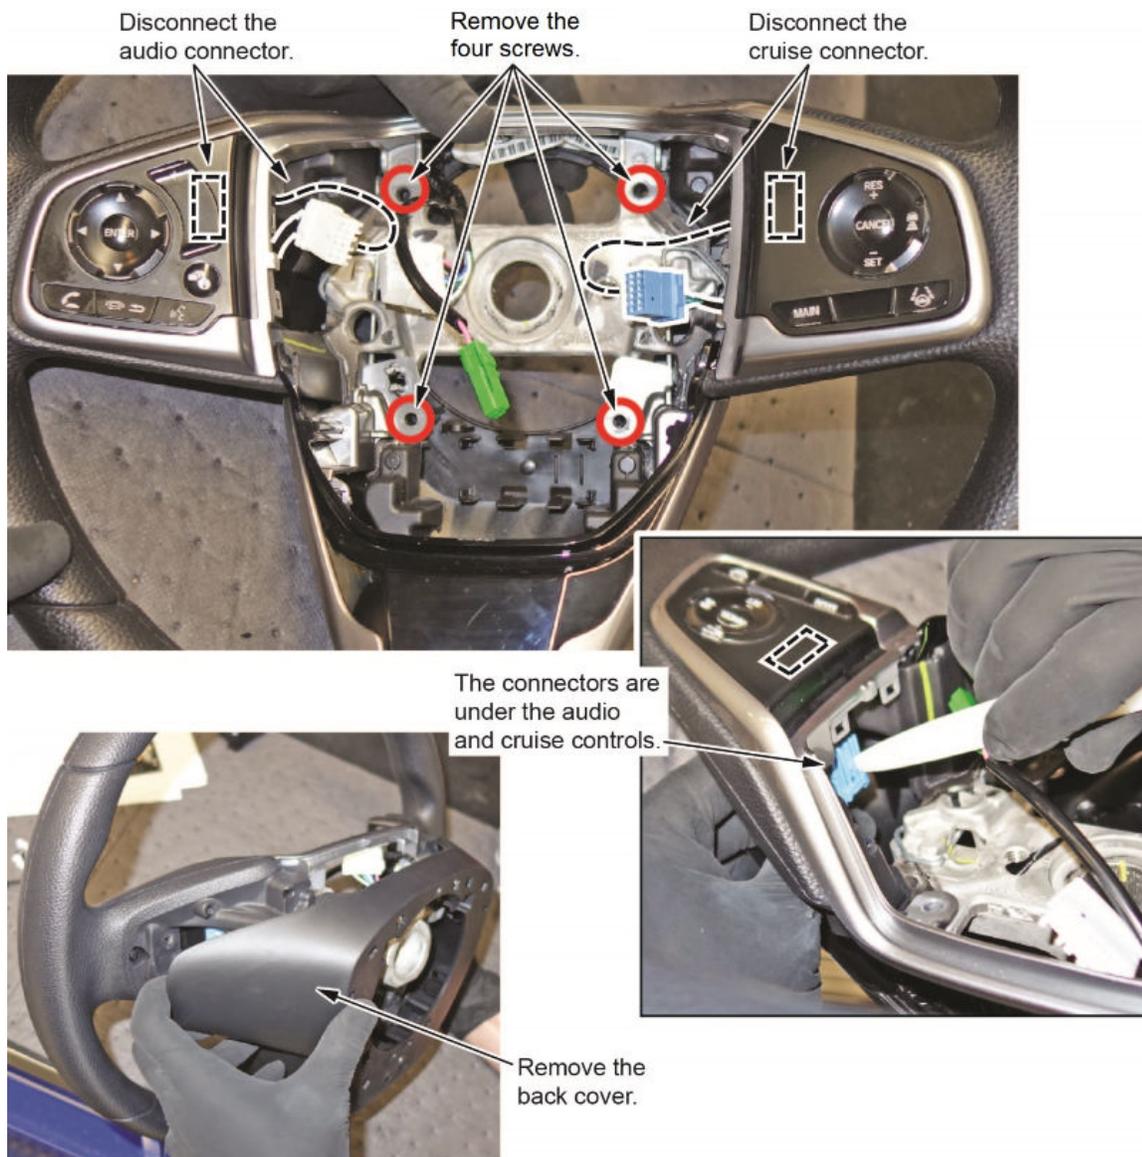
18. Disconnect the sub-wire harness from the audio remote switch assembly and the cruise control switch assembly. Remove the four screws, and remove the back cover from the steering wheel.

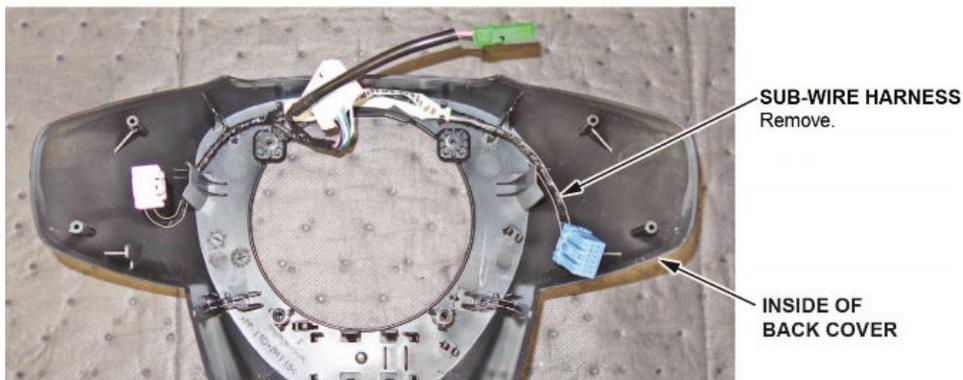
19. Remove the sub-wire harness from the back cover.

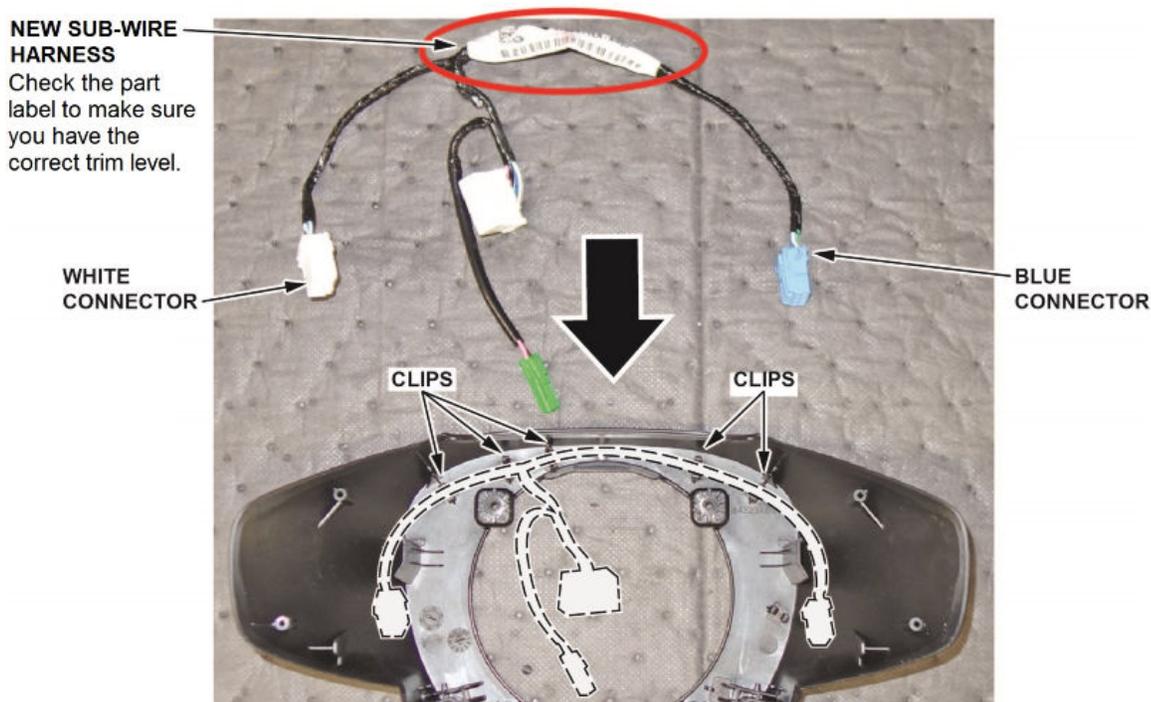
21. Install the new sub-wire harness on the back cover. Make sure the harness is installed as shown. If the harness is reversed, the steering wheel controls will not work.

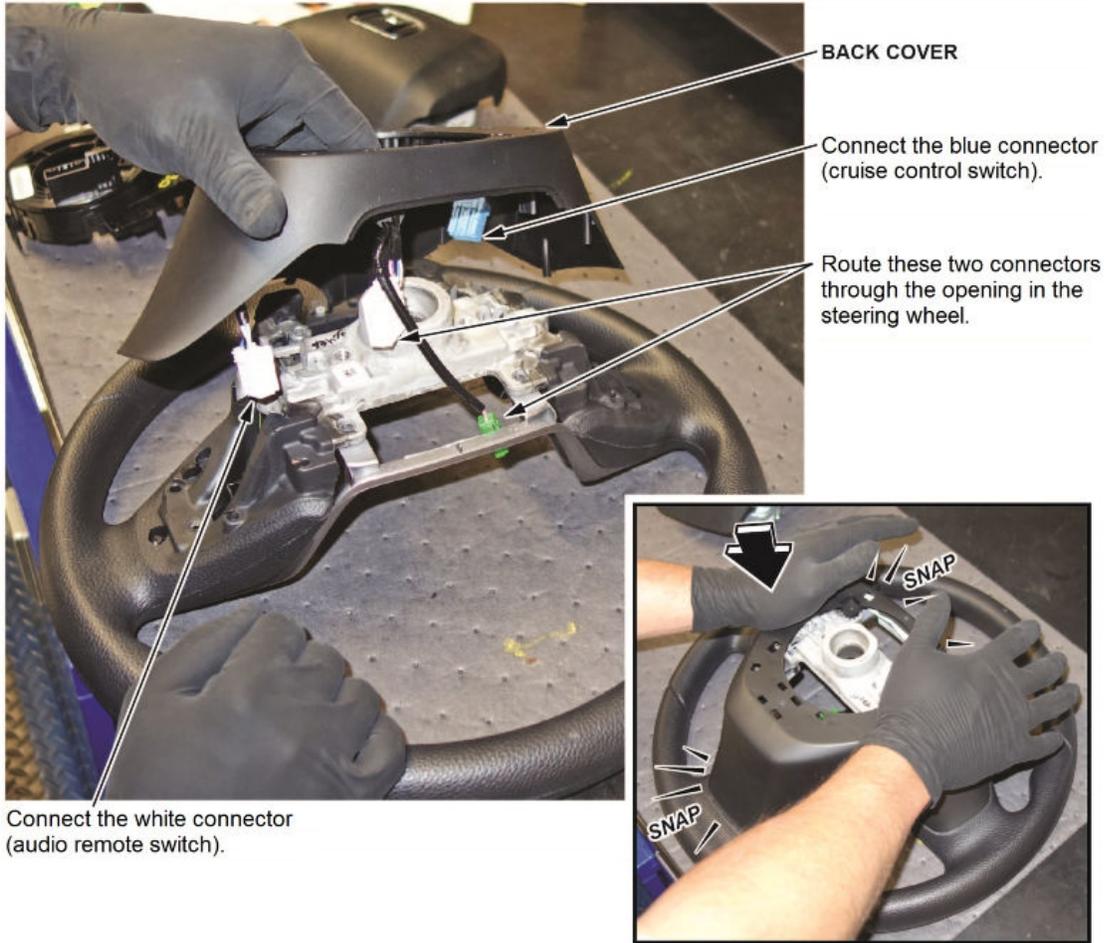
22. Install the back cover to the steering wheel. Make sure the blue and white connectors are routed through their openings in the steering wheel.

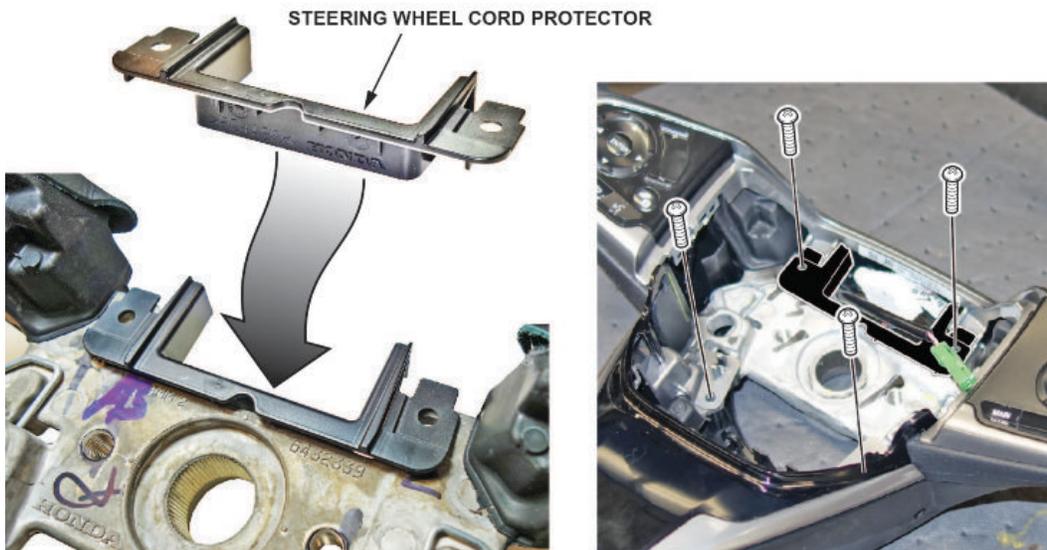
Revised Image

24. Install the cord protector and the four screws that secure the steering wheel back cover.

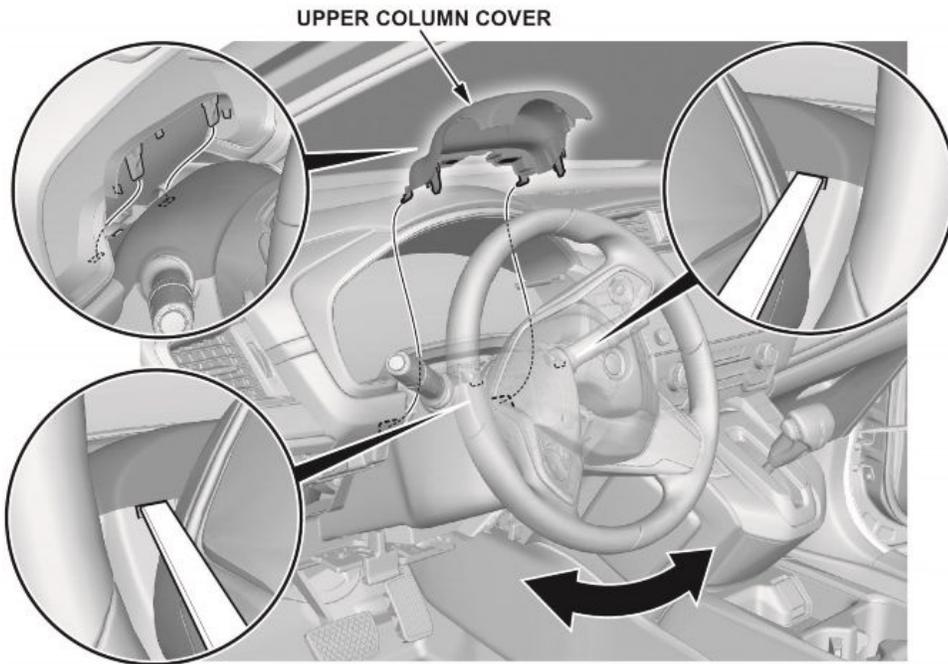
25. Remove the upper column cover. Use a plastic trim tool (commercially available) to unclip it.

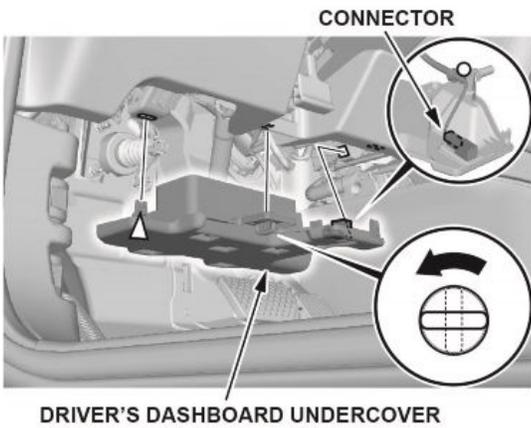
26. All trim levels except LX: Remove the driver's dashboard undercover.

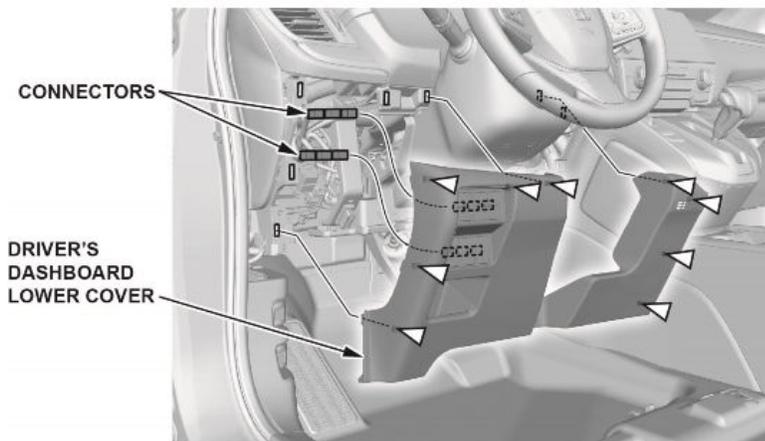
27. Remove the driver's dashboard lower cover. Disconnect the connectors.

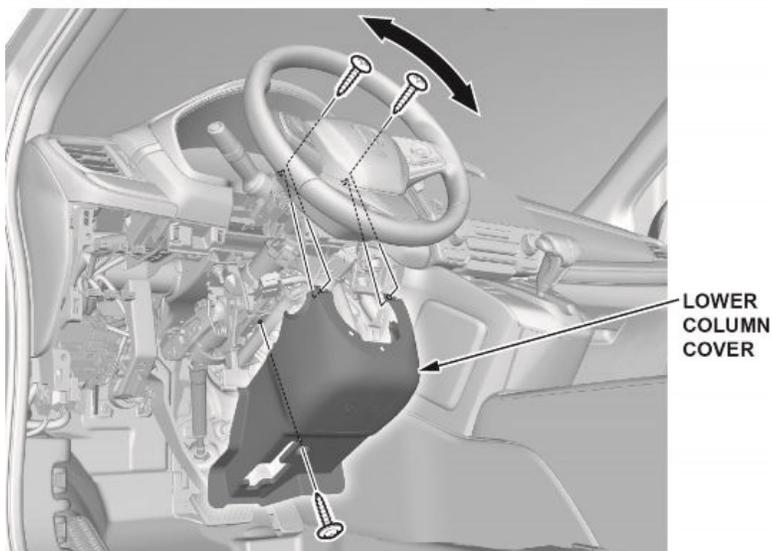
28. Remove the lower column cover.

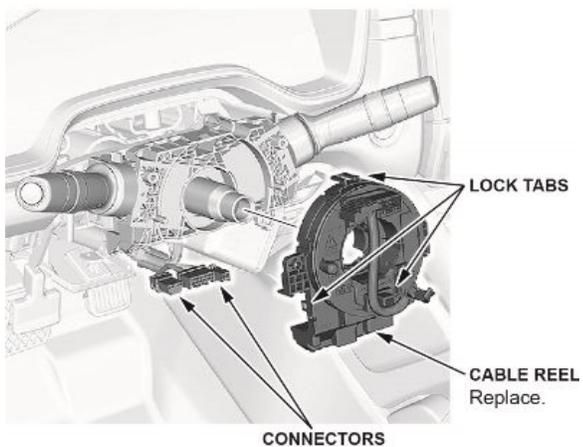
29. Disconnect the connectors from the back of the cable reel.

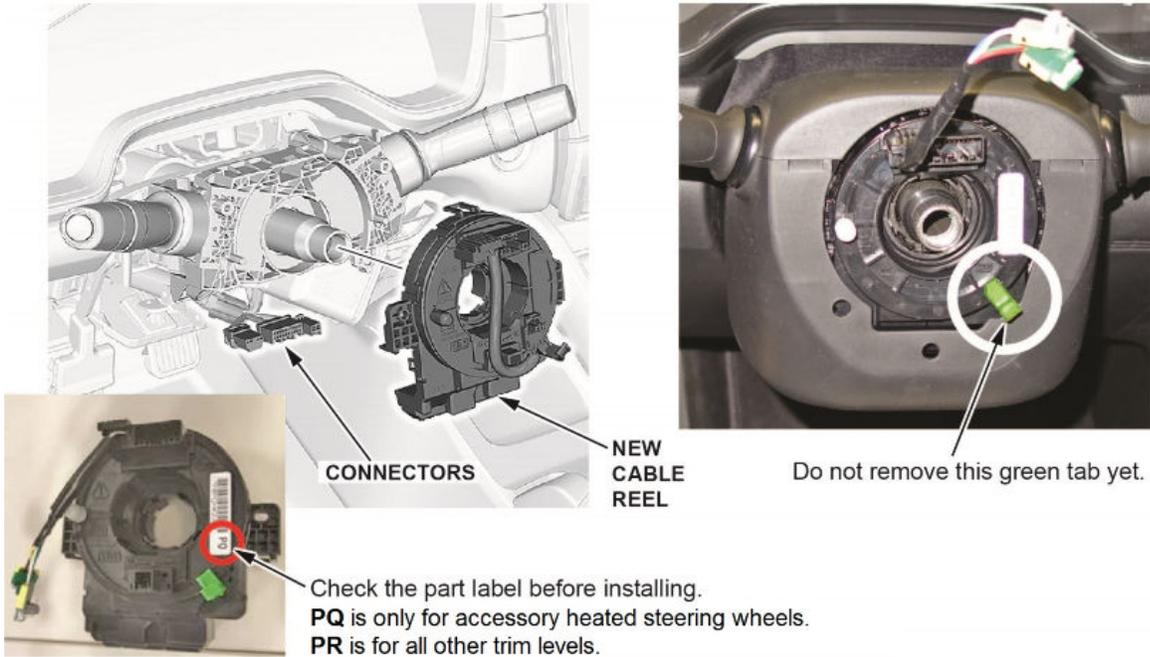
31. Check the part label on the new cable reel to make sure you are installing the correct part. Cable reels labeled **PQ** are only for accessory heated steering wheels. Cable reels labeled **PR** are for all other trim levels.

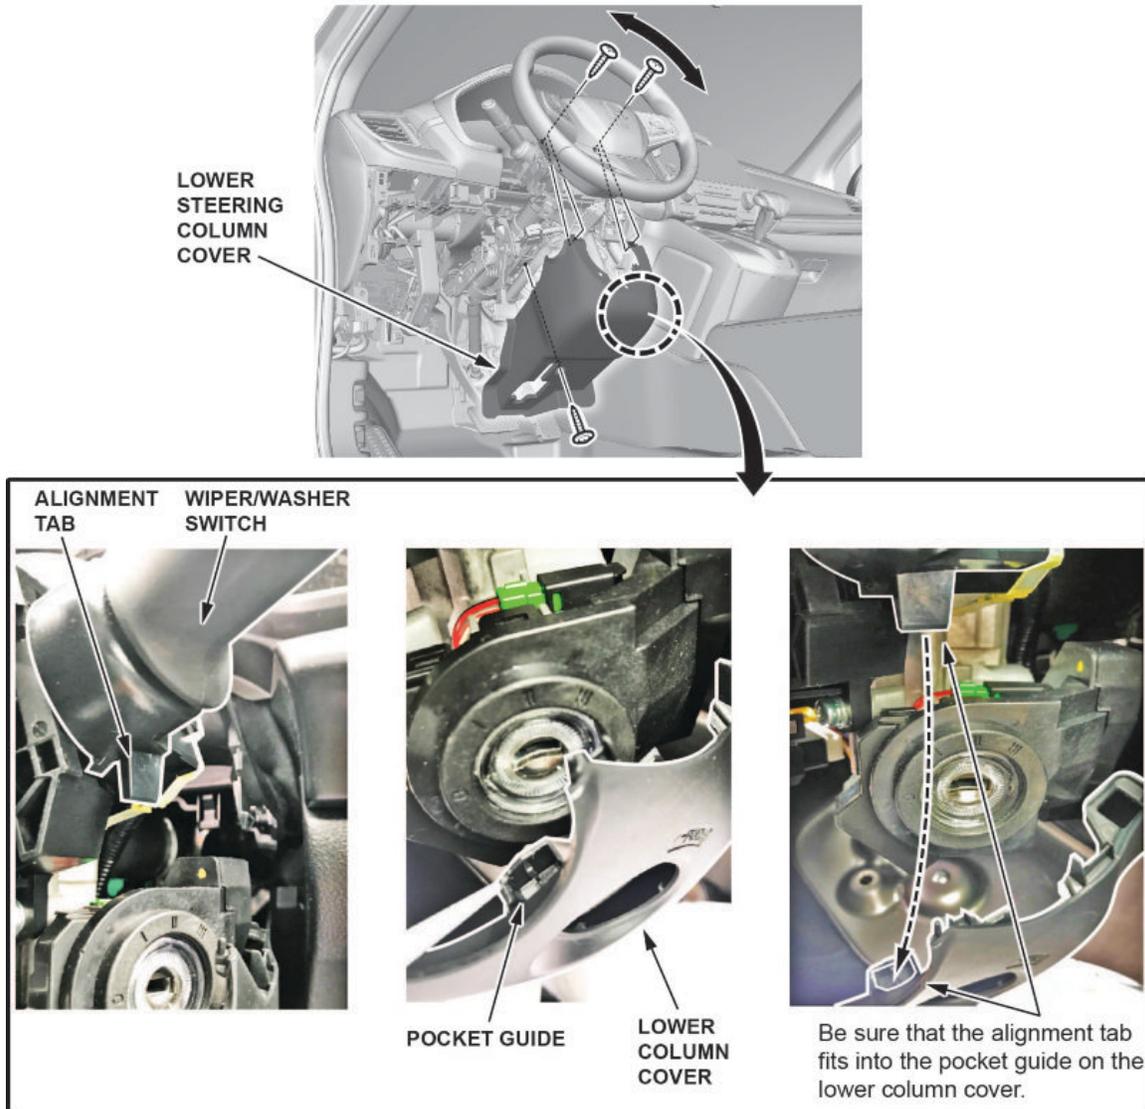
33.1. **Locate the alignment tab at the bottom of the wiper/washer switch.**

33.2. **Install the lower steering column cover. Make sure the pocket guide on the cover fits over the ignition switch and into the alignment tab, then install the three screws.**

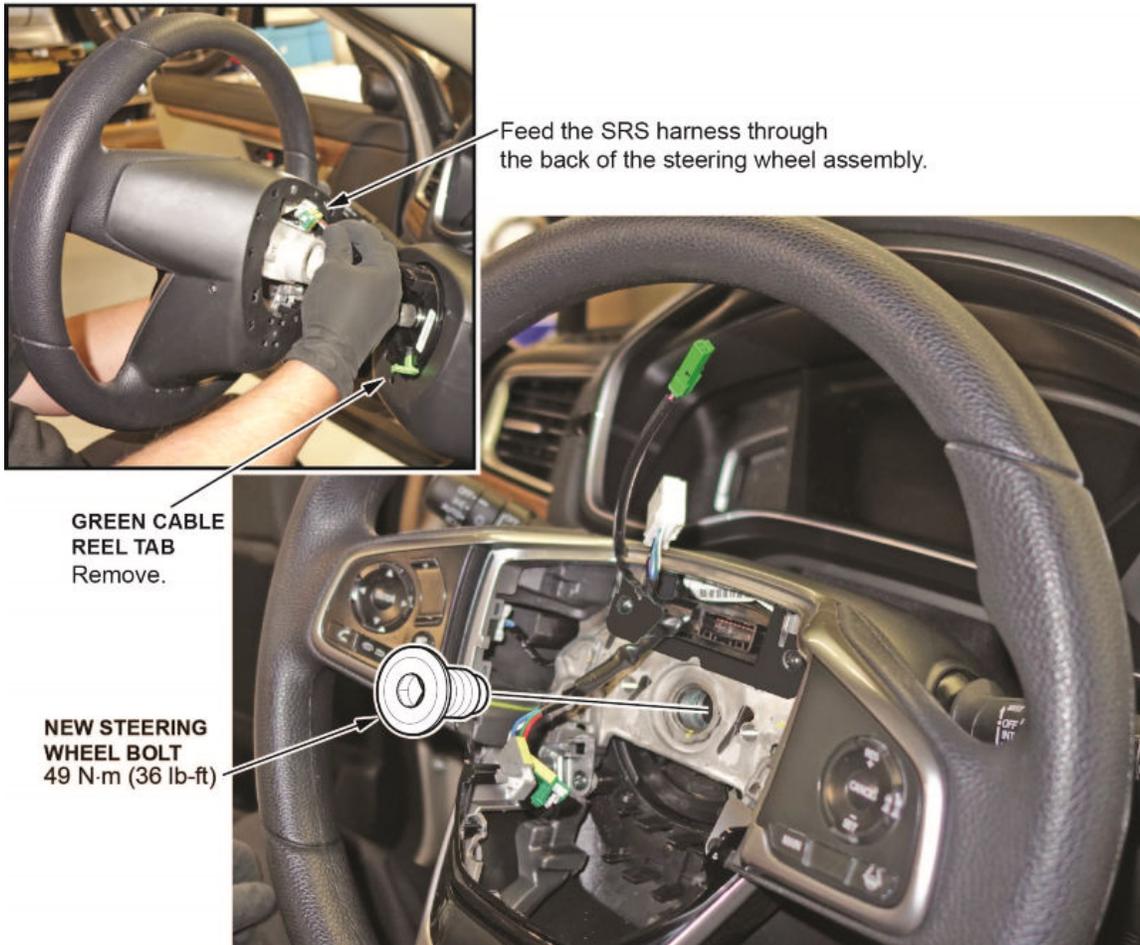
37. Remove the green tab right before installing the steering wheel. Make sure to line up the mark made in step 16.

38. Install the new steering wheel bolt, and torque it to **49 N·m (36 lb-ft)**.

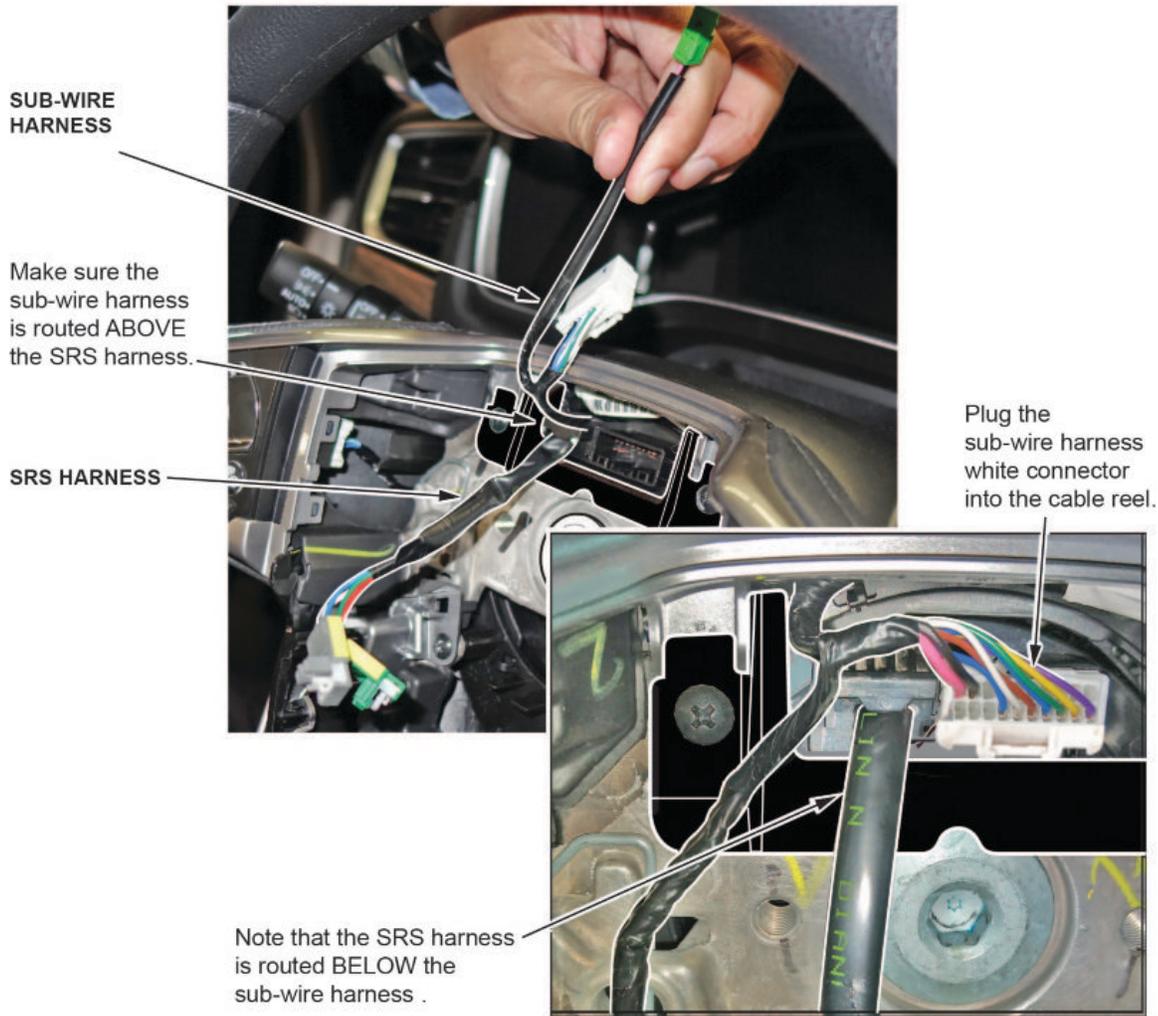
Revised Image

39. Connect the sub-wire harness to the cable reel.

The sub-wire harness must be routed above the SRS harness.

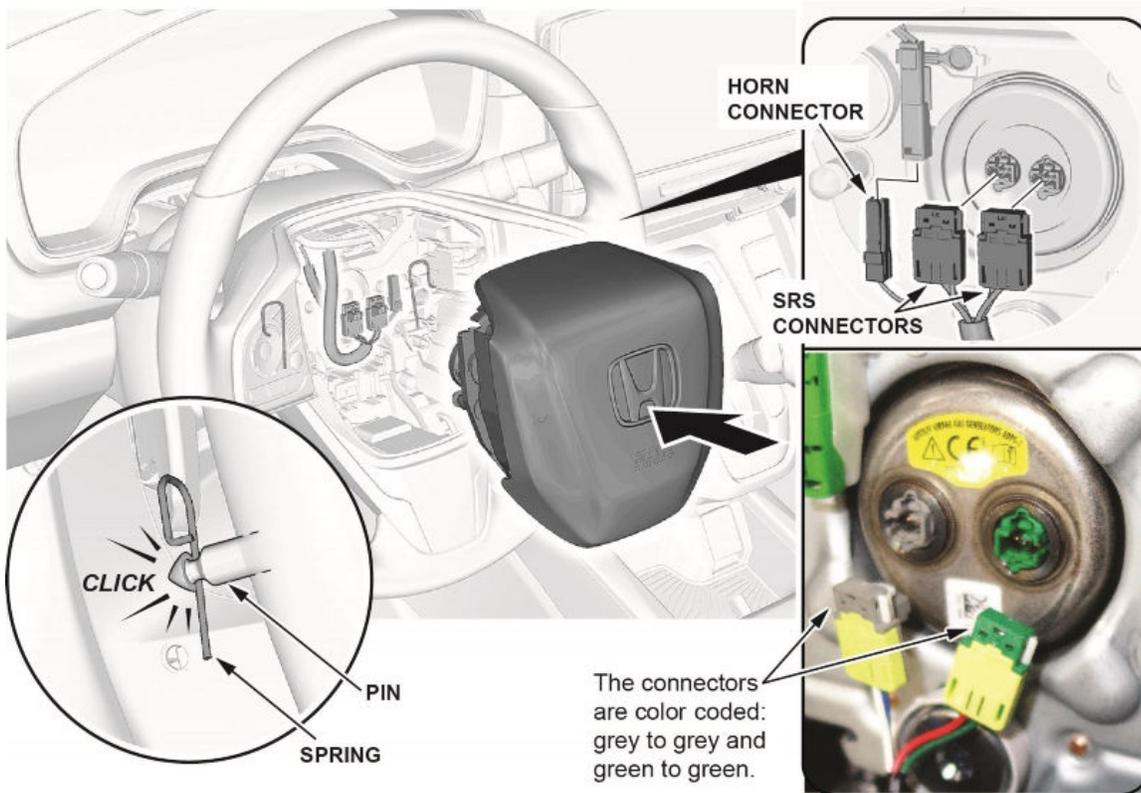
41. Connect the airbag module connectors.

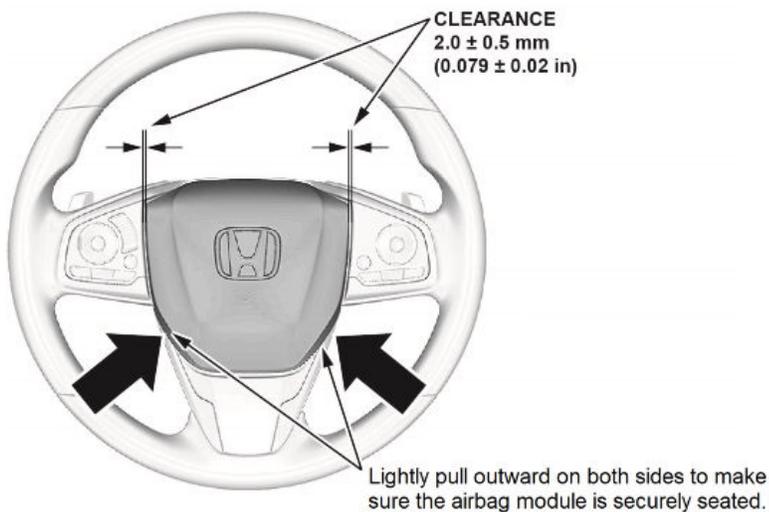
44. Make sure the driver's airbag module is centered in the steering wheel.

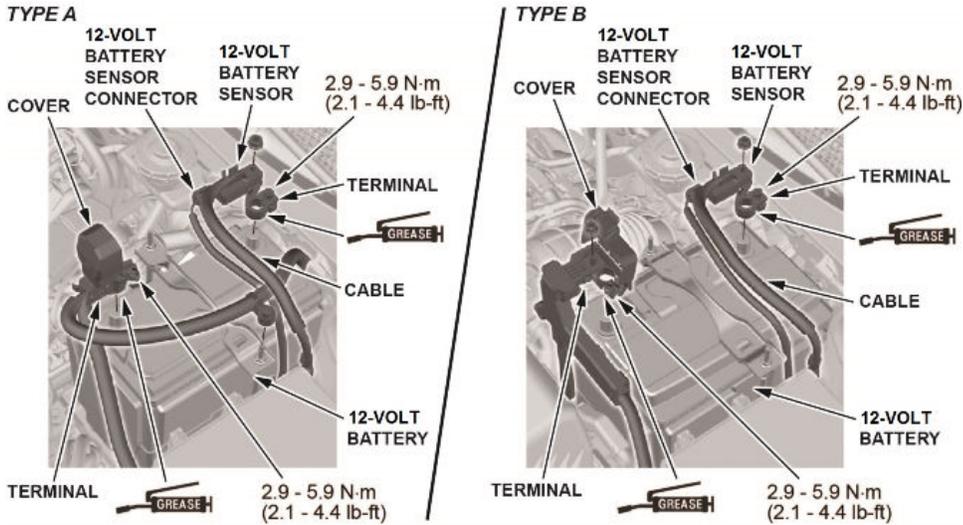
45. Connect the battery terminals.

- Always connect the positive side first.
- To protect the battery sensor from damage, do not hold it when installing the negative terminal
- Apply multipurpose grease to the terminals to prevent corrosion.
