TOOLS AND PARTS INFORMATION

A. REPAIR PROCEDURE

Repair on C-43 and C-44

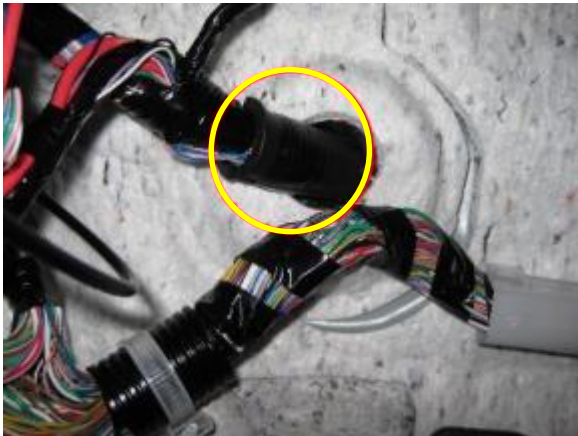
1. Locate Joint Connector C-43 and C-44 (Refer to "Joint Connector Locations")

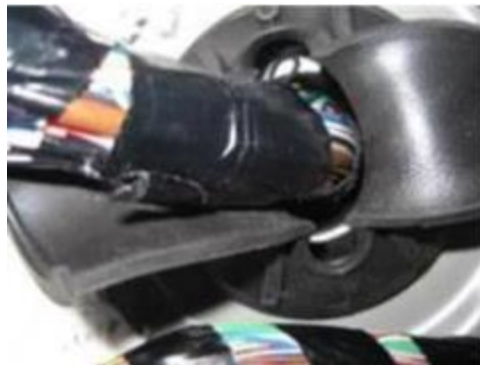
2. Open the rubber boot and cut the tape to gain access to joint connectors C-43 and C-44.

Rubber boot opened

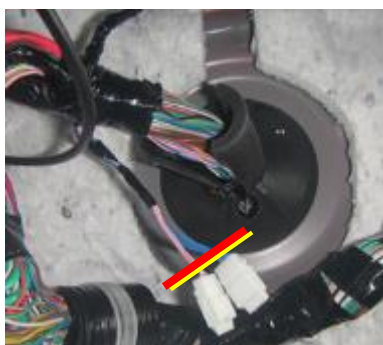
3. Remove Joint Connector C-43 and C-44 by cutting the wiring harness at the joint connectors.

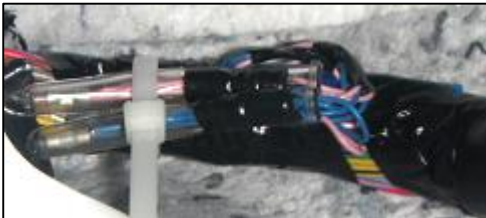
11. Fix the protective caps to the wire harness using a zip tie and cut off the excess material.

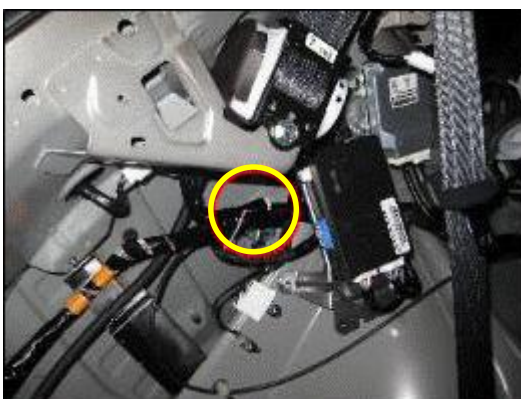
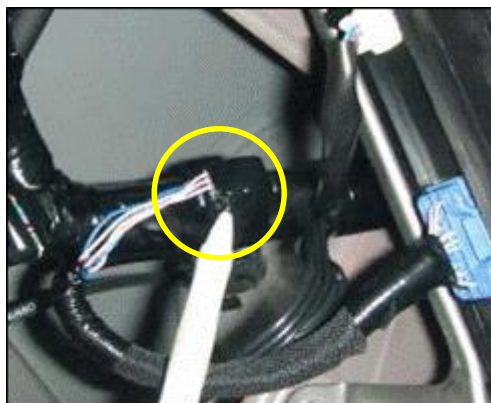
13. Locate Joint Connector C-47 and C-48 (Refer to "Joint Connector Locations")

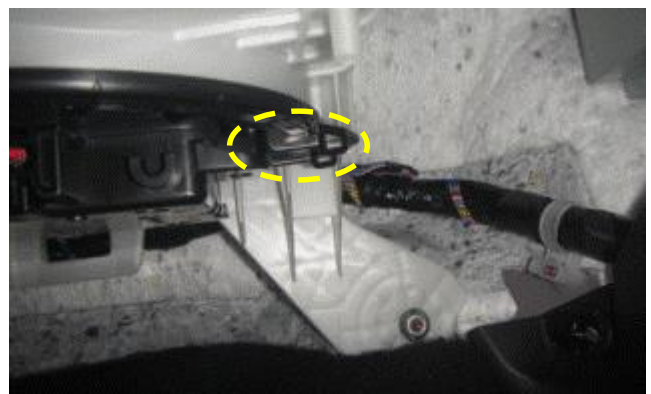
18. Locate the C-51 and C-52 connectors.

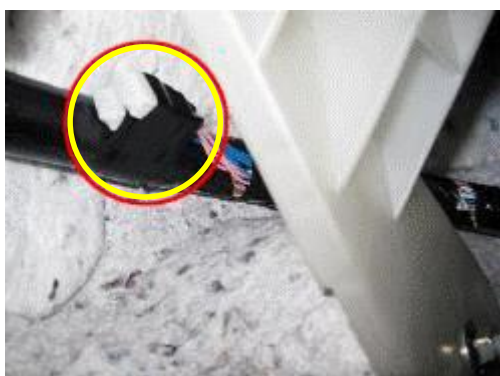
View A-A

19. Carefully cut the tape while holding the connectors and wires in place.

- An art knife (or equivalent blade) is recommended since it is not easy to access the connectors.
- Take care not to cut wires.

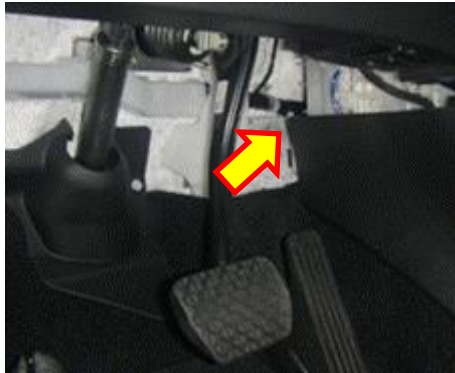
23. Remove the RH and LH console side wall panels. Refer to MGSS online or the workshop manual "SIDE WALL REMOVAL/INSTALLATION".
24. Locate Joint Connector C-54 and C-55 (Refer to "Joint Connector Locations")

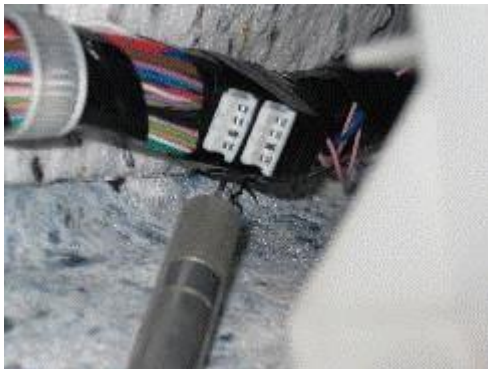
25. Carefully cut the tape while holding the connectors and wires in place.

- An art knife (or equivalent blade) is recommended since it is not easy to access the connectors.
- Take care not to cut wires.

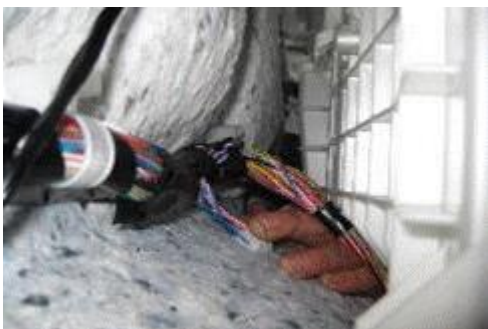
26. Pull the joint connectors to the passenger side for repair reaching under the HVAC Unit from the passenger side.

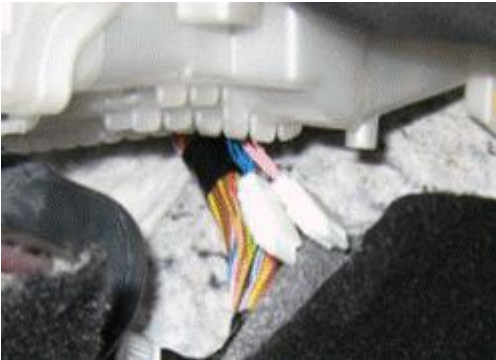
28. If the connectors cannot be pulled out enough for the work, proceed to next step. If it can be, proceed to step 37.

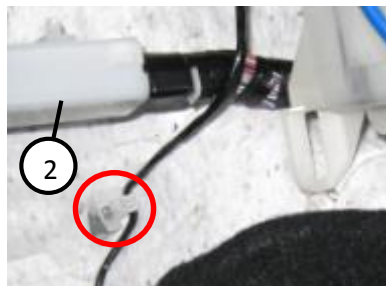
30. Release harness clips near C54 and C55 (1) and harness protector (2)

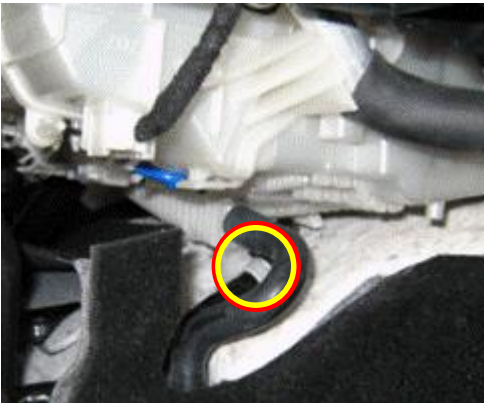
32. Release a harness clip under HVAC
