**AKB1 – Replacing Plastic Bushing on the Selector Lever Cable (Recall Campaign)**

Model Line: **Cayenne (9PA)  
Panamera (970)**

Subject: **Selector lever cable**

Information: **Due to insufficient strength of the material of a plastic bushing for the selector lever cable, the durability of the cable cannot be guaranteed over the service life of the vehicle.**

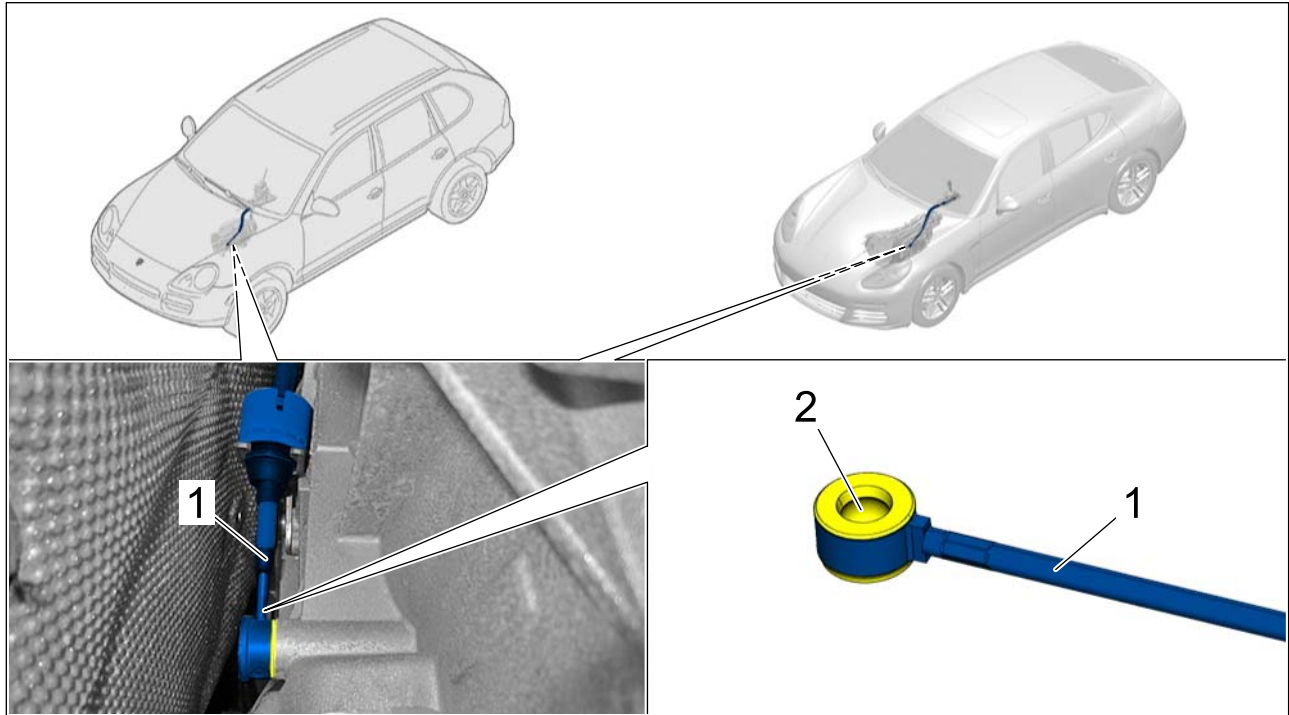
Overview of installation position of plastic bushing

- 1 – Selector lever cable
- 2 – Plastic bushing (**replace**)

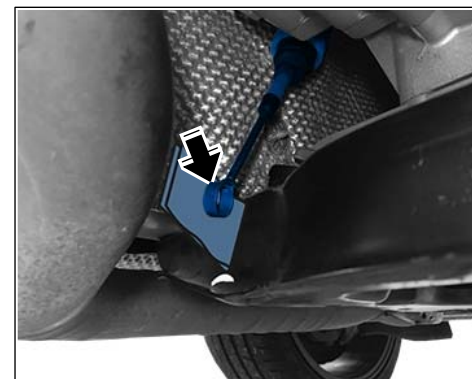
*Cleaning bore on pendulum joint*

- 4.4 Clean the bore on the pendulum joint ⇒ *Cleaning bore on pendulum joint -arrow- thoroughly* using a clean, lint-free cloth.

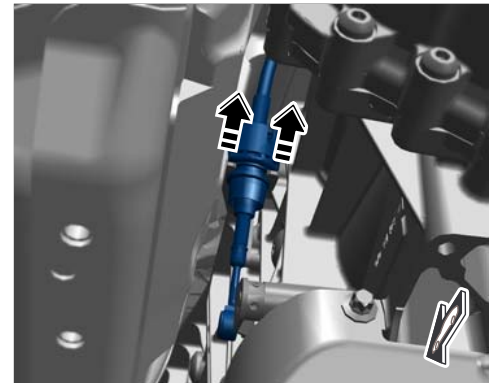
*Pulling out selector lever cable*

3.2 Press the pendulum joint on the selector lever cable upwards and pull it to the rear and out of the support ⇒ *Pulling out selector lever cable*.

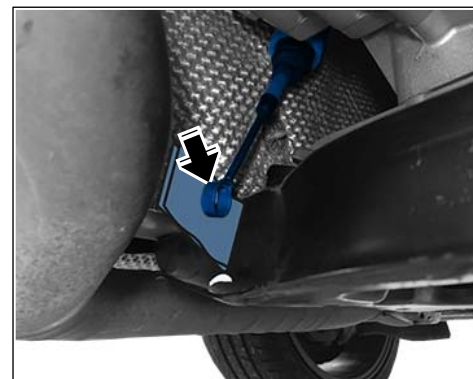
*Cleaning bore on pendulum joint*

- 4.4 Clean the bore on the pendulum joint ⇒ *Cleaning bore on pendulum joint -arrow-* **thoroughly** using a clean, lint-free cloth.

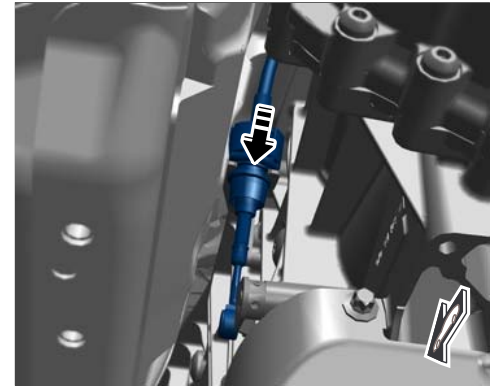
*Pushing in selector lever cable*

- 5.1 Push the pendulum joint on the selector lever cable into the support on the transmission in direction of travel ⇒ *Pushing in selector lever cable.*

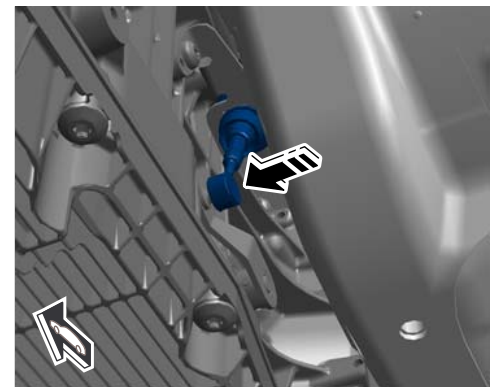
*Pressing in selector lever cable*

- 5.2 Press in plastic bushing on the selector lever cable at the transmission lever ⇒ *Pressing in selector lever cable.*
