Mercedes-Benz

Campaign No. 2019090018, November 2019

SUBJECT: **Model GT-Class vehicles (190 platform)**
Model Year 2016 and 2017
Carbon-Fiber Driveshaft Bonding

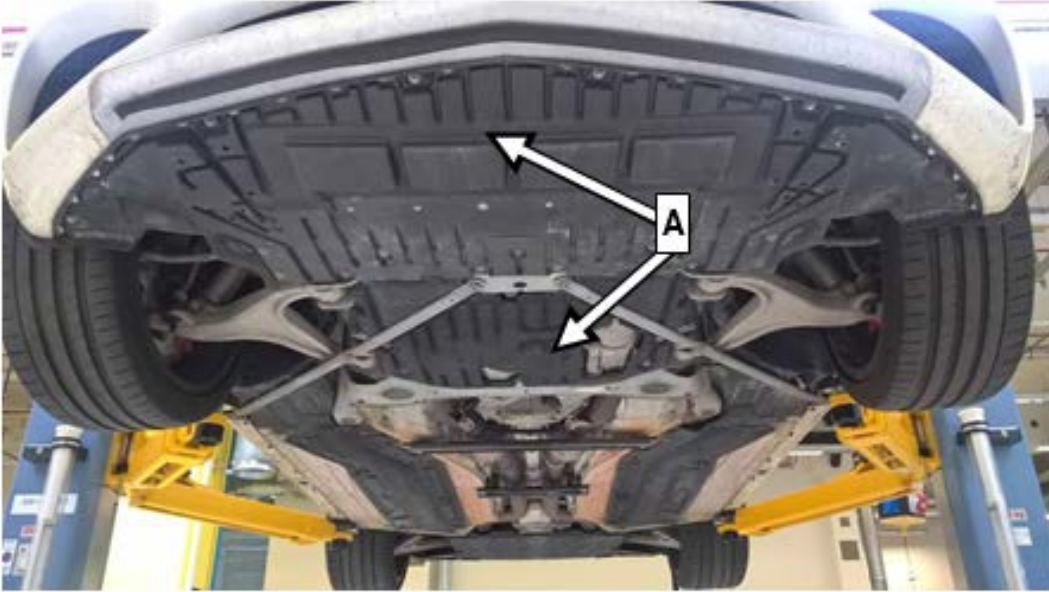
**Figure 1**

1. Remove lower engine compartment lining (A, figure 1).

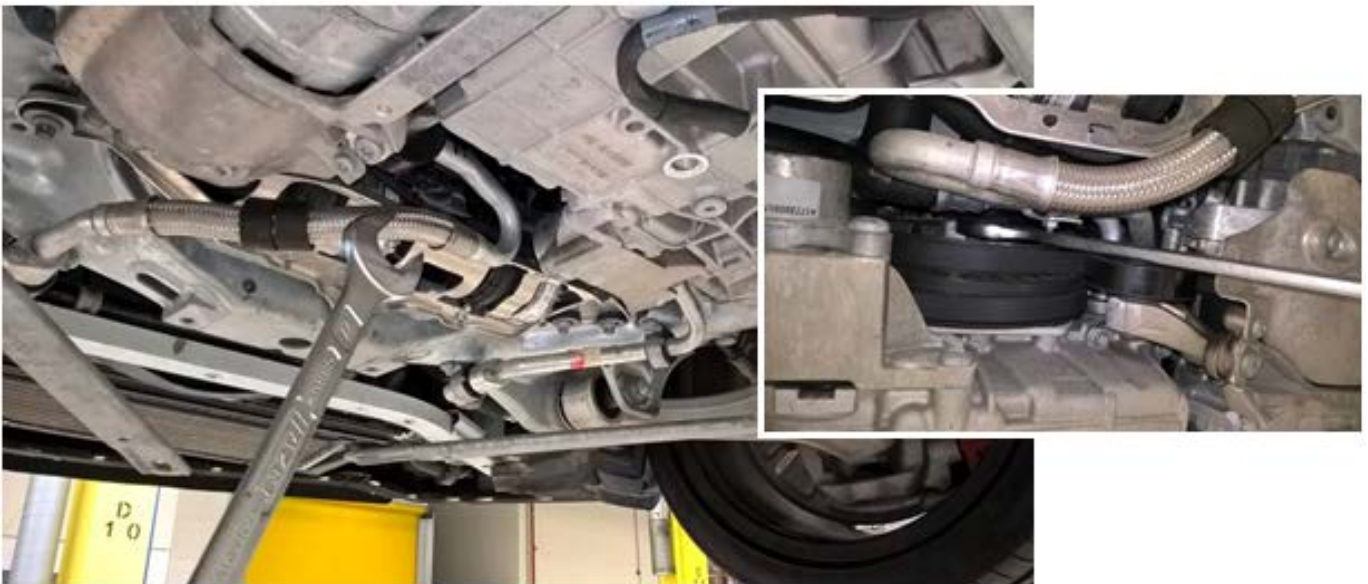
**Figure 2**

2. Open maintenance access on engine-side drive shaft housing.

Rotate engine at center bolt in direction of rotation until affixed label on drive shaft is visible.

i Rotate engine at center bolt in direction of rotation with a 27 mm open end wrench.
