September 4, 2019

Version 3

Safety Recall: Front Passenger's Airbag Inflator Can Be Over-Pressurized (Phase 5)

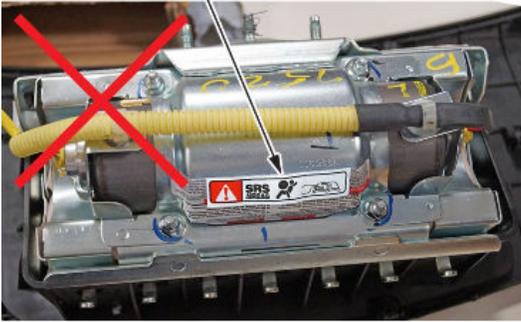
NON-STANDARD SAFETY LABEL

- If there is nothing unusual about the airbag or the inflator, continue with the inflator replacement procedure.
- If there are any unusual markings, like an incorrect label or a model year written in marker, the airbag and inflator may not be the correct airbag and/or inflator for the vehicle or it may be a counterfeit part. For more information about counterfeit airbags, you can refer to safercar.gov, enter keywords **MANAGING COUNTERFEIT**, and select **Recommended Dealer Guidance for Managing Counterfeit Air Bags** from the list. **If you suspect that the airbag or inflator is counterfeit, do not continue this procedure.** Contact your DPSM for assistance.

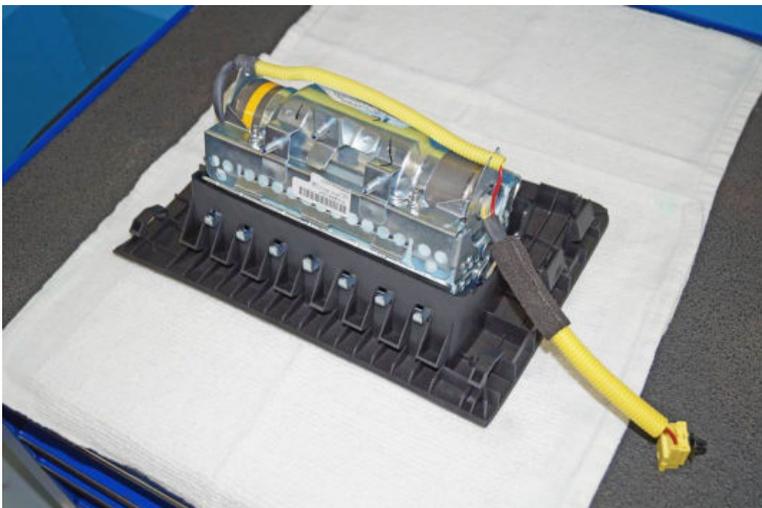
4. Place the airbag, face-down, on a clean shop towel.

- The orientation of the airbag is critical because if the inflator is installed incorrectly, the harness will be too short when you reinstall the airbag.
- The brackets between the various models are similar but may differ from the example shown.

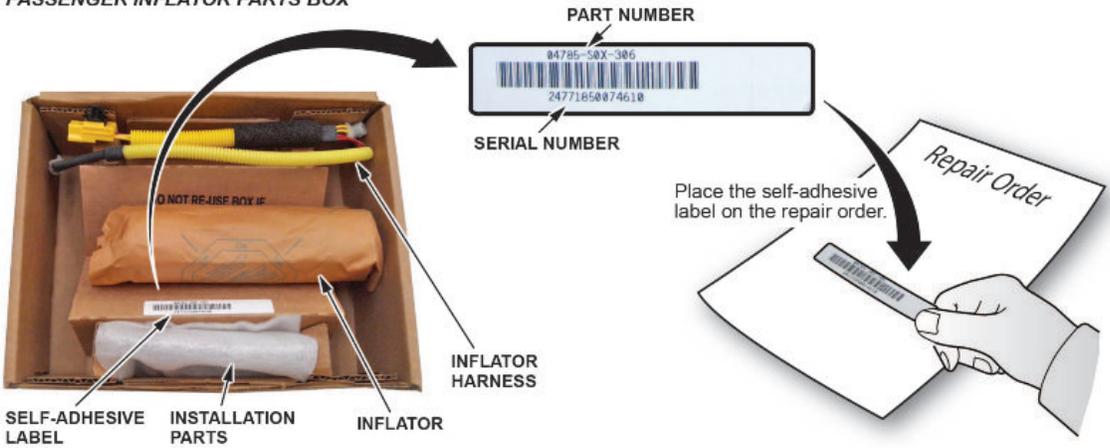
PASSENGER INFLATOR PARTS BOX

- The replacement part number is printed on the top part of the label, and the serial number is printed on the bottom. **Make sure you attach the label to the RO and give it to the warranty clerk .**
- There may also be a colored sticker located in the kit; ignore it because it is not used.
- Not all inflator kits have a label included. In those cases, write the serial number and part number from the side of the inflator box on the RO. The part number always starts with 047.

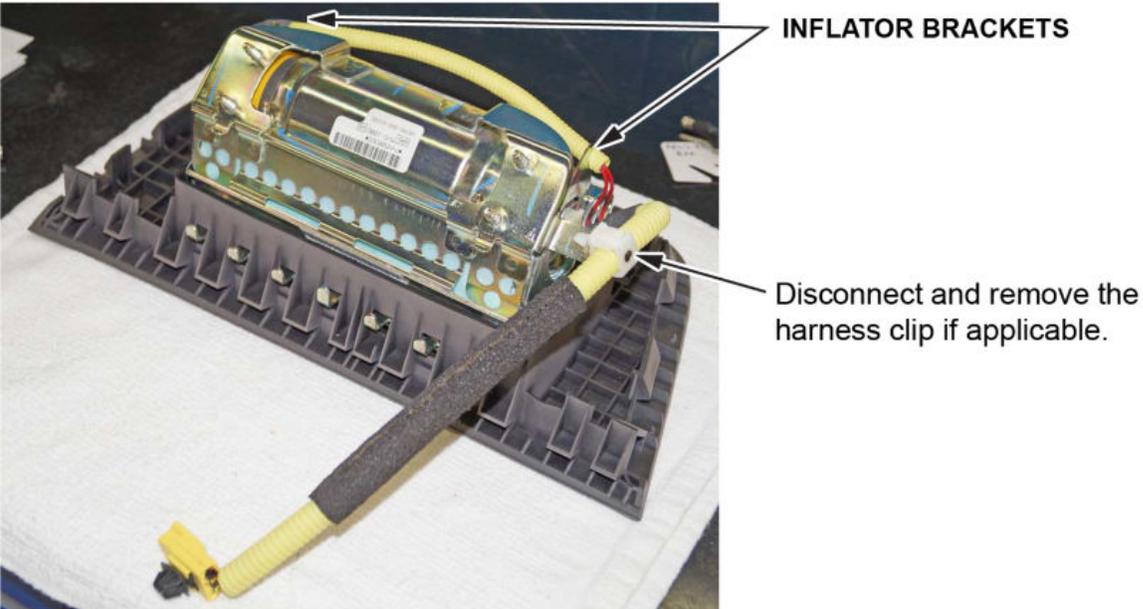
7. Remove the harness from both ends of the inflator bracket.

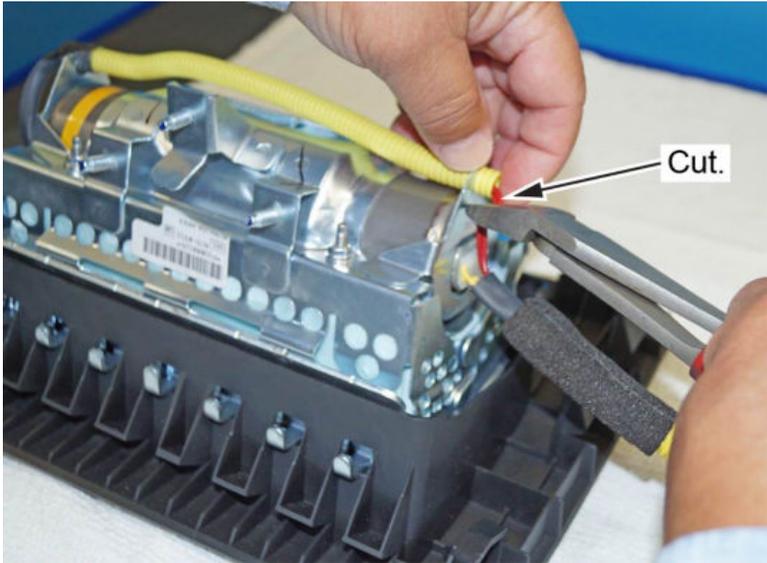
8.1. Cut the red wires as shown.

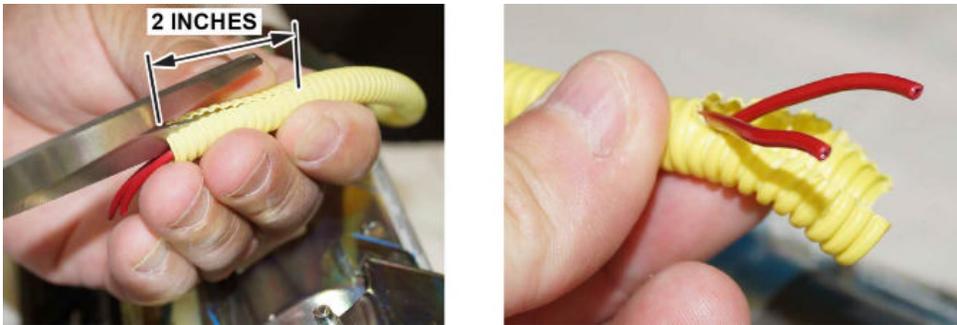
8.2. Cut about 2 inches of the corrugated tube, then pull out the two red wires.

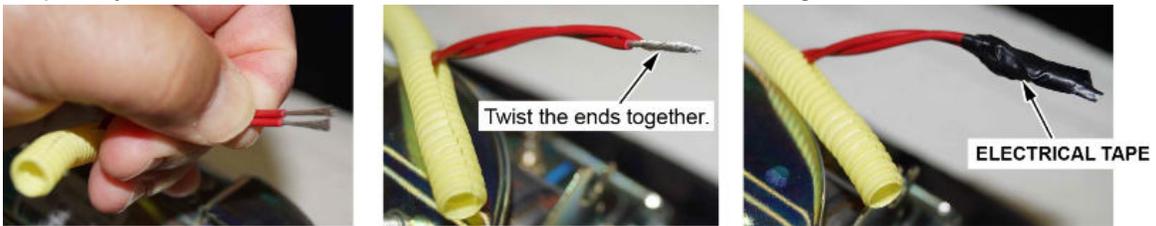
8.3. Strip away about 1 inch of the wire insulation, then twist the wires together.

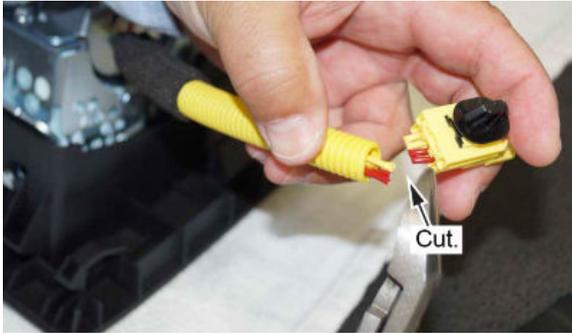
9.1. Cut all four wires to remove the connector.

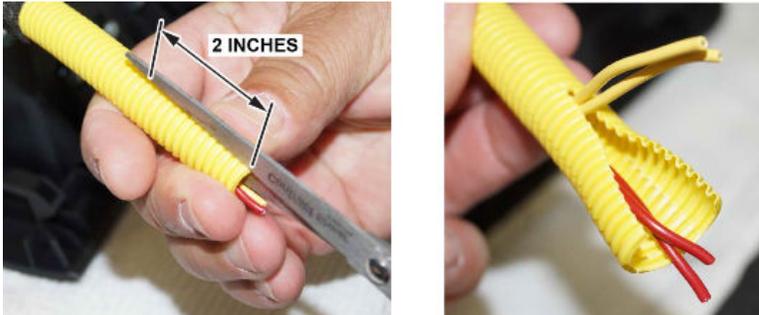
9.2. Cut about 2 inches of the corrugated tube, then pull out the yellow wires.

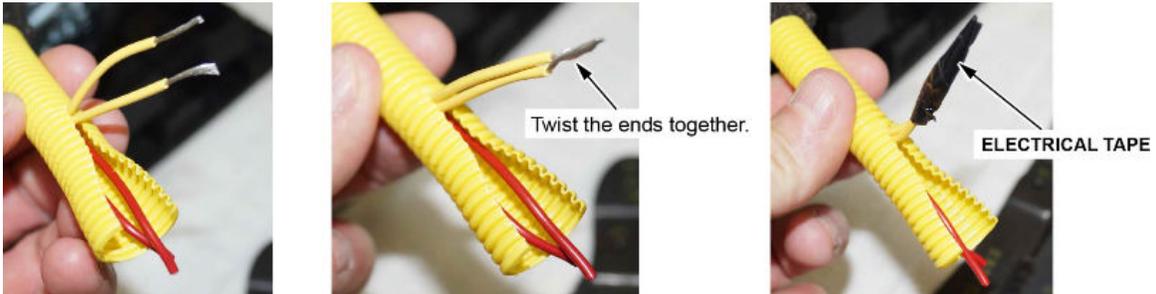
9.3. Strip away about an inch of the wire insulation, then twist the wires together.

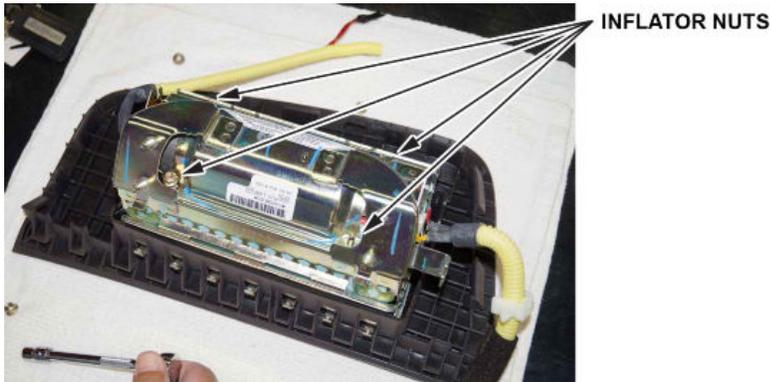
10. Remove the four inflator nuts.

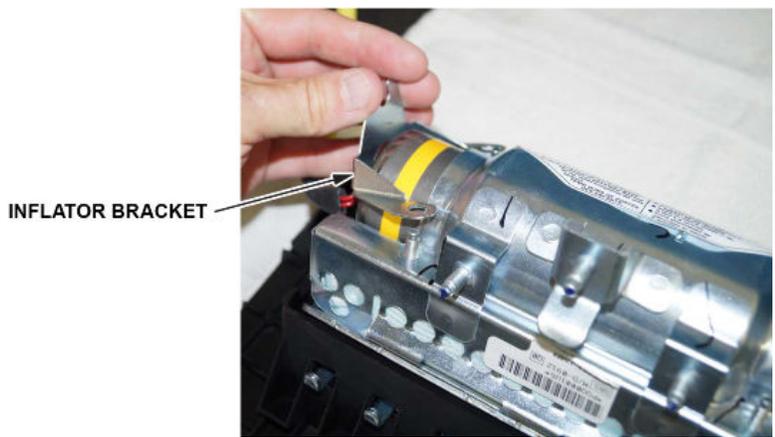
11. Remove the inflator bracket.

You can only remove one of the brackets, as the other is welded to the airbag housing.

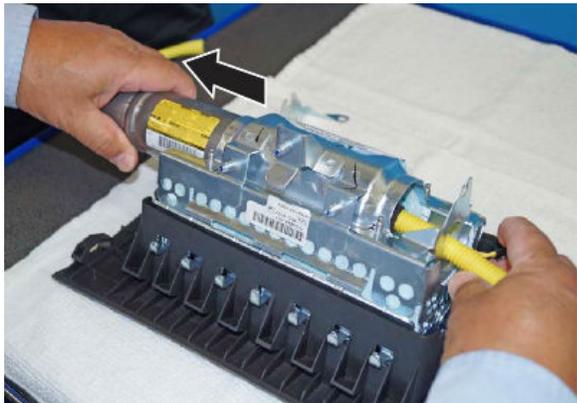
12. Remove the inflator by pushing it out.

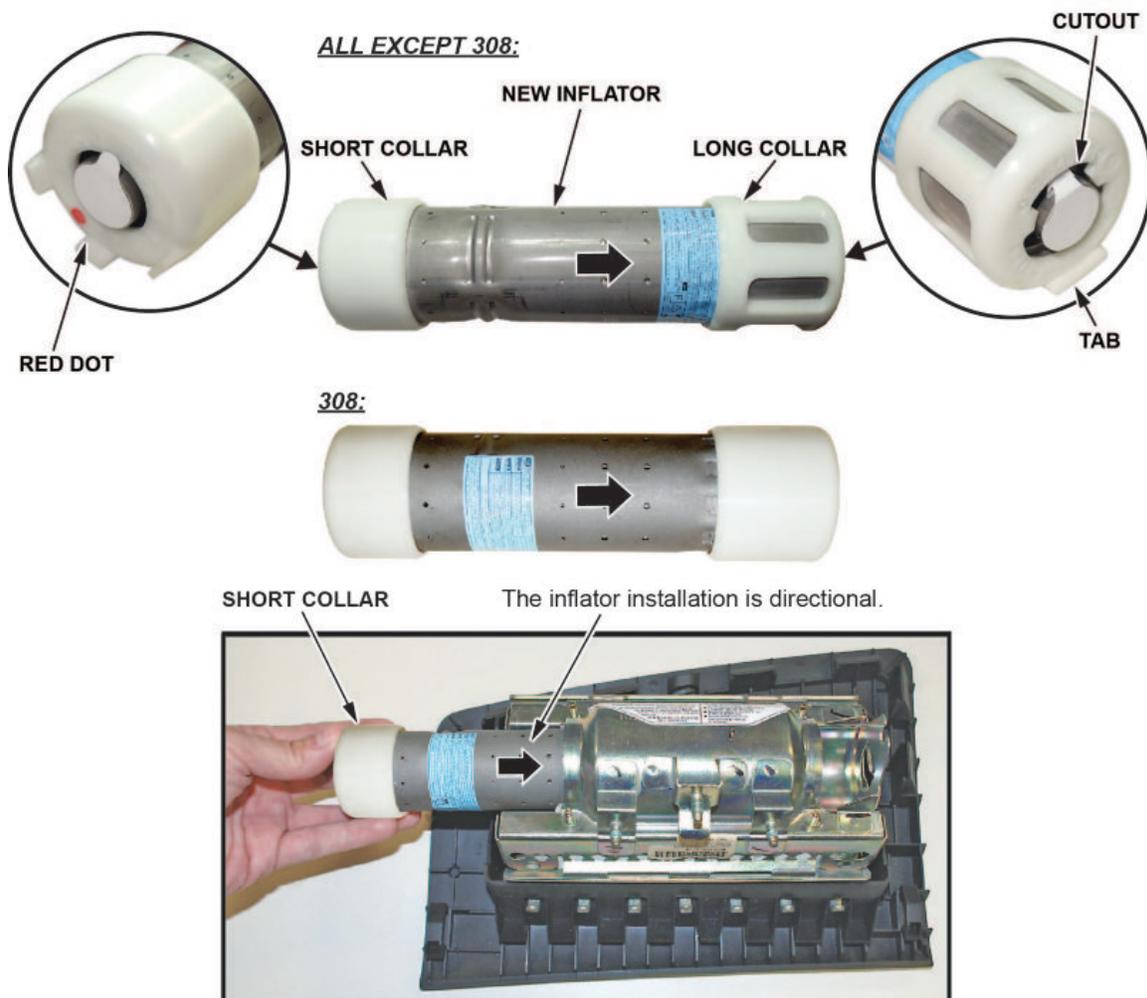
For part numbers ending in 318, A00, A10, and A20: One side of the inflator has a shorter collar, three tabs, and a red dot. The other side of the inflator has a longer collar, a tab, a plastic cutout, and a small flat spot on the connector. Make sure you insert the end with the longer collar into the airbag first.

For part numbers ending in 308: One side of the inflator has a shorter collar with one tab and a red dot. The other side of the inflator has a longer collar, a tab, a plastic cutout, and a small flat spot on the connector. Make sure you insert the end with the longer collar into the airbag first.

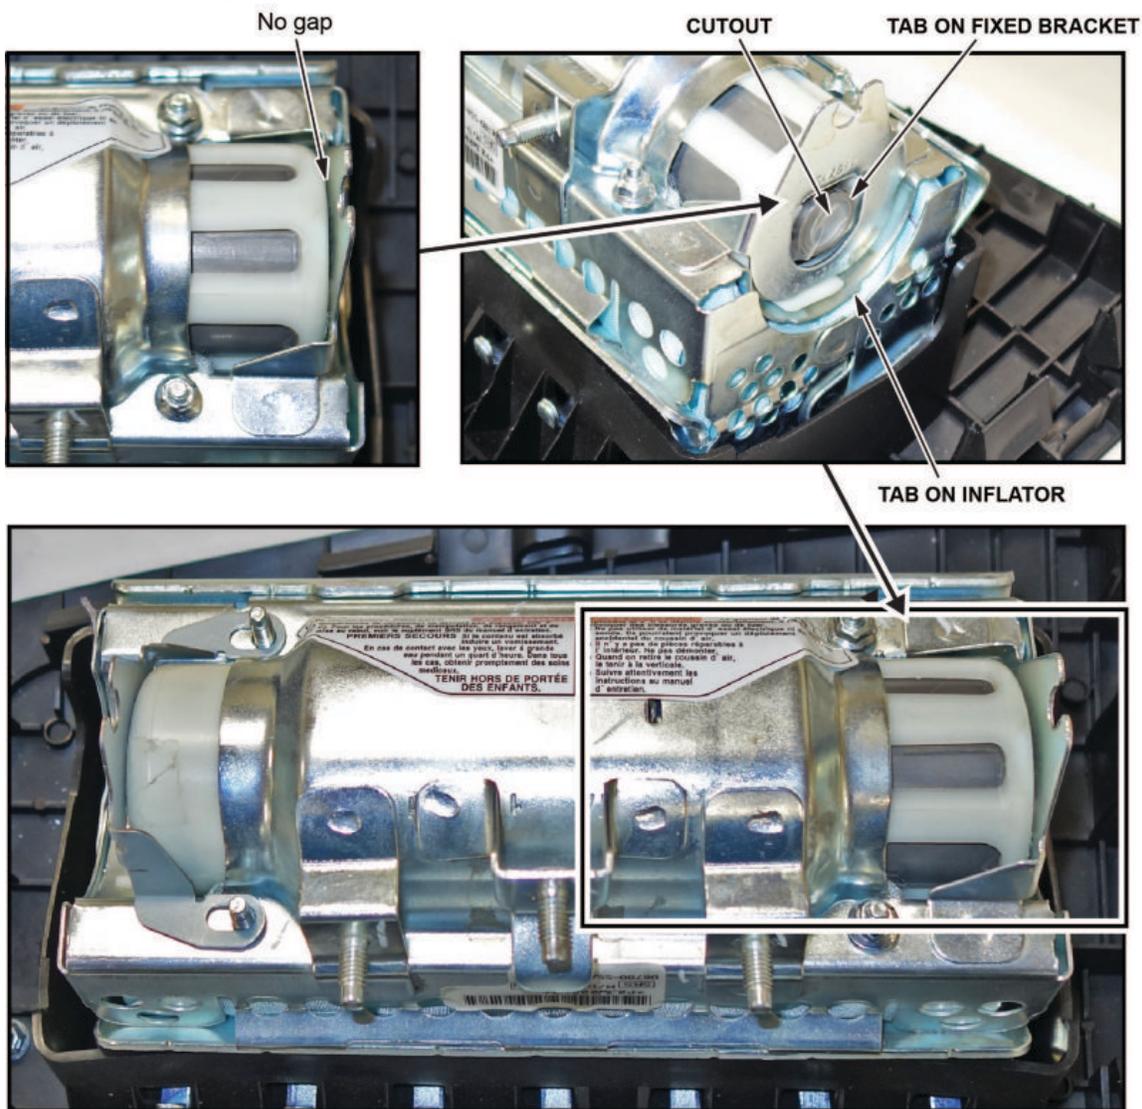
FIXED BRACKET END

13.3. Slide the inflator in until the plastic cutout and the small flat spot align with the tab on the bracket. There should be no space or gap between the inflator and bracket.

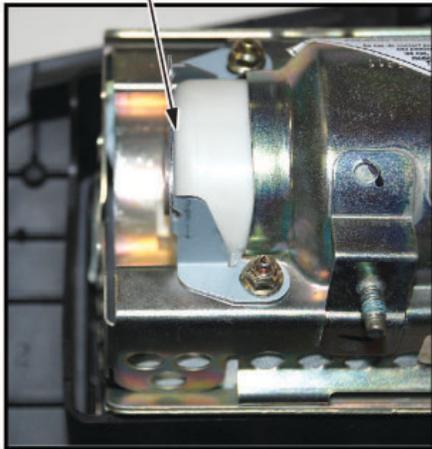
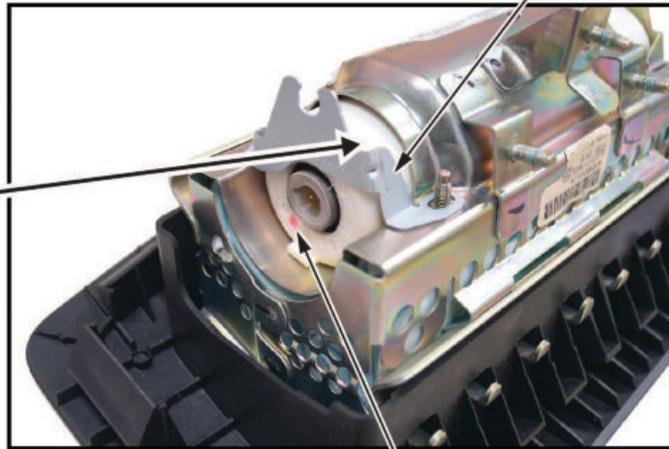
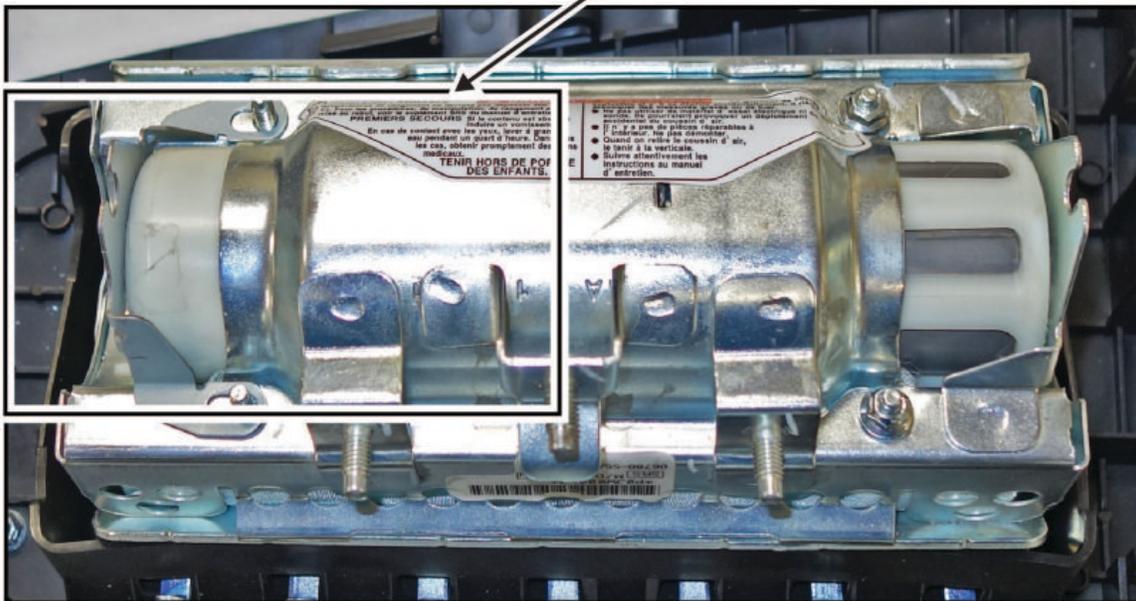
ADJUSTABLE BRACKET END

13.4. Install the bracket included in the kit onto the airbag module. There should be a red dot visible on the end of the plastic collar. There should be no space or gap between the inflator and bracket.

No gap

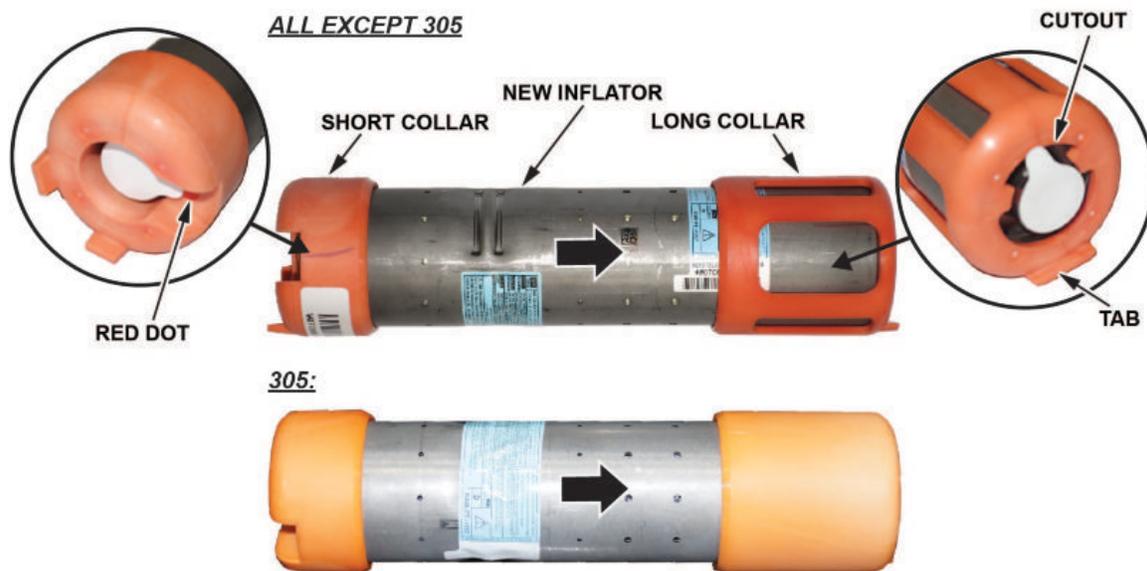
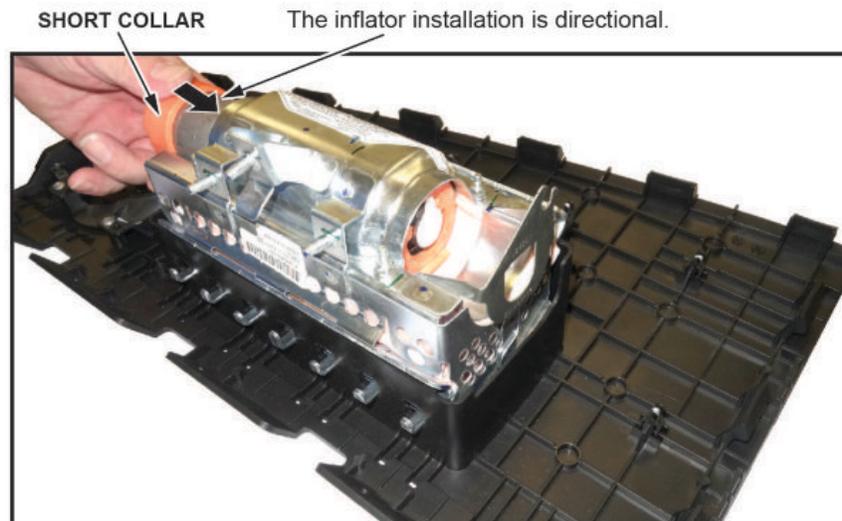
For part numbers ending in 315, 316, 317, 325, A00 and A10: One side of the inflator has a longer collar, a tab, a plastic cutout, and a small flat spot on the connector. The other side of the inflator has a shorter collar, two tabs, and a notch with a red dot. Make sure you insert the end with the longer collar into the airbag first.

For part numbers ending in 305: One side of the inflator has a longer collar, a tab, a plastic cutout, and a small flat spot on the connector. The other side of the inflator has a shorter collar with no tabs and a notch with a red dot. Make sure you insert the end with the longer collar into the airbag first.

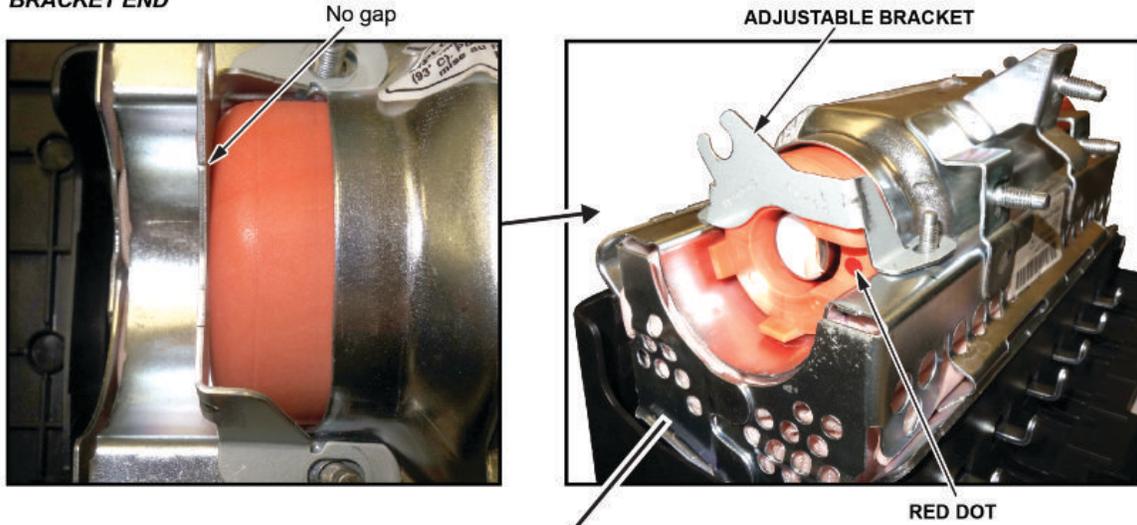
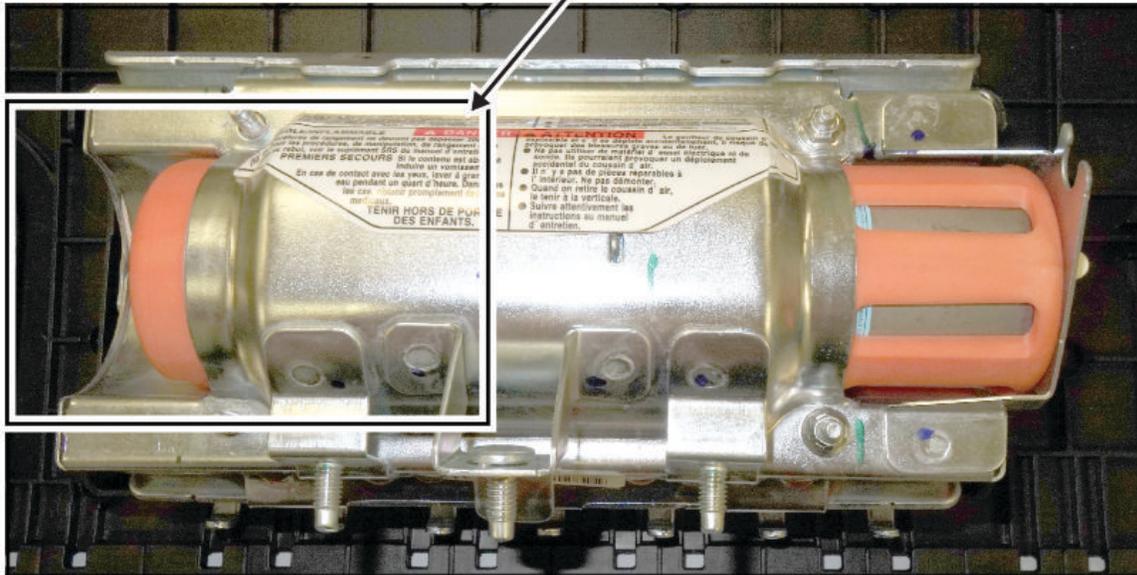
**ADJUSTABLE
BRACKET END**

13.4. Install the bracket included in the kit onto the airbag module. There should be a red dot visible on the end of the plastic collar. There should be no space or gap between the inflator and bracket.

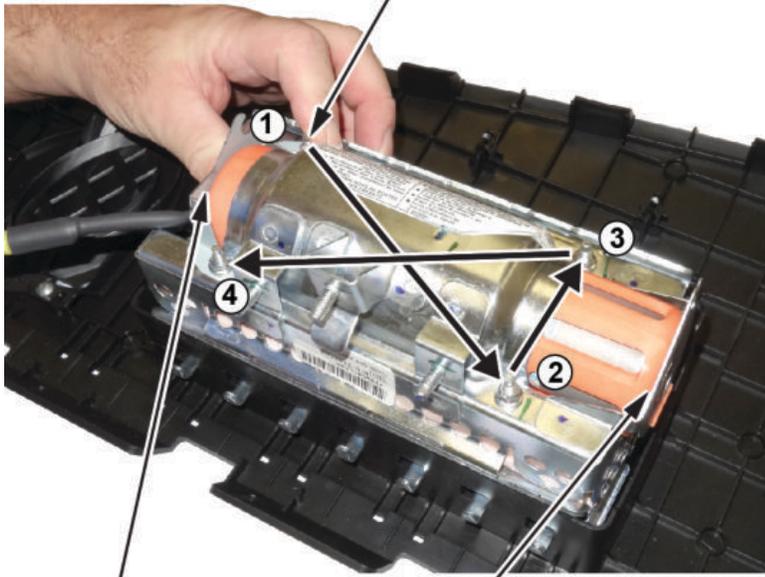
LOCK NUTS (4)
3.9 N•m (34 lb-in)

14. Install the new 5 mm locknuts, and torque them in sequence to **3.9 N•m (34 lb-in)** .

Be sure there are no gaps between the inflator ends and the inflator brackets

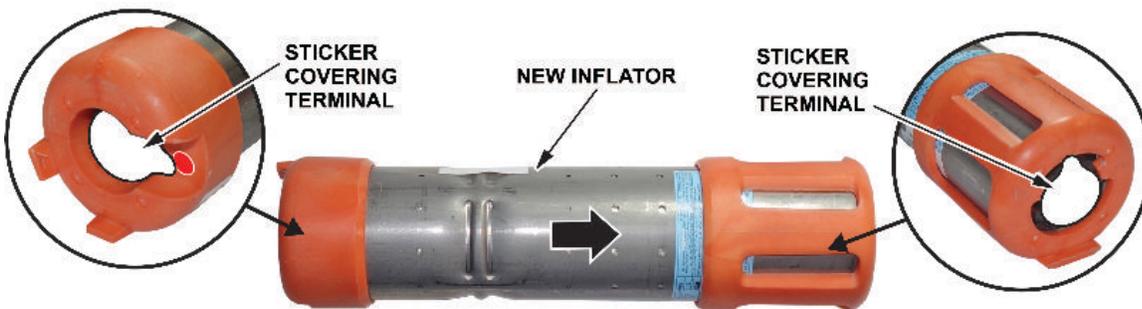
15. Remove the stickers covering the terminals on both sides of the new inflator.

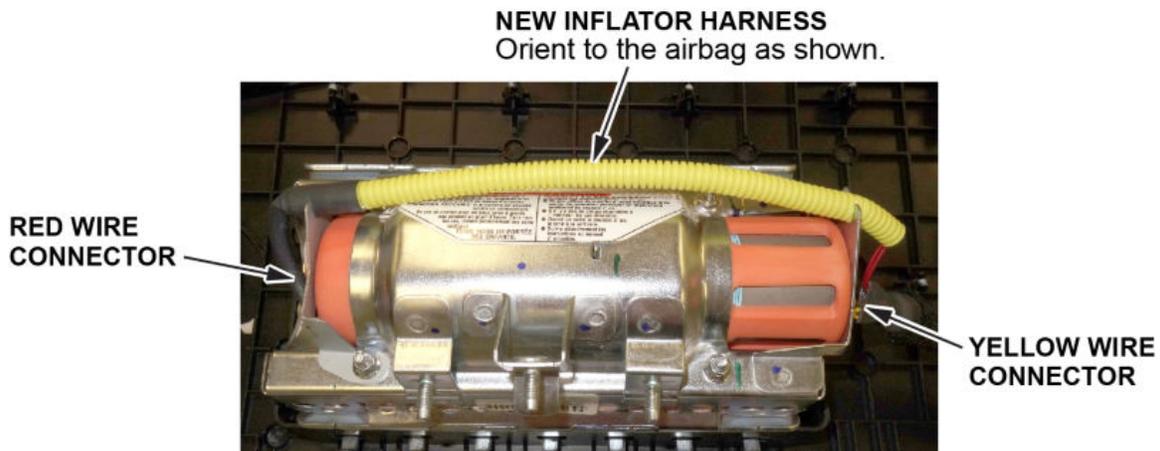
17.1. Make sure the airbag and harness are aligned as shown.

- **Make sure you have the orientation correct as shown below.** If you connect the harness incorrectly, the harness cannot be removed, and you will not be able to reinstall the airbag because the harness will be too short.
- Connect the red wire connector to the short collar side of the inflator with the red dot.

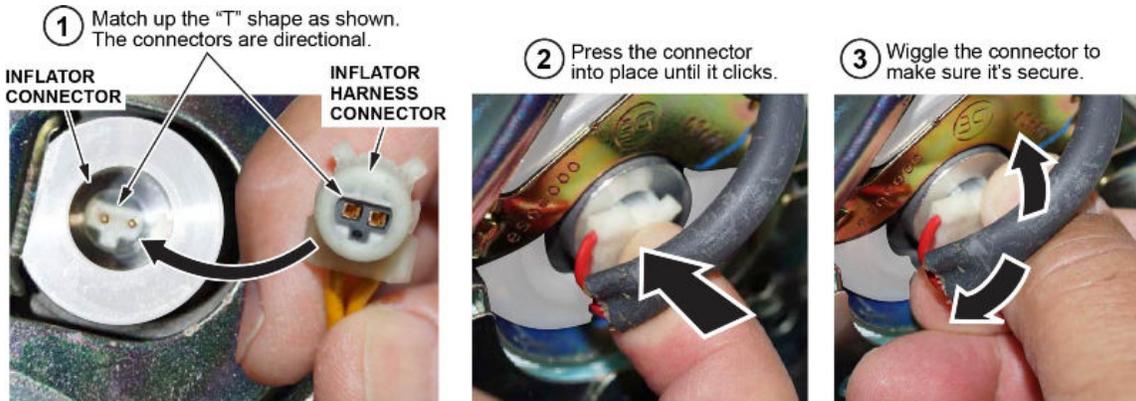
17.2. Connect the two connectors. Align the "T" shape in the inflator harness connector with the T-shaped inflator connector, then press the connector into place.

The harness connectors may be yellow.

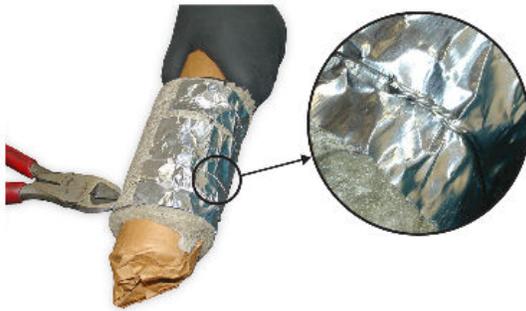
- Wear disposable gloves and protective glasses. The insulation is not toxic or dangerous, but some people may be sensitive to the insulation.
 - Dispose of the insulation and wrapping paper to avoid getting the insulation dust/fibers on you or the airbag assembly.
 - Do not reuse the insulation or wrapping paper. You do not need to wrap the inflator being removed from the vehicle when it is returned.
1. Cut the wires off from the opposite side from where they are tied (twisted) together.

Do not cut the insulation.

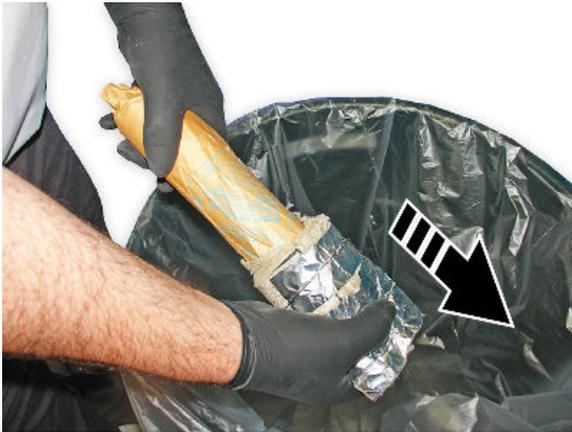
2. Hold the paper wrapping the inflator with one hand and slide the insulation off into the trash.

The insulation is securely wrapped around the inflator. You may have to use some force to slide the insulation off. Do not cut the insulation and be careful that you do not move the white or orange plastic ends.

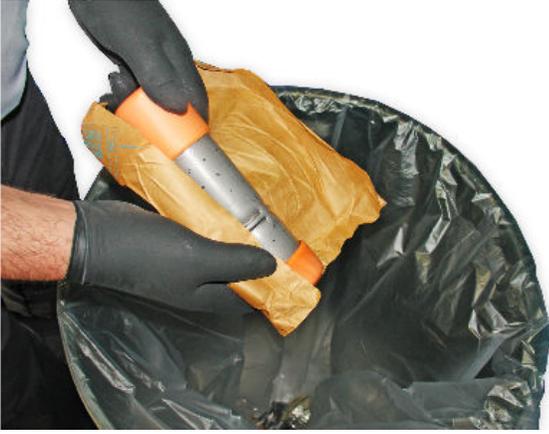
3. Remove the wrapping paper and drop it into the trash.

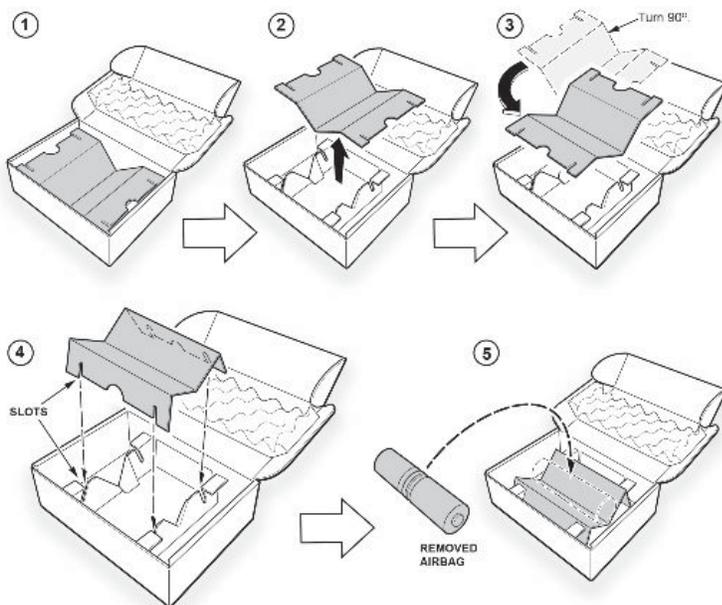
4. To return the original inflator, remove the cardboard insert and turn it 90 degrees. Then insert the cardboard into the slots as shown.

- **Do not reuse the shipping insulation.**
- The cardboard insert needs to be adjusted to send back the original inflator otherwise the original inflator removed from the vehicle will rattle around and may be rejected by the courier.
