Service Bulletin

19-076

Safety Recall: Front Passenger's Airbag Inflator Can Be Over-Pressurized (Phase 5)

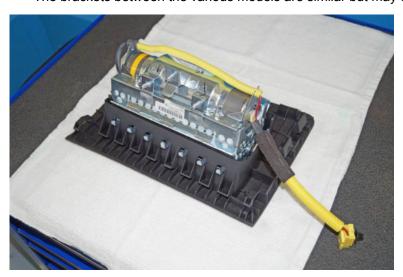
4. Place the airbag, face-down, on a clean shop towel.

- The orientation of the airbag is critical because if the inflator is installed incorrectly, the harness will be too short when you reinstall the airbag.
- The brackets between the various models are similar but may differ from the example shown.

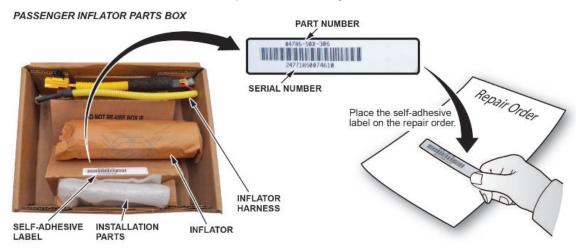
- The replacement part number is printed on the top part of the label, and the serial number is printed on the bottom. Make sure you attach the label to the RO and give it to the warranty clerk.
- There may also be a colored sticker located in the kit; ignore it because it is not used.
- Not all inflator kits have a label included. In those cases, write the serial number and part number from the side of the inflator box on the RO. The part number always starts with 047.

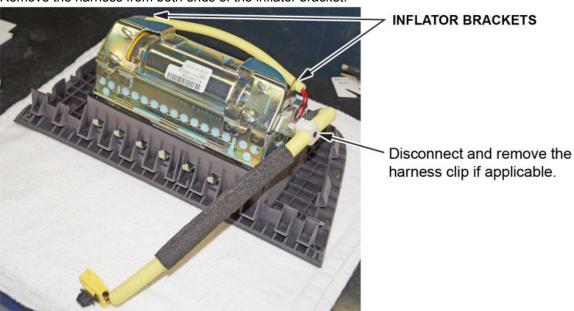
Remove the harness from both ends of the inflator bracket.

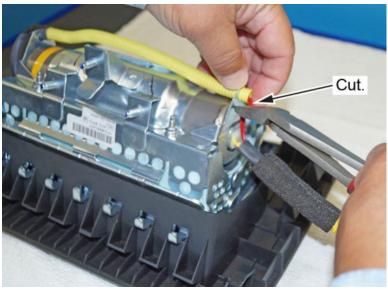
8.1. Cut the red wires as shown.

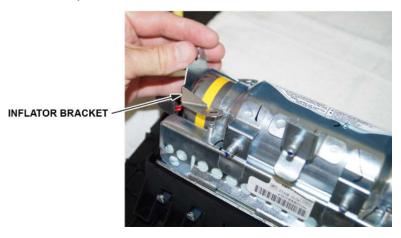
11. Remove the inflator bracket.

You can only remove one of the brackets, as the other is welded to the airbag housing.

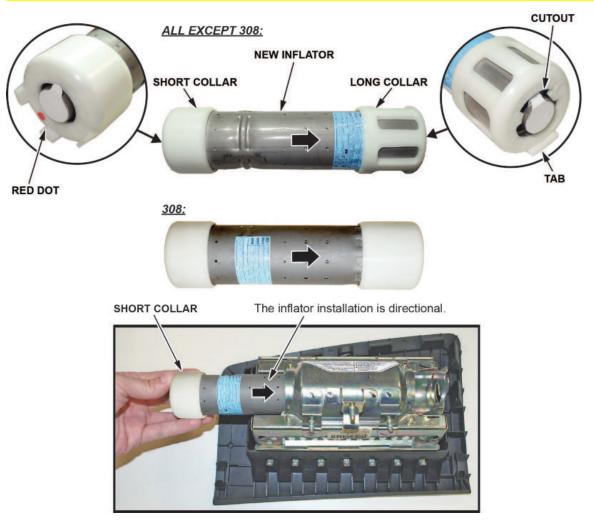
13.2. The collars on this inflator are white.

For part numbers ending in 318, A00, A10, and A20: One side of the inflator has a shorter collar, three tabs, and a red dot. The other side of the inflator has a longer collar, a tab, a plastic cutout, and a small flat spot on the connector. Make sure you insert the end with the longer collar into the airbag first.

For part numbers ending in 308: One side of the inflator has a shorter collar with one tab and a red dot. The other side of the inflator has a longer collar, a tab, a plastic cutout, and a small flat spot on the connector. Make sure you insert the end with the longer collar into the airbag first.

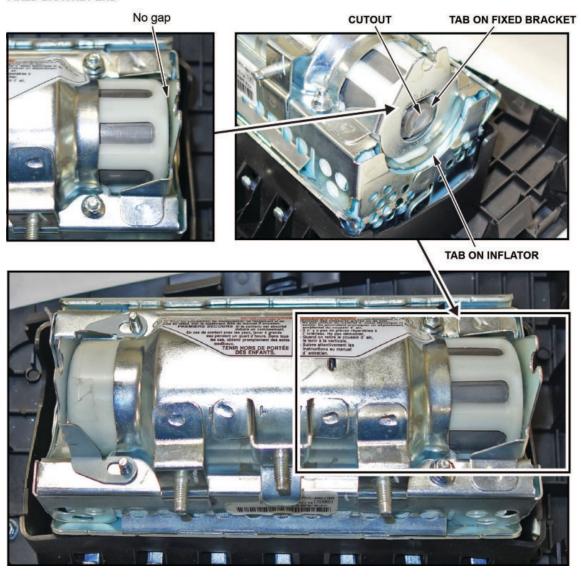
FIXED BRACKET END

13.3. Slide the inflator in until the plastic cutout and the small flat spot align with the tab on the bracket. There should be no space or gap between the inflator and bracket.

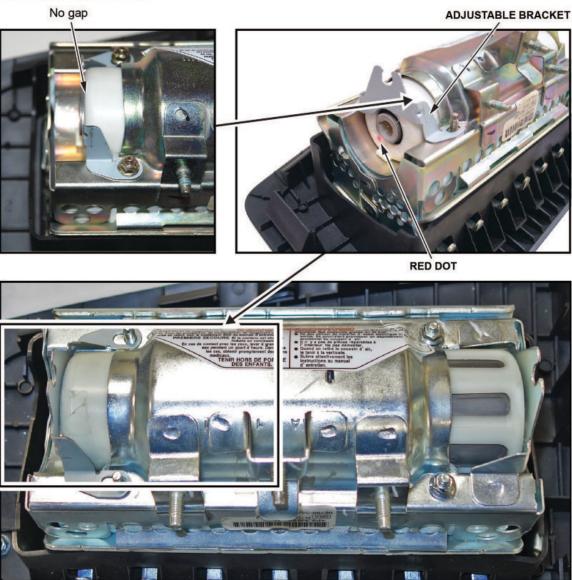
ADJUSTABLE BRACKET END

13.4. Install the bracket included in the kit onto the airbag module. There should be a red dot visible on the end of the plastic collar. There should be no space or gap between the inflator and bracket.

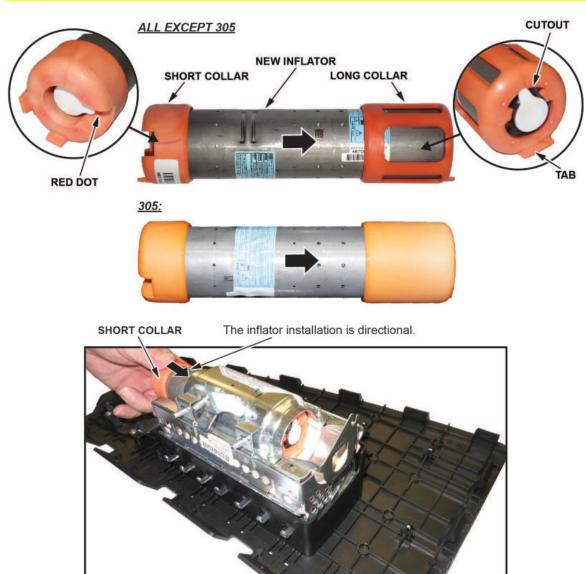
13.2. Collars on this inflator are orange.

For part numbers ending in 315, 316, 317, 325, A00 and A10: One side of the inflator has a longer collar, a tab, a plastic cutout, and a small flat spot on the connector. The other side of the inflator has a shorter collar, two tabs, and a notch with a red dot. Make sure you insert the end with the longer collar into the airbag first.

For part numbers ending in 305: One side of the inflator has a longer collar, a tab, a plastic cutout, and a small flat spot on the connector. The other side of the inflator has a shorter collar with no tabs and a notch with a red dot. Make sure you insert the end with the longer collar into the airbag first.

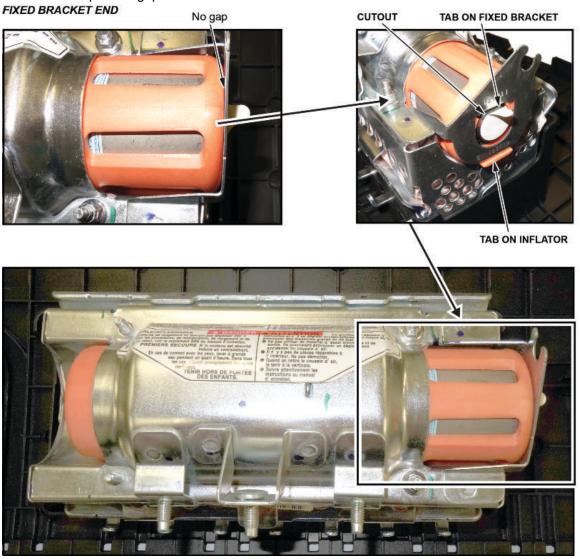
FIXED BRACKET END

13.3. Slide the inflator in until the plastic cutout and the small flat spot align with the tab on the bracket. There should be no space or gap between the inflator and bracket.

No gap

CUTOUT

TAB ON FIXED BRACKET

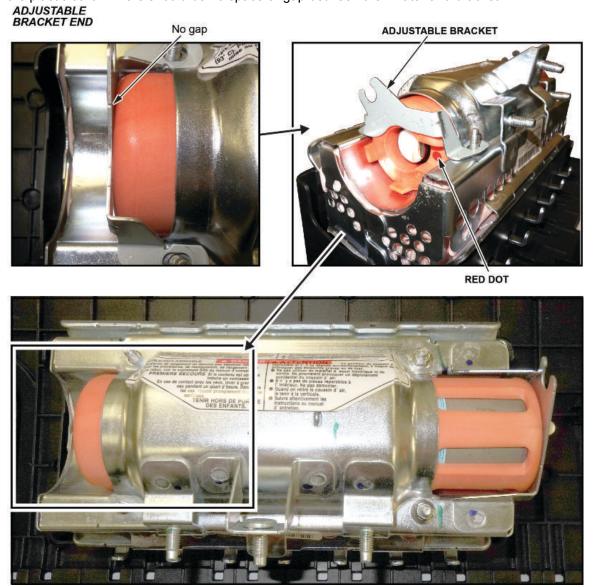
13.4. Install the bracket included in the kit onto the airbag module. There should be a red dot visible on the end of the plastic collar. There should be no space or gap between the inflator and bracket.

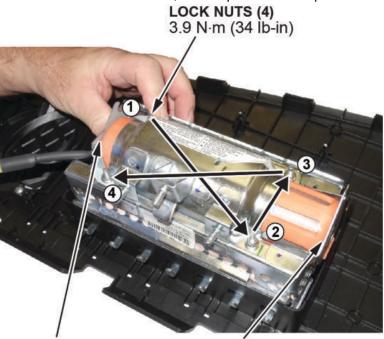
14. Install the new 5 mm locknuts, and torque them in sequence to 3.9 N·m (34 lb-in) .

Be sure there are no gaps between the inflator ends and the inflator brackets

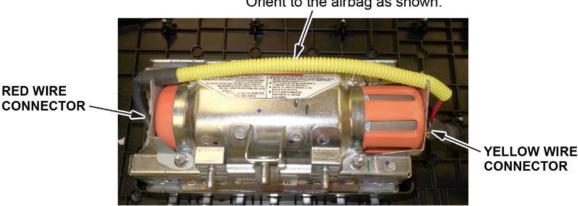
NEW INFLATOR HARNESSOrient to the airbag as shown.

- 16. Install the new inflator harness.
 - 16.1. Make sure the airbag and harness are aligned as shown.

- Make sure you have the orientation correct as shown below. If you connect the harness incorrectly, the harness cannot be removed, and you will not be able to reinstall the airbag because the harness will be too short.
- · Connect the red wire connector to the short collar side of the inflator with the red dot.

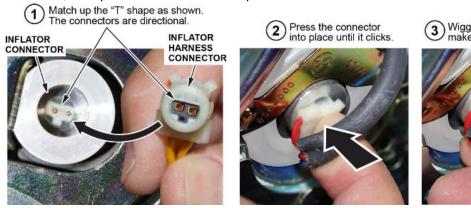
16.2. Connect the two connectors. Align the "T" shape in the inflator harness connector with the T-shaped inflator connector, then press the connector into place.

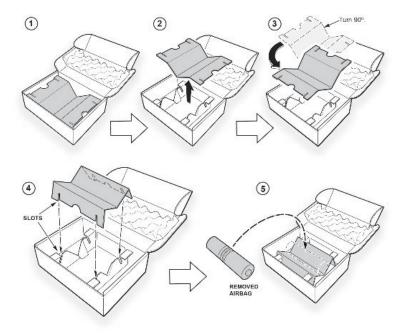
4. To return the original inflator, remove the cardboard insert and turn it 90 degrees. Then insert the cardboard into the slots as shown.

- Do not reuse the shipping insulation.
- The cardboard insert needs to be adjusted to send back the original inflator otherwise the original inflator removed from the vehicle will rattle around and may be rejected by the courier.
