SAFETY RECALL

Date	Number	Release	Page
07.2019	RVXX1904	01	1(5)

Air Tank Strap, Inspection VNL, VAH

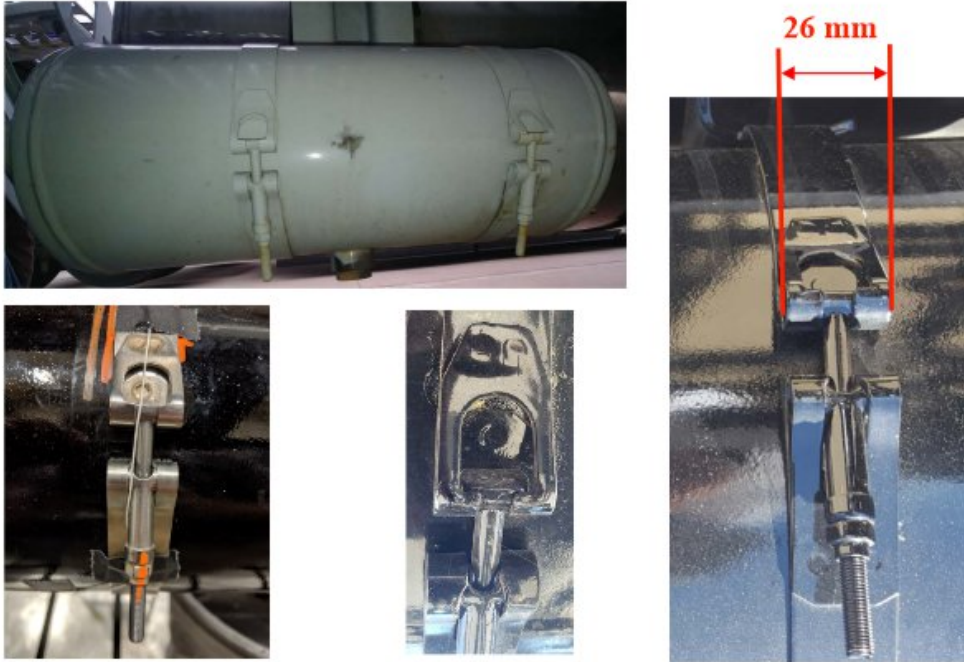
1. Inspect the auxiliary air tank straps.

Acceptable Straps: Wings should not show signs of deformations. Gap of wing should be no wider than **26 mm**.

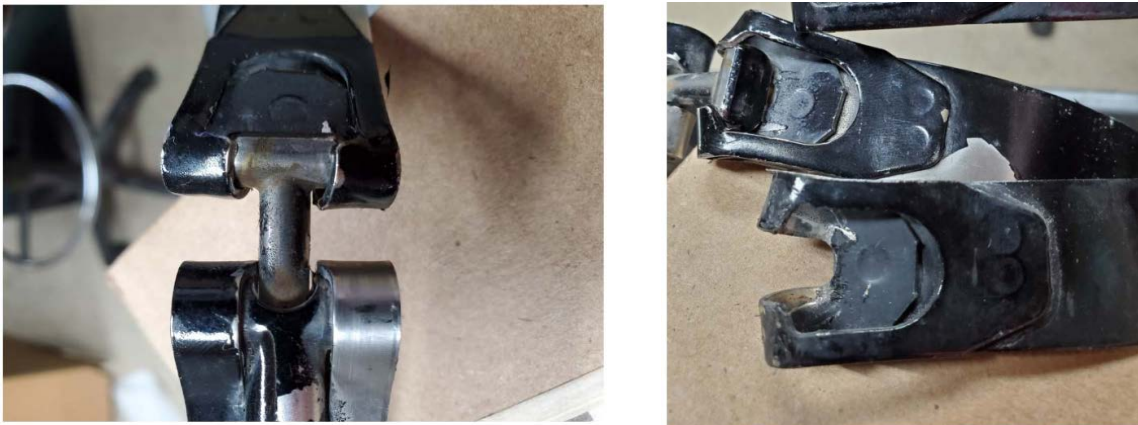
Not acceptable Straps:

If the inspection shows a failed strap, continue with the repair procedure.

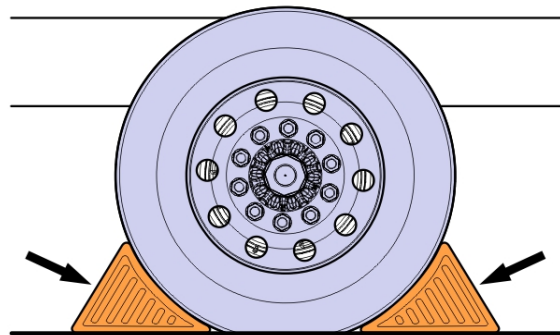
1. Park the vehicle on a level surface.
2. Apply the parking brake.
3. Place the gear lever in neutral.

4. Install the wheel chocks.

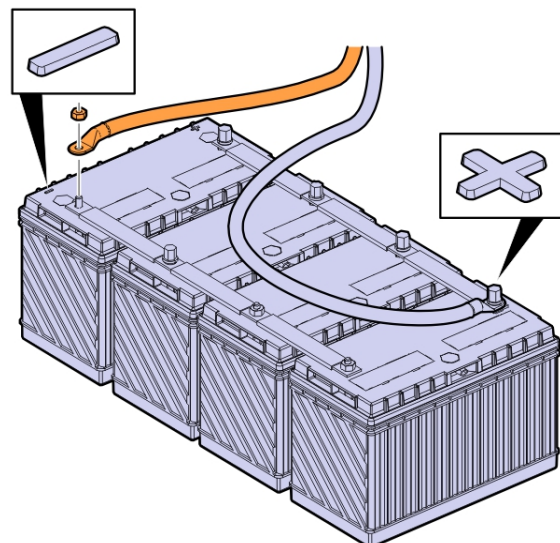
5. Disconnect the cable from the negative terminal.

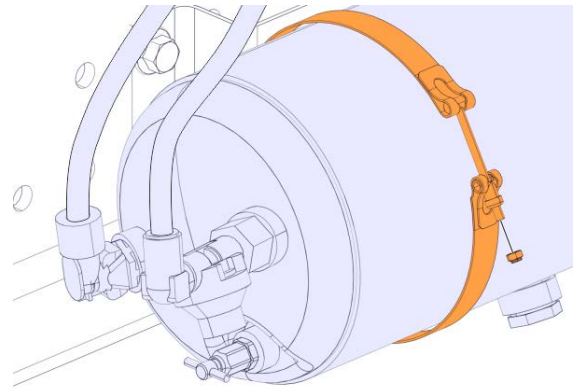
6. Remove the strap.
7. Remove the nut.

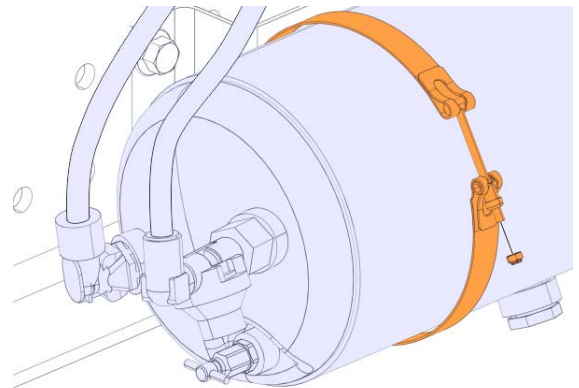
8. Install the strap.
9. Install the nut.
10. Torque tighten the nut.

Tightening torque	
1/4-28 t-bolt clamp nut	12 ±1.5 Nm (9 ±1 lbf ft)

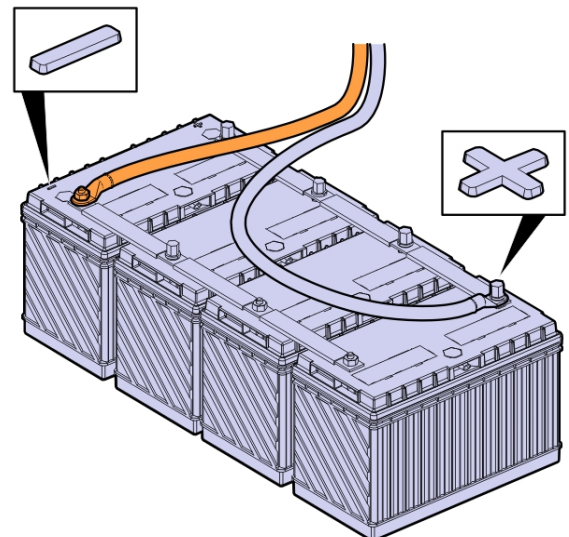
11. Connect the cable to the negative terminal.
