REFERENCE:	Nova Bus Manuals
SECTION:	12: Passenger Seats
RS N°:	MQR 7621-1275
EFFECTIVE IN PROD.:	LC67(2019SE)
TC RECALL N°:	2019-332
NHTSA RECALL N°:	19V511

SUBJECT:	Cantilever-type passenger seat anchor rails
JUSTIFICATION:	Hardware used to secure some cantilever seats may not have been properly tightened.

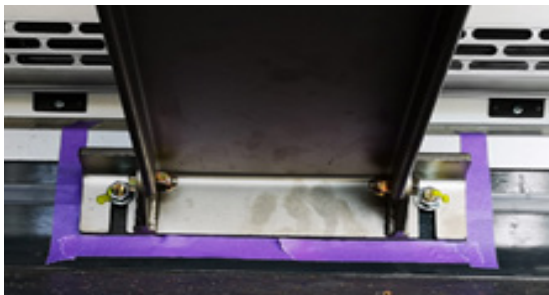
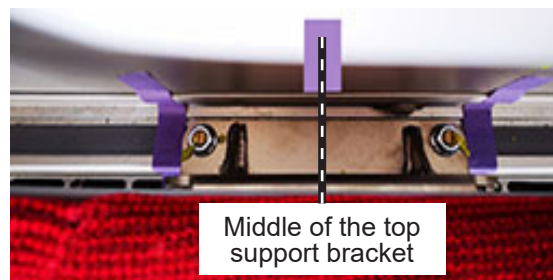
Figure 2 - Steps to do Before Seat Removal

a - Place tape on each side of the lower anchor bracket or brackets. Place tape on the wall to align with the middle of the top support bracket.

- 1.2. For all cantilever-type two passenger seats with no stanchion affixed to the backrest, follow steps a-q to replace the upper support bracket
- a. Place tape on each side of the lower anchor bracket. Place tape on the wall to align with the middle of the top support bracket. See Figure 2.
  - b. If required, disconnect any electrical harness connected to an electrical device on the seat frame and remove the tie wraps. See Figure 2.

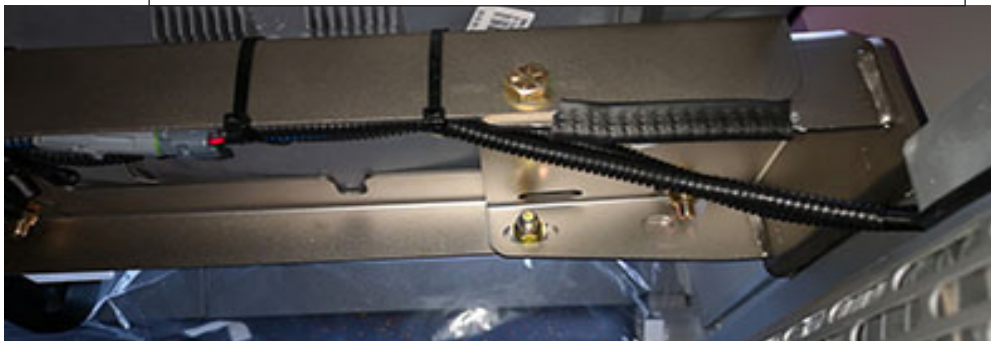
b - Typical electrical harness to disconnect and remove

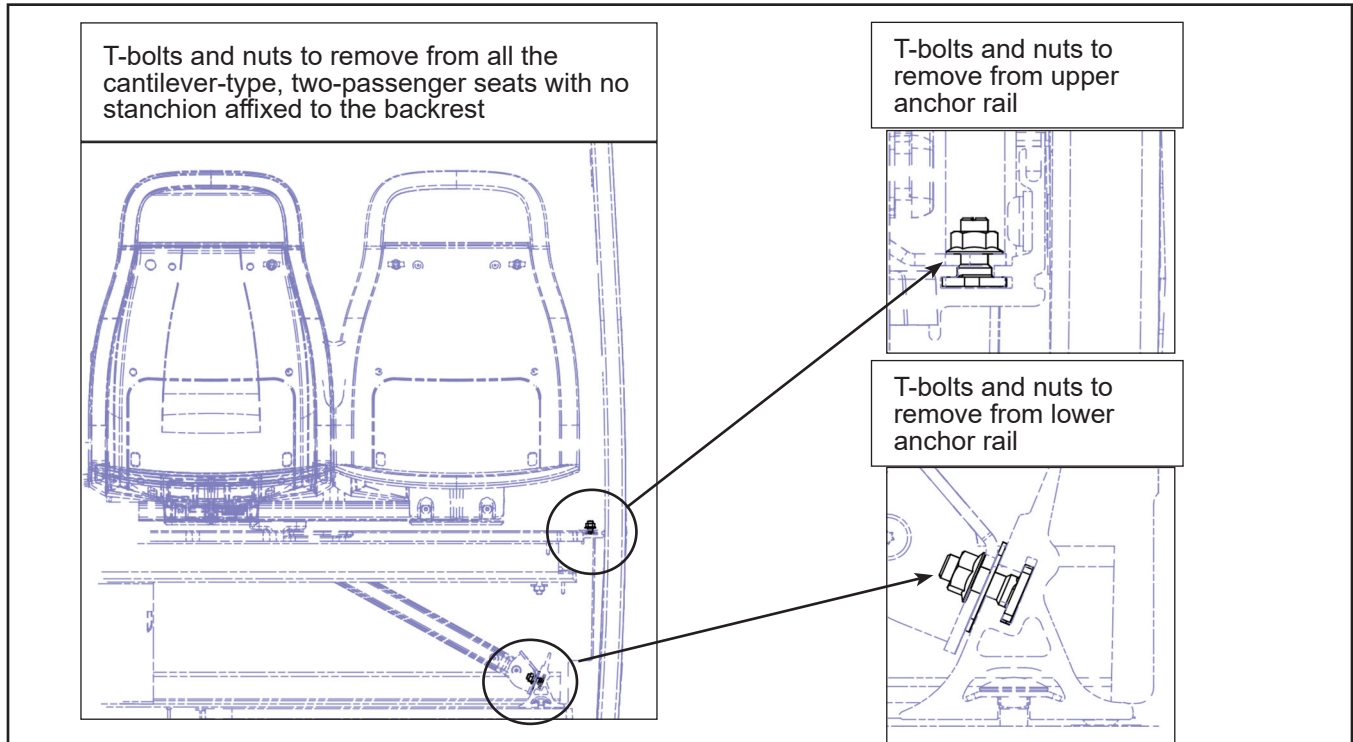
Figure 3 - T-bolts and Nuts to remove

- c. Remove the cantilever-type two passenger seats with no stanchion affixed to the backrest from the seat anchor rail. Remove all T-bolts and nuts from the upper and lower anchor rails. Dispose of all the removed T-bolts and nuts. See Figure 3.

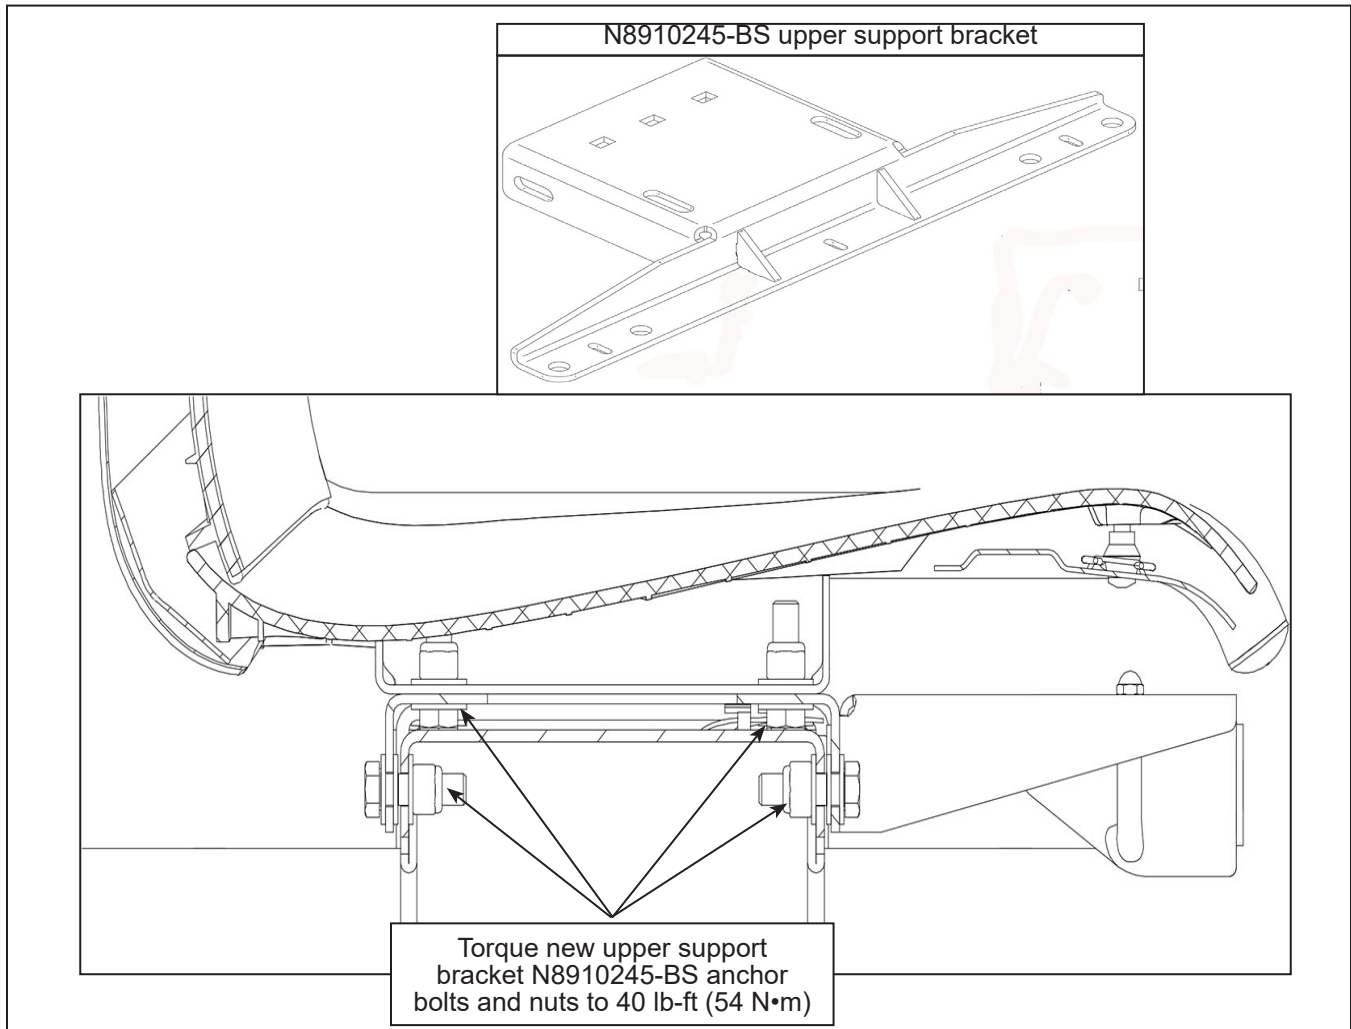
*Figure 5 - Upper Support Bracket N8910245 Torque Value*

- e. Install a new upper support bracket N8910245-BS on all the removed two-passenger seats using the retained hardware. See Figure 5 for installation details and torque value.

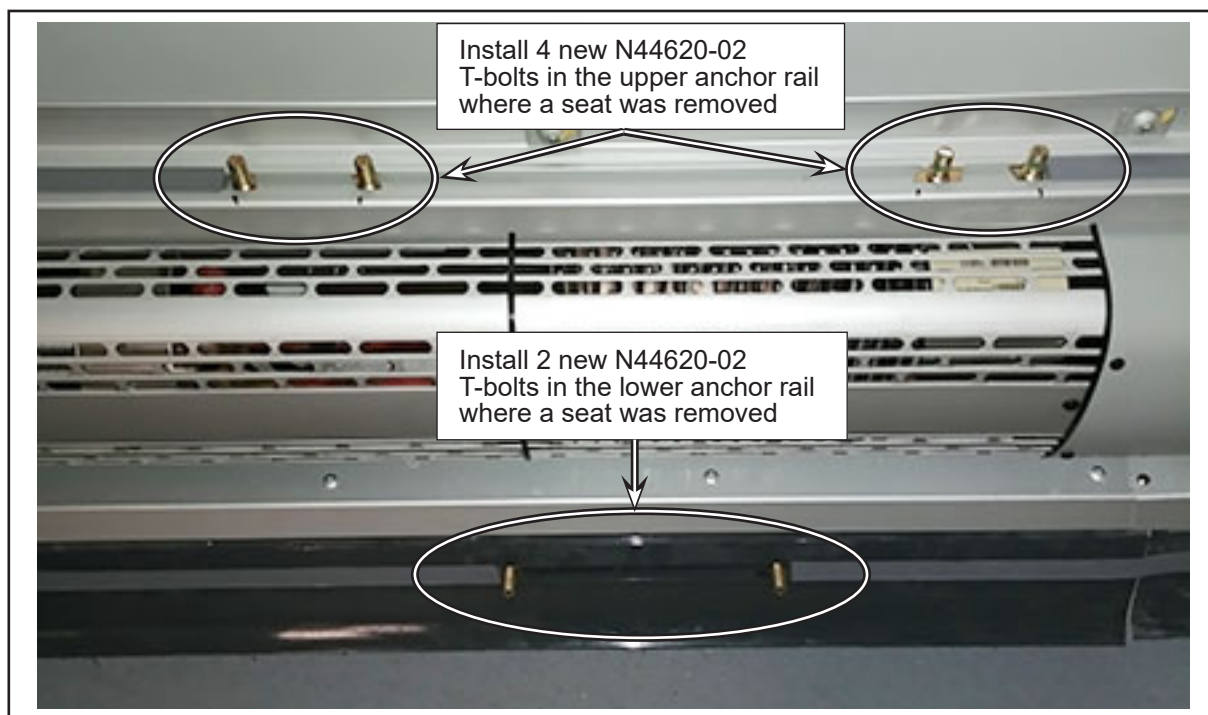
Figure 6 - Position of N44620-02 T-bolts

- g. Place L-bracket N8910246-BS on the upper anchor rail and position the middle hole of the L-racket in line with the tape on the wall. Mark the rubber filler strip on each side of the L-bracket. Repeat this step for all removed seats.
- h. Remove L-bracket N8910246-BS and cut the portion of rubber filler strip that was under the L-bracket. Repeat this operation for all removed seats.
- i. Install 6 N44620-02 T-bolts in the anchor rail for each removed seat. See Figure 6.

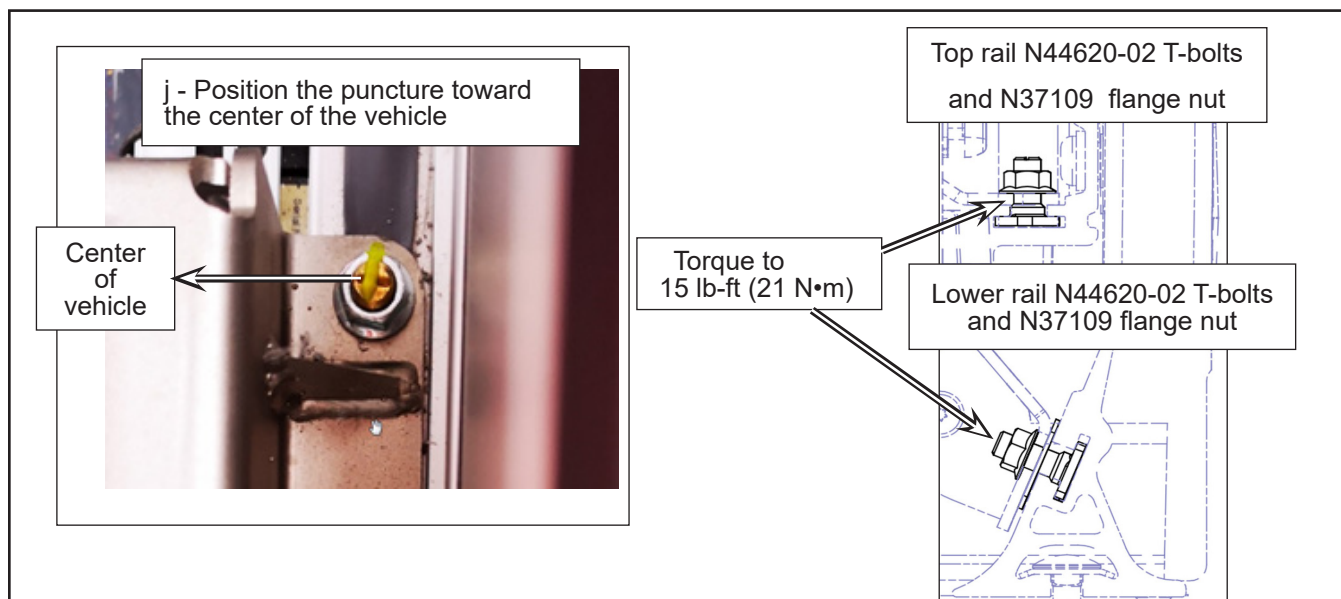
Figure 8 - T-bolt Puncture Alignment and Torque Value

- l. Hand tighten the N37109 serrated flange nuts on all the T-bolts that affix the removed seat(s) to the upper and lower anchor rail. Make sure the puncture in the T-bolts is facing the center of the vehicle. See Figure 8.
- m. Push the N8910246-BS L-bracket toward the upper anchor rail, make sure there is full contact between the L-bracket and the upper anchor rail, and torque the N37109 serrated flanged nut. See Figure 8 for torque value.
- n. With a torque wrench, torque the T-bolts on the lower rail See Figure 8 for torque value.

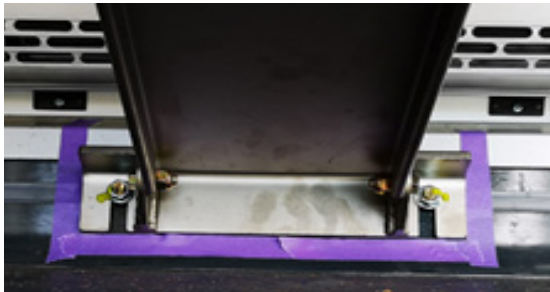
Figure 10 - Steps to Perform Before Seat Removal

Place tape on each side of the lower anchor bracket. Place tape on the wall to align with the middle of the top support bracket.

- 2.1. For all seats affixed to the defective upper anchor rail, place tape on each side of the lower anchor bracket. Place tape on the wall to align with the middle of the top support bracket. See Figure 10.,
- If required, disconnect any electrical harness connected to an electrical device on the seat frame and remove the tie wraps. See Figure 10.
  - If a seat has a stanchion bolted to the backrest, remove the anchor cup from the backrest. Retain the cup and hardware. Do not remove the stanchion. See Figure 10.
  - If a seat has a cup-style stanchion, do not remove the stanchion cup; the stanchion can be disconnected when the seats will be lowered. See Figure 10.

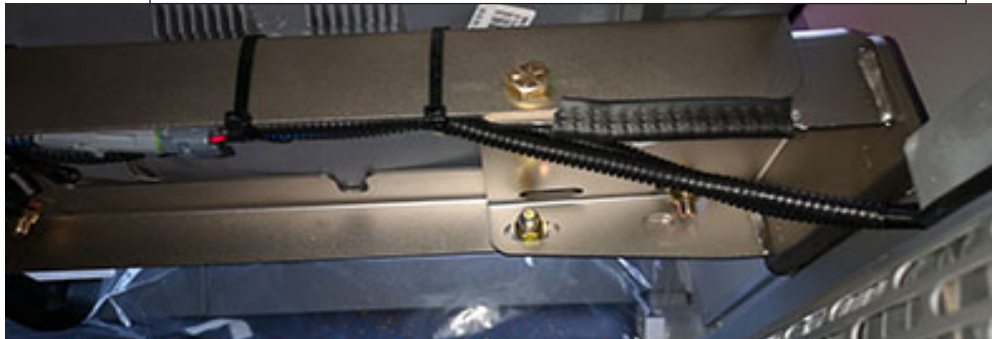
a - Typical electrical harness to disconnect and remove

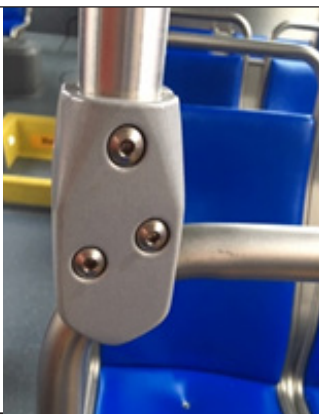
b - Typical stanchion cup to remove from seats

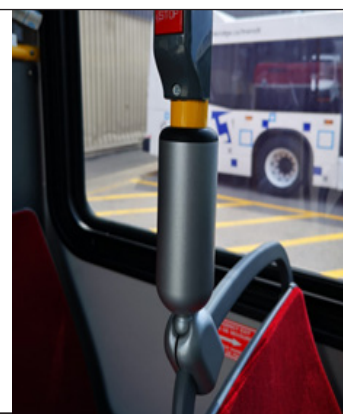
c - Typical stanchion cup NOT to be removed from seats

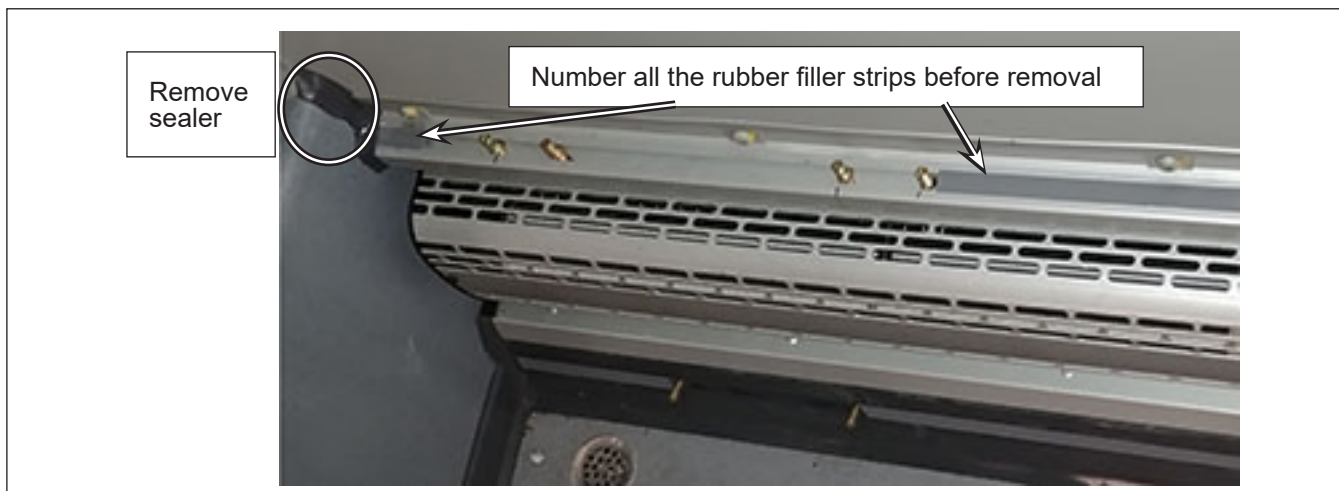
Figure 11 - Typical Anchor Rail, Rubber Filler Strips and Sealer

- d. Remove the seats from the seat anchor rail and remove all T-bolts and nuts from the upper and lower anchor rails. Dispose of all the removed T-bolts and nuts.
- e. If equipped with an accessibility seat belt on the top anchor rail, put tape on the wall on each side of the seat belt.
- f. Cut and remove the sealer installed at each end of the rail. See Figure 11.
- g. Number the rubber filler strips installed on the upper anchor rail before removing them. Remove the numbered rubber filler strips. Retain all the rubber filler strips. See Figure 11.

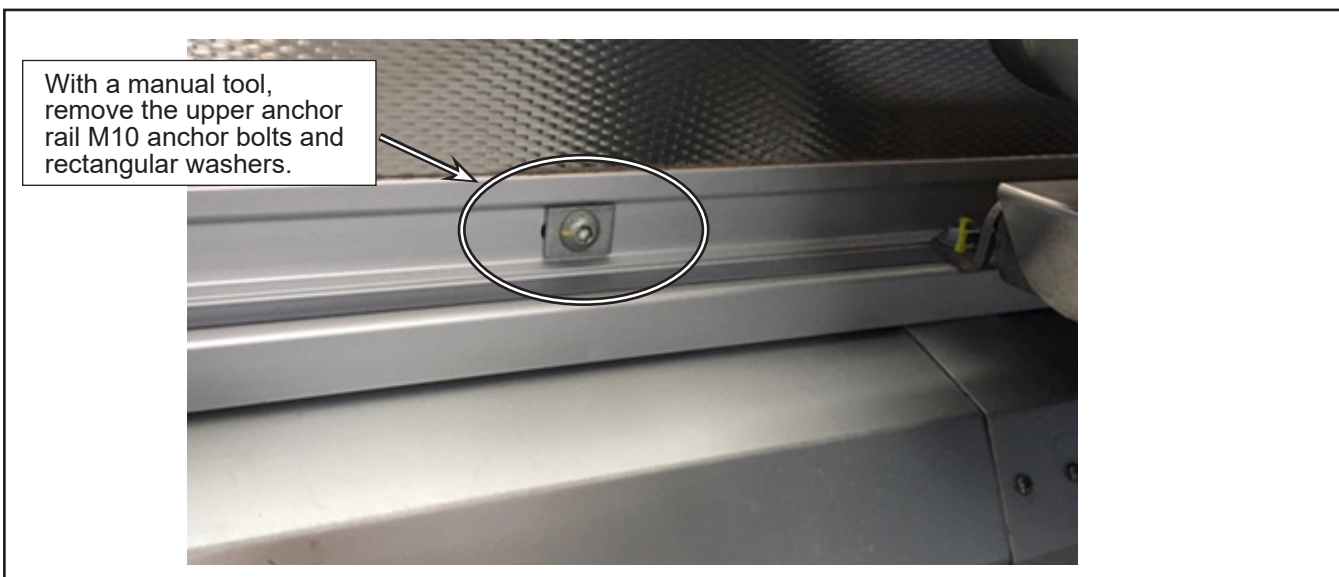
Figure 12 - M10 Bolts and Rectangular Washers to Remove

- h. With a manual tool remove the top anchor rail M10 anchor bolts and rectangular washers. Be careful not to strip the wall rivnuts while removing the anchor bolts. Discard the bolts and retain the rectangle washer. See Figure 12.
- i. Remove the upper anchor rail by pulling the bottom of the rail toward the center of the vehicle. Dispose of the removed anchor rail.

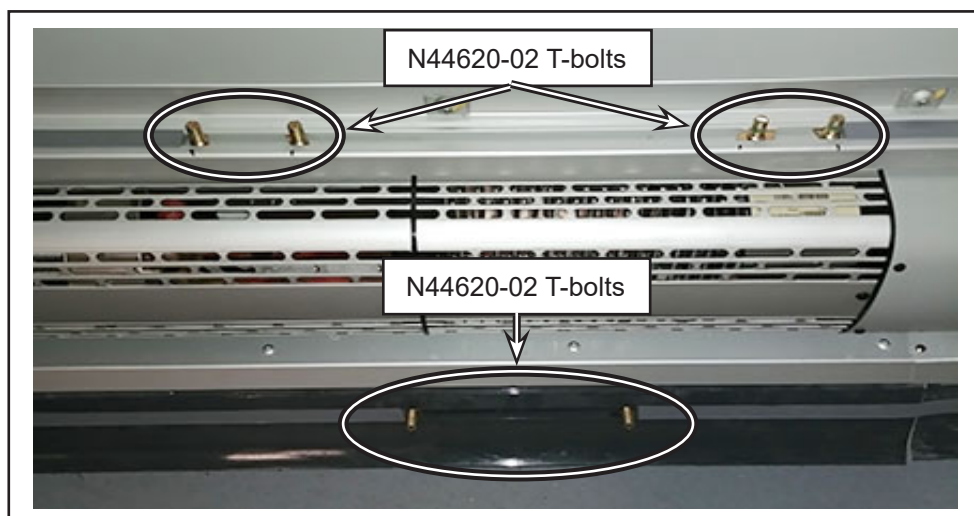
Figure 14 - T-bolts N44620-02

- p. Install the retained rubber filler strips from step G, and with the tape placed on the wall in step 2.1, position them according to the number tag on each strip.
- q. Place L-bracket N8910246-BS on the upper anchor rail and position the middle hole of the L-bracket in line with the tape on the wall. Mark the rubber filler strip on each side of the L-bracket. Repeat this step for all removed cantilever seats with no stanchion affixed to the backrest.
- r. Remove L-bracket N8910246-BS and cut the portion of rubber filler strip that was under the L-bracket. Repeat this operation for all removed seats with no stanchion affixed to the backrest.
- s. Install N44620-02 T-bolts in the upper and lower anchor rail where seats were previously installed. See Figure 14.

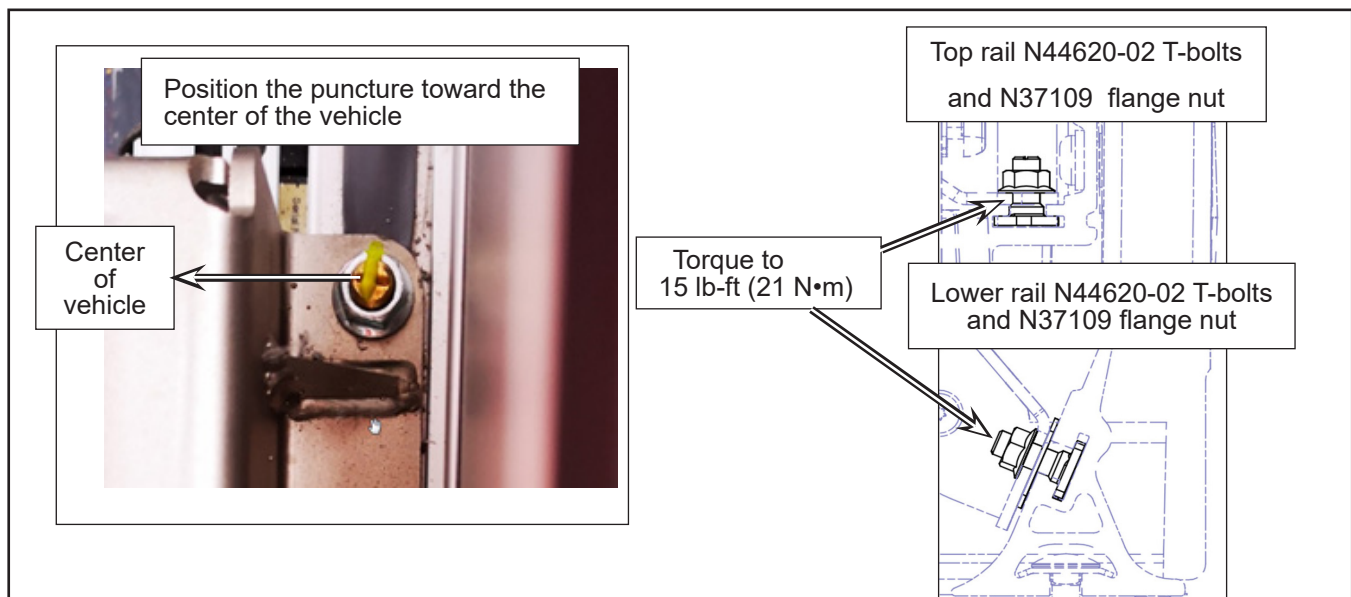
Figure 15 - T-bolts Positioning and Torque Value

- u. Install the retained seats in alignment with the tape placed on the seat anchor rail and wall. See Figure 15.
- v. Affix the seats to the N44620-02 T-bolts with N37109 flanged serrated nuts.

- w. Hand tighten the N37109 flanged nuts on the T-bolts of all the affected seats. Make sure that the puncture in the T-bolts is facing the center of the vehicle. See Figure 15.

- x. With a torque wrench, apply the torque to all the N37109 flange nuts installed. See Figure 15 for torque value.
- y. Apply torque seal to all the torque nuts. See Figure 15.

- z. Install the retained seat belt(s) with new N44620-02 T-bolt and N37109 flanged serrated nuts. Align the seat belt(s) with tape. See Figure 15 for torque value.

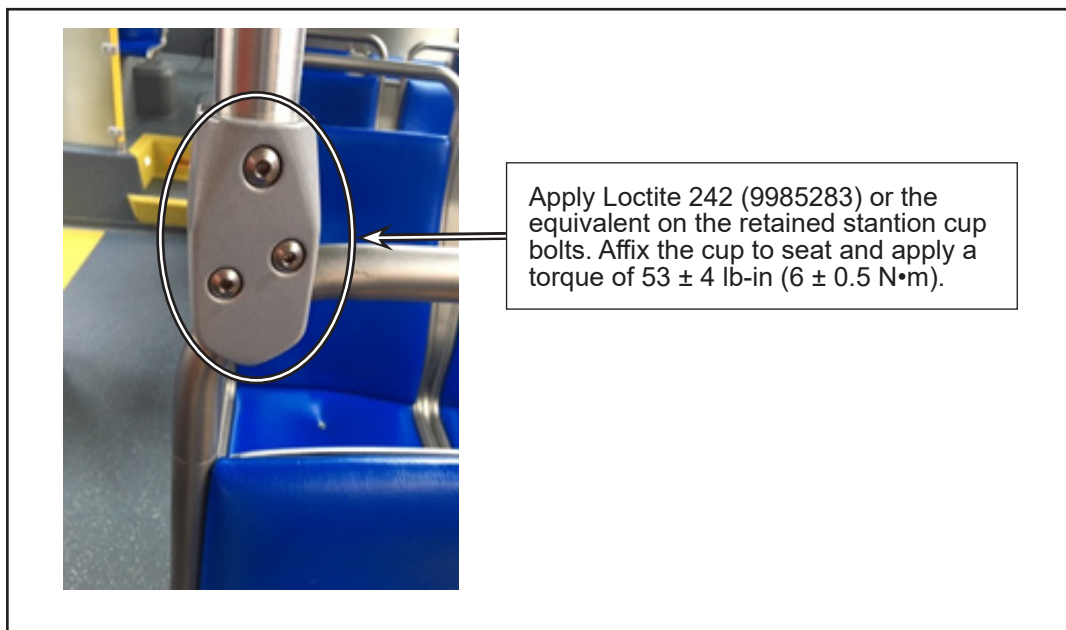
*Figure 16 - Torque Value for Typical Stanchion Cup Bolts*

ab. Install the retained stanchion cup with the retained hardware. See Figure 16 for torque value.

aa. If required, apply Loctite 242 (Nova Bus part number 9985283), or the equivalent to each of the retained stanchion cup bolts.
