**RECALL
BULLETIN:
190709REV**

2016-2019 American Eagle manufactured 12/19/2014 through 05/31/2019

2016 American Heritage manufactured 08/18/2015 through 10/21/2015

SUBJECT:
Inspection / Correction of Rear Air Deflector Installation

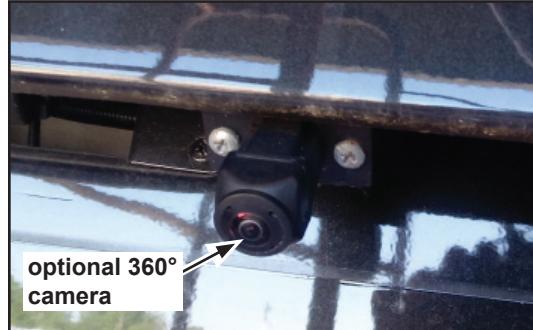
Figure 1

4. Use a ladder to access the optional 360° camera (if equipped), located behind the rear air deflector. Remove the camera from its mounting bracket using a Phillips screwdriver and 3/8" open end wrench. Leave the camera hang from its cord for the duration of the repair. Set aside the fasteners for reinstallation. See Figures 1 and 2.

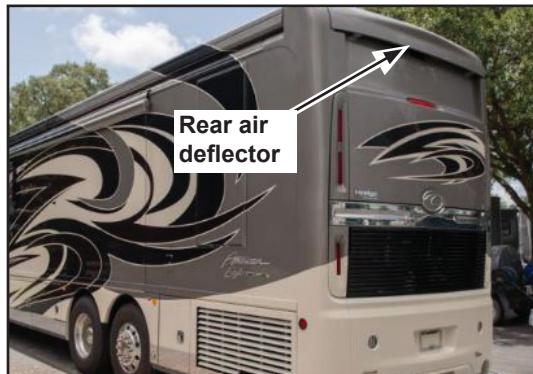
Figure 2

5. With the properly sized step-ladder and appropriate safety equipment, go onto the roof of the motorhome and locate the rear air deflector. While working on the roof, ensure there is adequate overhead clearance and the proper fall protection is used. See Figure 2.
6. At the center of the air deflector, locate the wire harness running from the top of the fiberglass cap to the three marker lights on the air deflector.

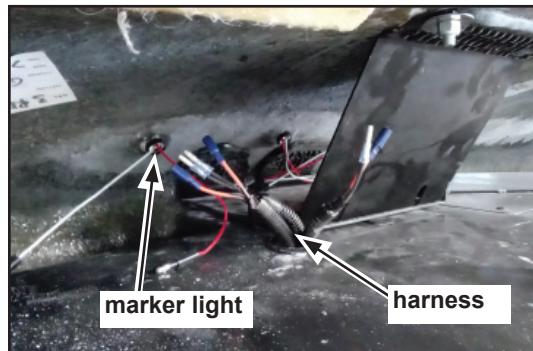
Figure 3

- a. If the harness has bullet connectors, disconnect the clearance lights from the harness.
- b. If the harness has butt connectors, cut the wire on the both sides of the connection as close to the butt connector as possible.

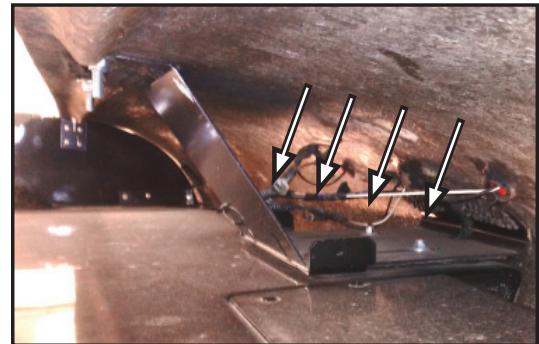
7. While at the center of the air deflector, use a 7/16" socket/ratchet remove the (4) nuts from the top of the mounting bracket located under the air deflector. See Figure 4 for details. Set the nuts and washers aside for reinstallation.
8. Move to the doorside of the coach and locate the lower mounting bracket under the air deflector at the corner of the fiberglass cap. See Figures 5 and 6 for detail. Remove the nut and washer from the mounting bracket stud with a 7/16" socket/ratchet and set them aside for reinstallation.

20. At the center mounting bracket, install the four 7/16" nuts and washers that were removed in Step 7. Torque these fasteners to 50-60 in-lbs. If locking nuts are not present, apply Loctite® Threadlocker Blue 242® to the threads prior to tightening.

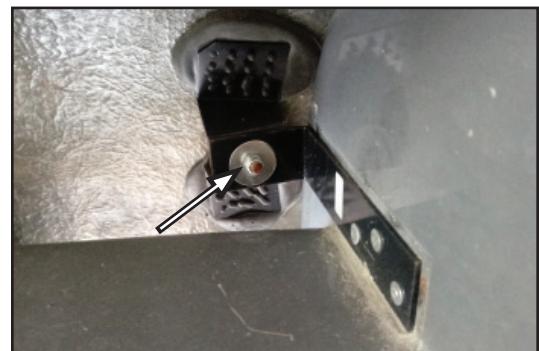
Figure 6

9. Move to the roadside of the coach and locate the lower mounting bracket. Remove the nut and washer from the mounting bracket stud with a 7/16" socket/ratchet and set them aside for reinstallation. This bracket will be located in a similar area as the doorside bracket that was removed in the previous step.

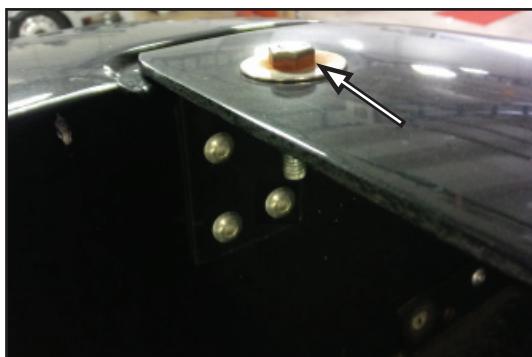
Figure 7

10. While having an assistant on a ladder at the rear of the coach hold the rear air deflector in place, remove the two bolts located at each end of the rear air deflector on the top surface using a 1/2" socket/ratchet and a 1/2" open end wrench. See Figures 7 and 8 for location detail. Set the fasteners aside for reinstallation.

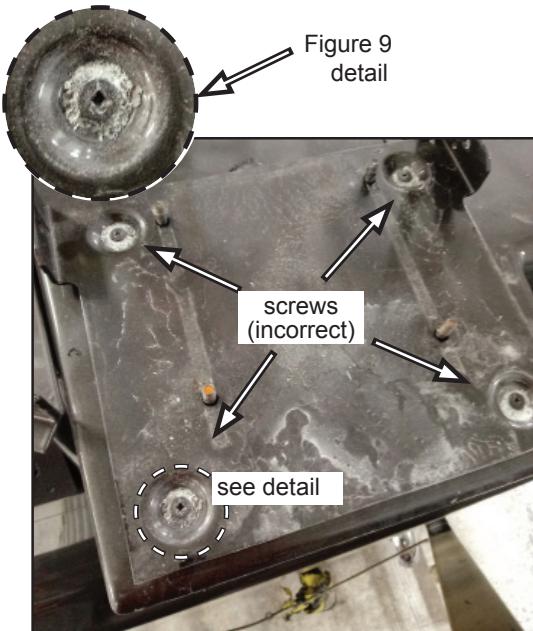
Figure 9

On motorhomes affected by this recall, the center mounting plate for the rear air deflector, located at the top of the rear fiberglass cap, was attached to the fiberglass with screws which, under certain circumstances, can work loose, allowing the rear air deflector to flex and possibly become detached from the vehicle.

11. Remove the rear air deflector and carefully set aside and secure it on the roof for reinstallation, **taking care to not damage the painted finish.**
12. With the rear air deflector removed, inspect the fasteners holding the center mounting plate to the fiberglass cap.
 - If screws are found (see Figure 9), proceed to Step 13.
 - If rivets are found (see Figure 10), proceed to Step 16.
13. If **screws were found** in the previous step, remove them from the plate and discard them as they will not be reused.

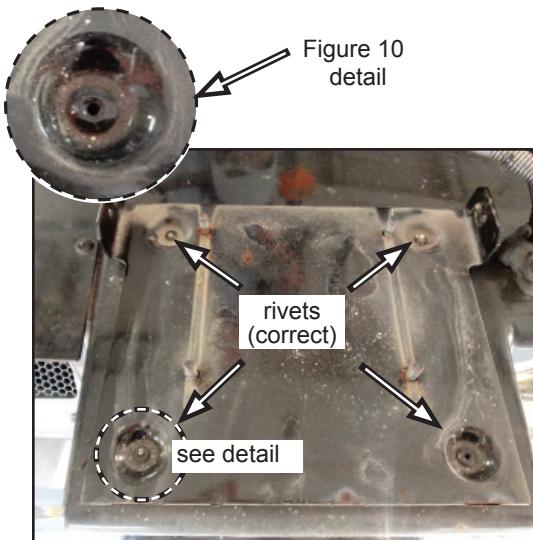
Figure 10

14. With the plate removed, temporarily turn it over so that the studs are facing down. Around each mounting "foot", apply a 1/8" bead of Sikaflex®-221 or 3M™ #540 adhesive. See Figure 11.
15. Return the plate to its original position so that the studs are pointed up and the tabs are towards the front of the unit. Position it over the existing holes in the fiberglass cap. Secure the plate to the fiberglass cap using the 3/16 rivets included in the parts kit.

- Use the holes that were originally used for the screws; if other holes are present, they should not be used.
- It may be necessary to drill out the holes in the fiberglass cap to 1/4" for the rivets to properly fit.

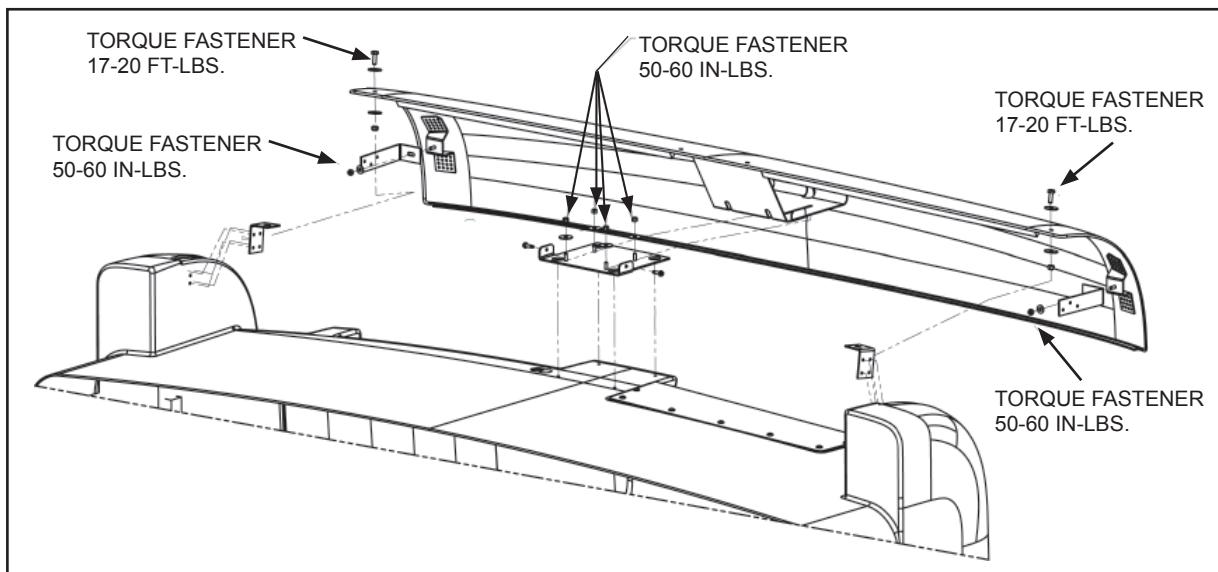
18. At the roadside of the coach, verify that the stud is properly seated in the lower bracket and install the 7/16" nut and washer that was removed in Step 9. Torque this fastener to 50-60 in-lbs. If locking nuts are not present, apply Loctite® Threadlocker Blue 242® to the threads prior to tightening.

19. Move to the doorside of the coach, verify that the stud is properly seated in the lower bracket and install the 7/16" nut and washer that was removed in Step 8. Torque this fastener to 50-60 in-lbs. If locking nuts are not present, apply Loctite® Threadlocker Blue 242® to the threads prior to tightening.

21. Torque the two bolts, installed in Step 17, to 17-20 ft-lbs. If locking nuts are not present, apply Loctite® Threadlocker Blue 242® to the threads prior to tightening. See Figure 12 for a summary of torque specifications.

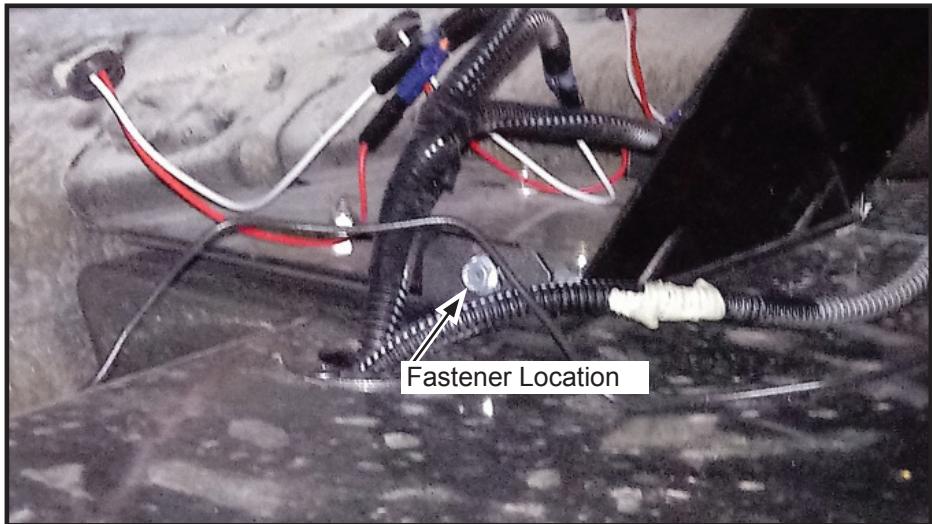
Figure 13

22. Using the two 1/4" HWH self-drilling screws, included in the parts kit, fasten through the center mounting plate tabs into the bracket attached to the rear air deflector at the location shown in Figure 13. The doorside is shown; the roadside is similar.
