Safety Recall Notice Service Bulletin 509057 Rev. A

Steering Shaft Extension Replacement

Applicable for 2019 Toyota Sienna Side Entry Vehicles
Manufactured February 20, 2019 to July 8, 2019.

This service bulletin details replacement of the Toyota Sienna steering shaft extension.

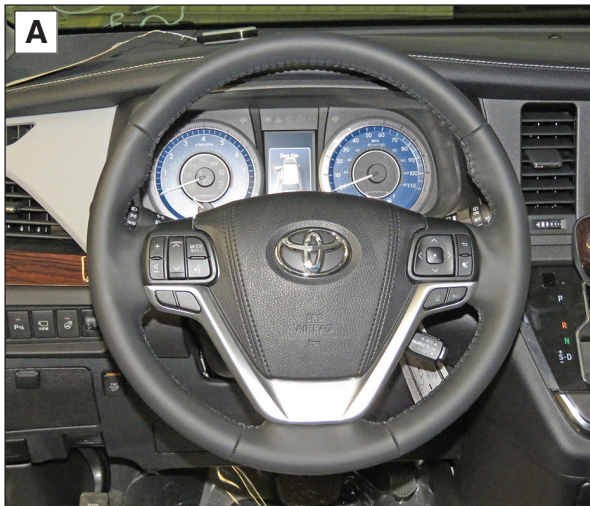
1. Turn front wheels and steering wheel to the straight position. See Photo A.
2. Turn steering wheel counterclockwise from straight to approximate position shown in Photo B.

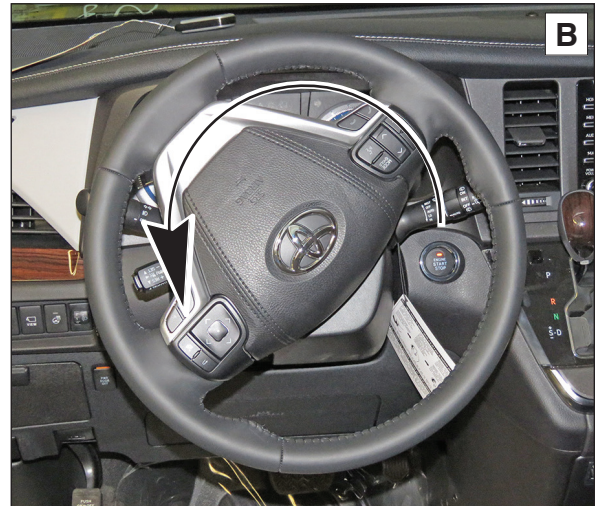
Steering shaft extension is now positioned to access steering shaft extension mounting bolts.

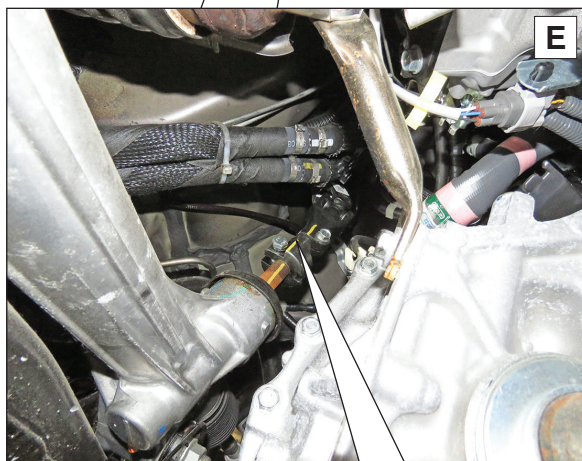
3. Locate steering shaft extension. See Photos C through F.

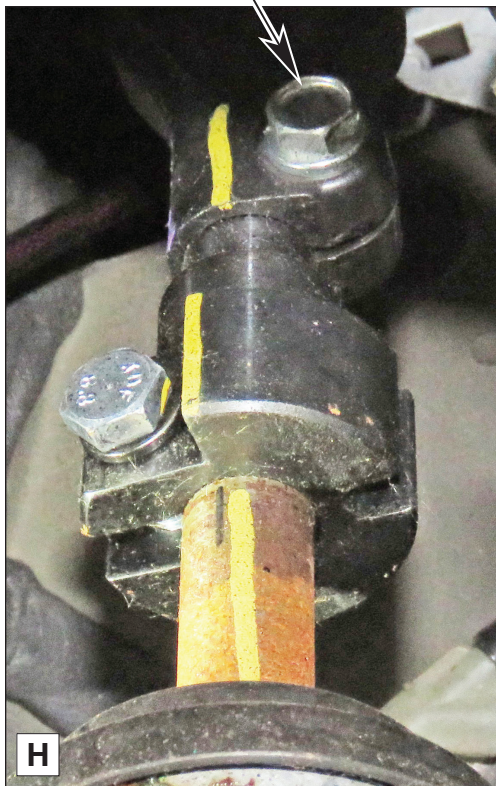
M8 Bolt (12mm Head) and Lock Nut

5. Remove and retain M8 bolt (12mm head) and lock nut shown in Photo H.

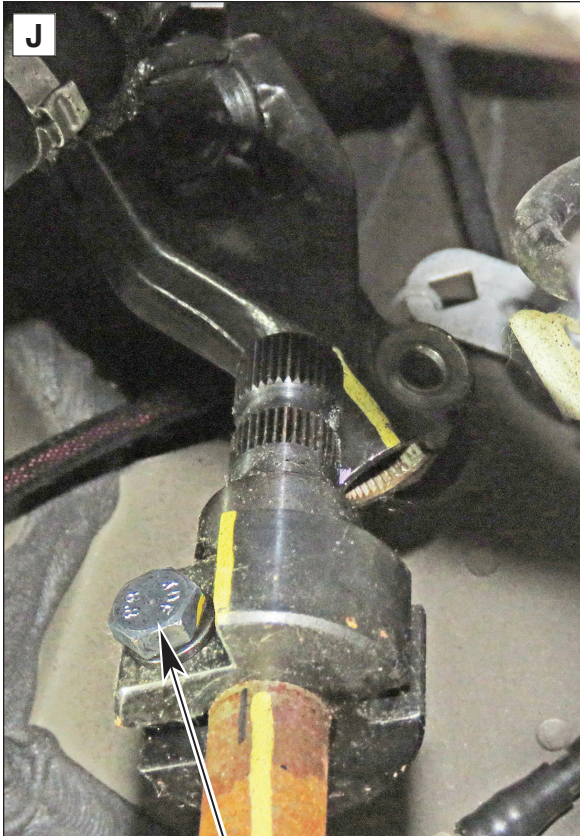
M8 Bolt (13mm Head) and Lock Nut

7. Remove and retain M8 bolt (13mm head) and lock nut shown in Photo J.
