SAFETY RECALL

**M0330 CONVENTIONAL OUTSIDE MIRROR
GLASS ADHESION**

RECALL NO: M0330

SUBJECT VEHICLES: Certain 2020 model year Hino Conventional vehicles equipped with a J08 engine that were assembled at the Williamstown, WV assembly plant.

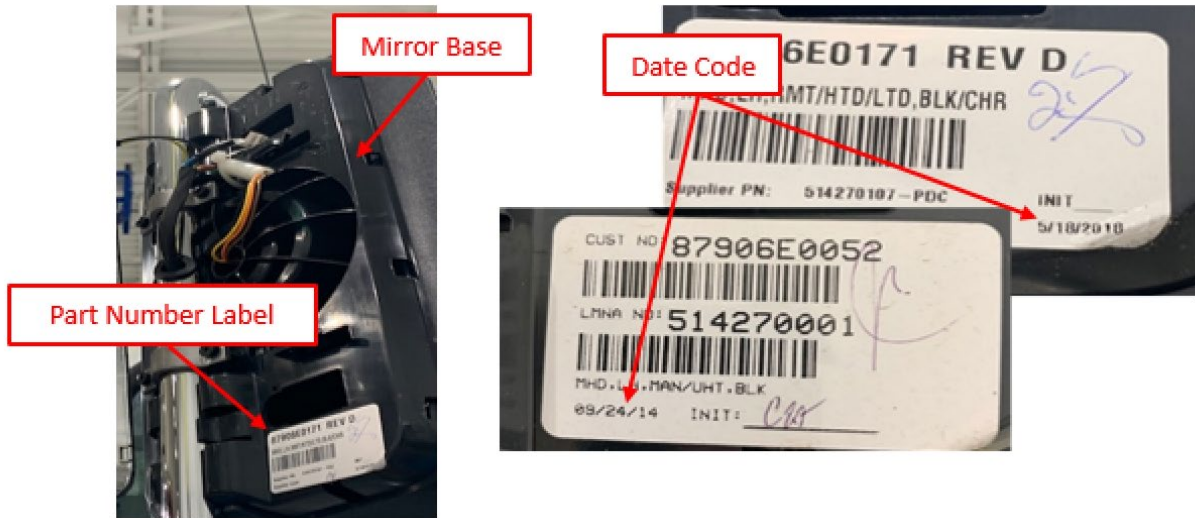
2. With the mirror covers removed, locate the part number label at the lower right corner of each mirror base. See the photographs, below. Check to determine if each mirror's manufacturing date code falls between the dates 2/13/19 – 2/27/19, build dates may be different for each mirror.

Does the mirror base date fall between 2/13/19 – 2/27/19?

Yes – Proceed to step 1 of the repair procedure, below.

No – Proceed to step 5 of the repair procedure, below.

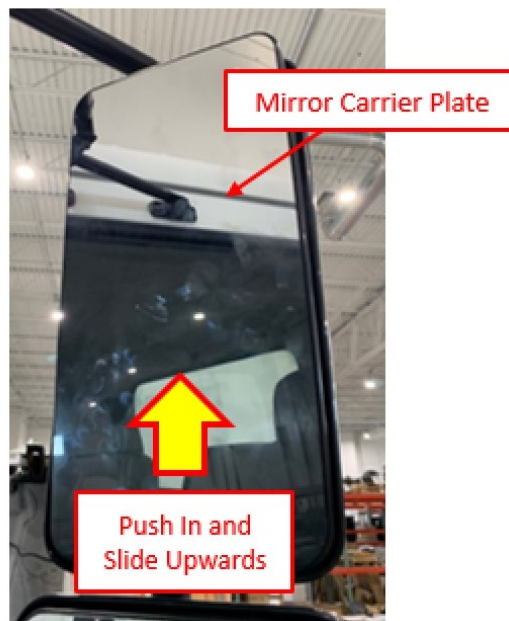
1. Starting from the bottom of the mirror, position the lower portion of the mirror inwards and then slide the mirror carrier plate upwards to release the mounting tabs.

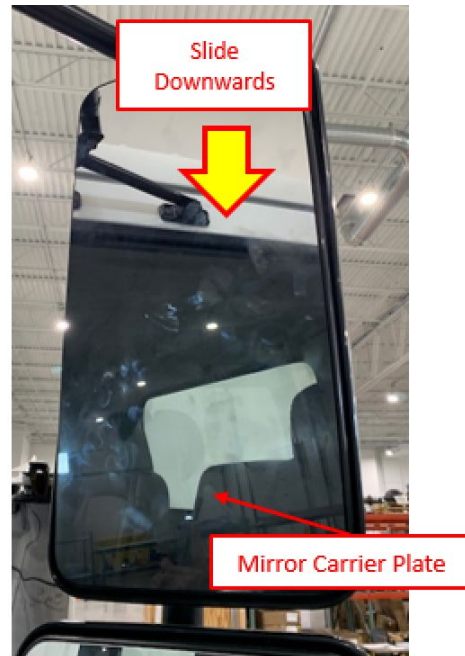
4. Position the mirror carrier plate and mirror base together. Place the mirror carrier plate slightly higher than the mirror base. Align the tabs (indicated by red arrows in the photo below left) of the mirror carrier plate and mirror base. Slide the mirror carrier plate downwards to engage the tabs.

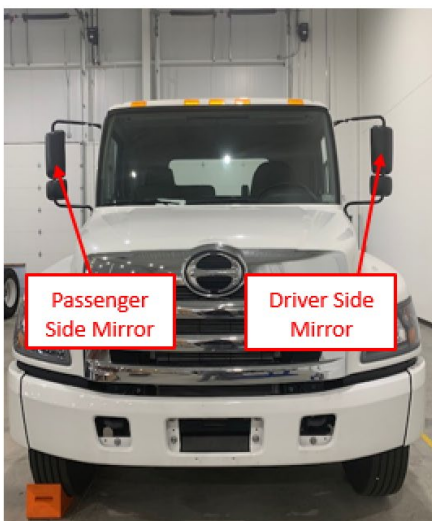
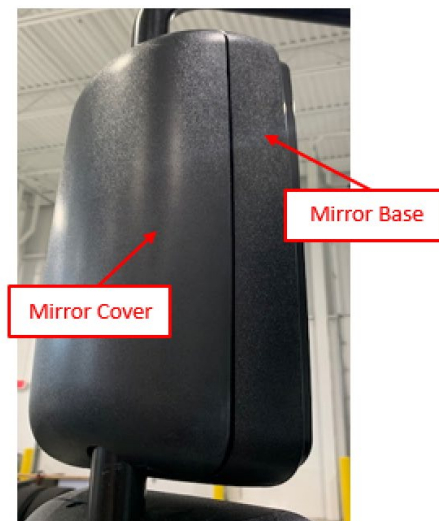
5. Reinstall the driver side and passenger side mirror covers on to the mirror bases by pushing each cover down all at once. Each mirror cover has 8 retaining tabs. Make certain that each of the 8 cover retaining tabs are engaged for each mirror cover.

NOTICE: Failure to properly engage the 8 retaining tabs can result in the mirror cover coming loose or falling off.
