**TECHNICAL INSTRUCTIONS**

**SAFETY (NONCOMPLIANCE) RECALL K0N**

**BACKUP CAMERA DISPLAY MAY NOT OPERATE**

**CERTAIN 2019 MODEL YEAR RAV4 / RAV4 HV**

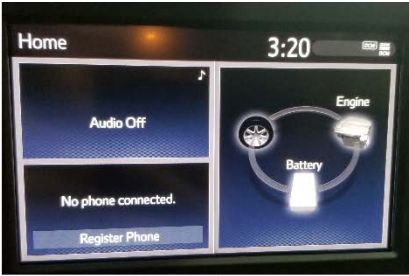
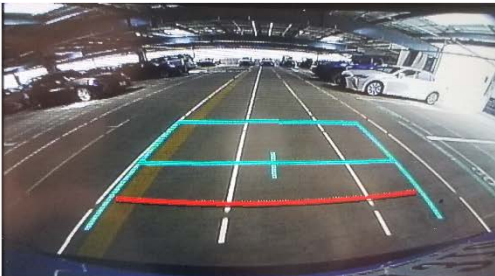
| INSPECTION METHOD | | |
|--|--|---|
| <p><b>1. INSPECT BACKUP MONITORING SYSTEM FUNCTION</b></p> <p>a. Turn the IG ON<br/>b. Shift the vehicle into Reverse</p> | | <p><b>ACTIONS TO TAKE</b></p> |
| <p><b>OK</b> Backup camera is functional</p> <div style="display: flex; align-items: center;"> <div style="margin: 0 20px; font-size: 2em;">➔</div> </div> <p>*Home screen is used as an example.</p> | <p>No further action required.<br/>Campaign Complete</p> | |

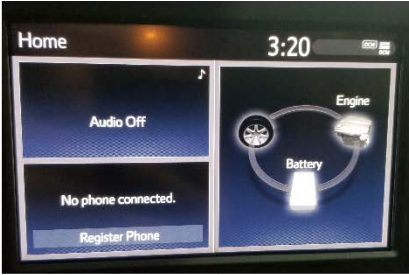
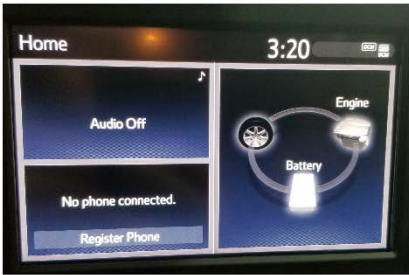
| INSPECTION METHOD | | |
|--|--|---|
| <p><b>NG</b> No response</p> <div style="display: flex; align-items: center;"> <div style="margin: 0 20px; font-size: 2em;">➔</div> </div> <p>*Home screen is used as an example.</p> | <p>Radio and Display Receiver Assembly replacement required</p> <p>Proceed to the next page for instructions on how to replace the Radio and Display Receiver Assembly</p> | |
