STEERING SHAFT BOLTS

Bulletin Type:	RECALL	Publication Date:	September 23, 2019
Bulletin #:	19V-625 Jayco 19V-626 2019-447 Entegra	Make:	Jayco Motorized Entegra
Job Code:	9903434	Models:	Embark Insignia, Aspire, Anthem, Cornerstone, Reatta
Flat Rate:	RC024 Inspection of two bolts NO repair required .25 Hour RC025 Inspect and repair .5 Hour	Model Year:	2019 & 2020

Incident:	Upper and lower steering shaft bolts on steering column may not be torqued correctly at 45ft lbs.
Affected Units:	Serial Number listing of affected units is on last page of Instructions
Misc. Tools & Supplies:	Torque wrench (Ft/Lbs) 11/16 socket 5/8 wrench or socket

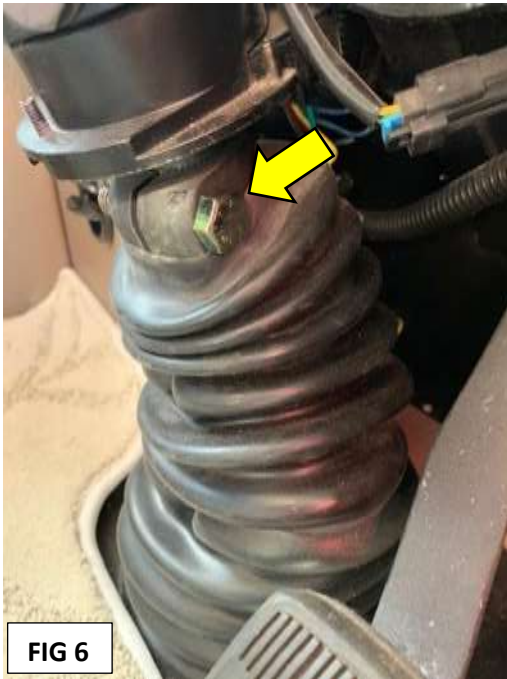
FIG 6:

- Upper steering shaft bolt is located on the steering column, beneath the steering wheel and under the large rubber boot.
- Lower the rubber boot on the steering column to see the bolt.

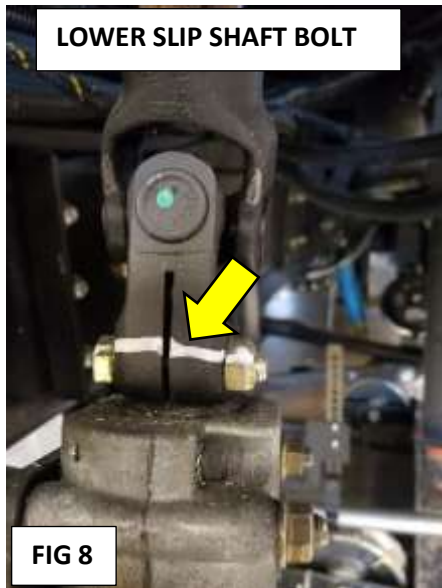
FIG 8:

- This is the lower slip shaft bolt below the U-joint.
- If the bolt has been properly torqued at the factory there will be a white line running from the head of the bolt to the nut end of the bolt (arrow).

Bolt head will require a 5/8" wrench or socket.

Nut on the bolt will require an 11/16" socket.

Use a torque wrench (FT/LBS) and **torque the nut end to 45 Ft/Lbs.**

Mark the bolt with a white line as shown in photo to indicate the bolt has been torqued properly.

Repeat this torque procedure for both slip shaft bolts (if the white line is missing).

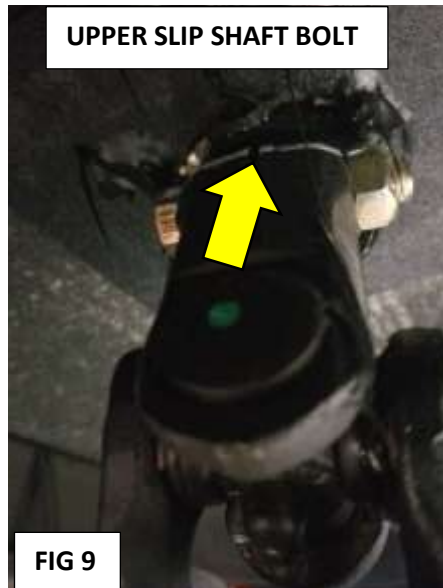
FIG 9:

- This is the upper slip shaft bolt which is directly above the U-joint shown in **Fig 8**.
- If the bolt has been properly torqued at the factory there will be a white line running from the head of the bolt to the nut end of the bolt (arrow).

IF THE WHITE LINE IS NOT VISIBLE PROCEED TO NEXT STEP TO COMPLETE REMEDY.

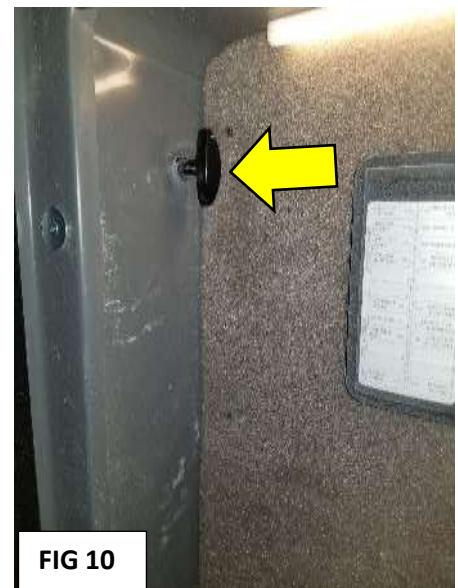
Both the upper and lower slip shaft bolts are located under the floor. The generator slide compartment must be opened to access the slip shaft bolts. Pull the generator slide manual release lever located in the electrical compartment beneath the driver side window (**FIG 10**). Both bolts should be visible on the steering shaft, one above the steering U-joint and one below the steering U-joint.
