TECHNICAL INSTRUCTIONS
FOR
SAFETY RECALL K0Q
PASSENGER AIRBAG MAY NOT INFLATE PROPERLY
CERTAIN 2003 – 2008 MODEL YEAR COROLLA

UPDATE 05/28/2020

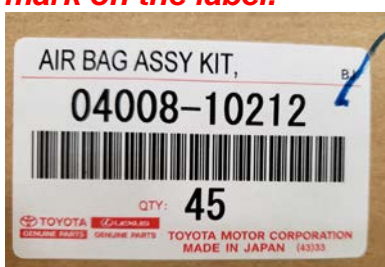
Make sure the parts box has a check mark as seen in the image above

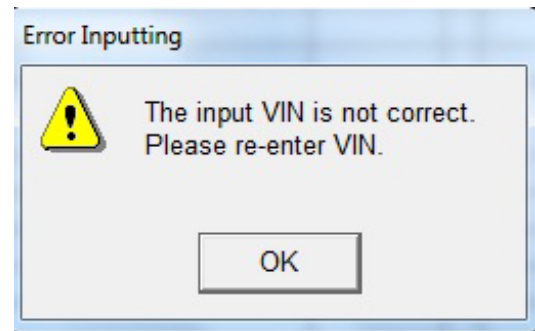
NOTE: If the VIN was not entered in ALL CAPS when Techstream was launched, an error will be displayed and there will be a prompt to reenter the VIN

- Enter the vehicle mileage and repair order information, then click the 'report' button.
