March 2020

Dealer Service Instructions for:

Safety Recall VA6 / NHTSA 19V-680 Seat Belt Buckle

2011-2018 (JK) Jeep® Wrangler

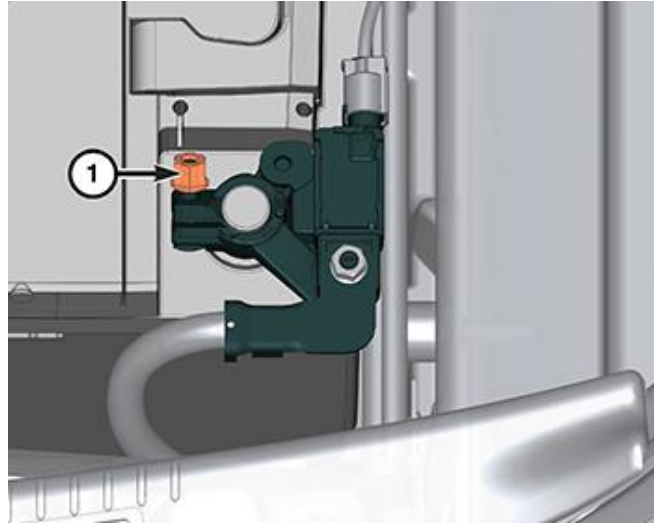
Figure 1 – Battery Negative Terminal Nut

1. Loosen the M6 captive nut (1) securing the battery negative cable clamp to the battery negative post (Figure 1).

NOTE: Do not remove the M6 captive nut, doing so will cause the M6 stud on IBS pole clamp to break.

- e. Tighten the battery negative cable clamp M6 nut (1) to 7 N·m (62 in. lbs.) (Figure 1).
- f. Wait two minutes before proceeding.
- g. Install the electrical connector (1) to the IBS. Make sure there is no stress on the wires (Figure 2).

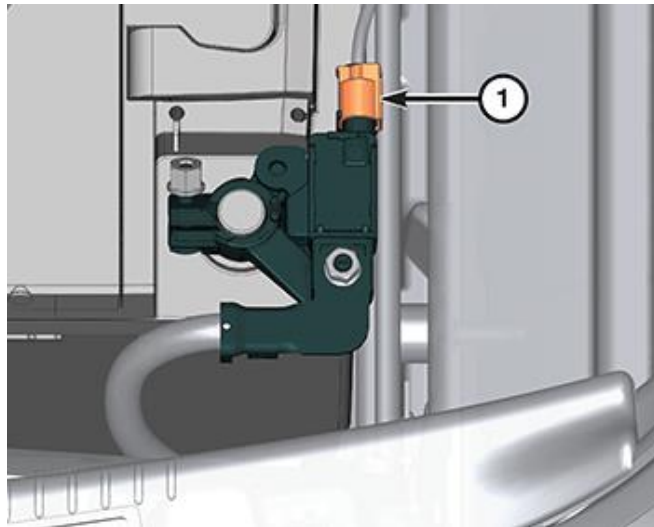
Figure 2 – IBS Electrical Connector

2. Disconnect the Intelligent Battery Sensor (IBS) electrical connector (1) (Figure 2).

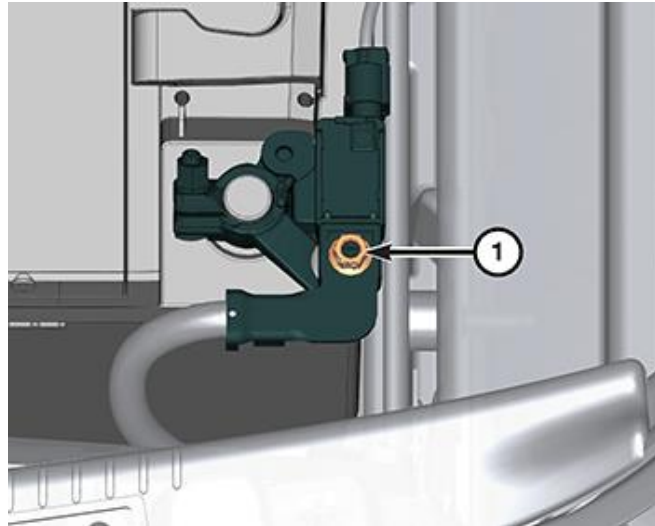
Figure 3 – Negative Cable Eyelet Nut

3. Remove the M8 hex nut (1) securing the battery negative cable eyelet to the IBS (Figure 3).

- a. Remove all special tools and jumper wires and reconnect all previously disconnected components, except the battery.
- b. Turn the ignition “ON”.
- c. Connect the battery negative cable eyelet (2) to the IBS M8 stud (Figure 4).
- d. Install the M8 hex nut (1) to the IBS and tighten the nut to 15 N·m (11 ft. lbs.) (Figure 3).

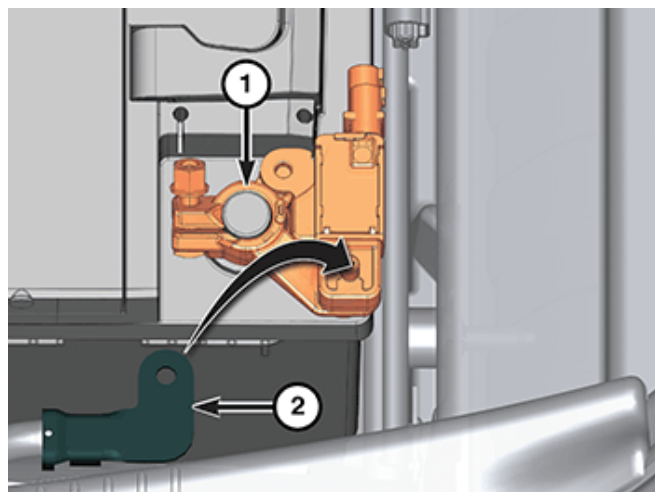
Figure 4 – Negative Cable Eyelet

4. Remove the battery negative cable eyelet (2) from the IBS M8 stud (Figure 4).

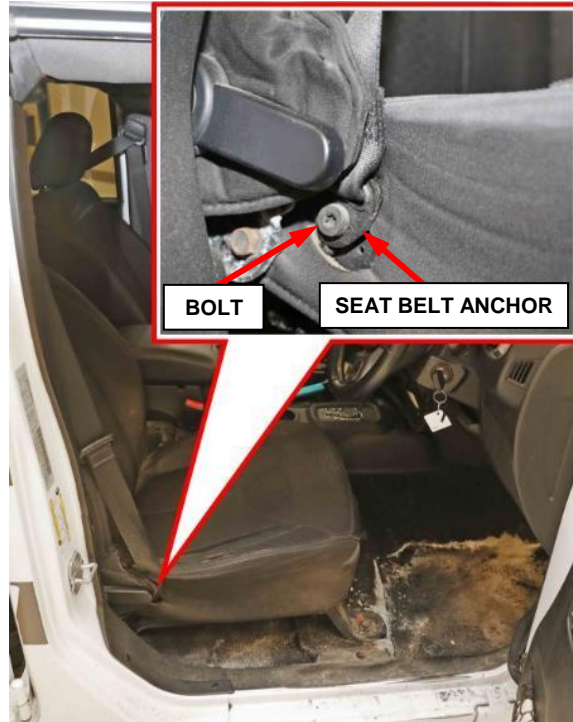
Figure 5 – Driver's Seat Belt Anchor

6. Remove and **DISCARD** the bolt that secures the lower seat belt anchor to the outboard side of the front driver's seat cushion frame (Figure 5).

26. Position the seat belt lower anchor to the mounting hole on the outboard side of the front seat cushion frame. Be certain that the seat belt webbing between the turning loop and the lower anchor is not twisted (Figure 5).

27. Install and tighten the **NEW** bolt that secures the seat belt lower anchor to the seat. Tighten the bolt to 40 N·m (30 ft. lbs.) (Figure 5).

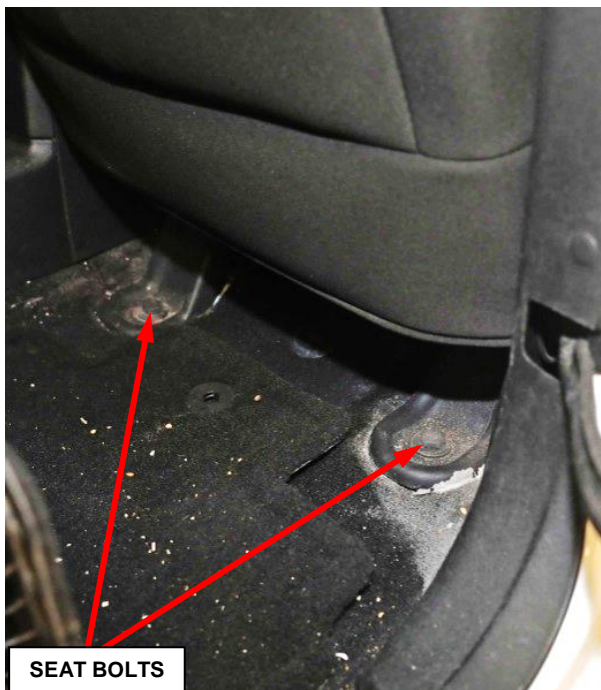
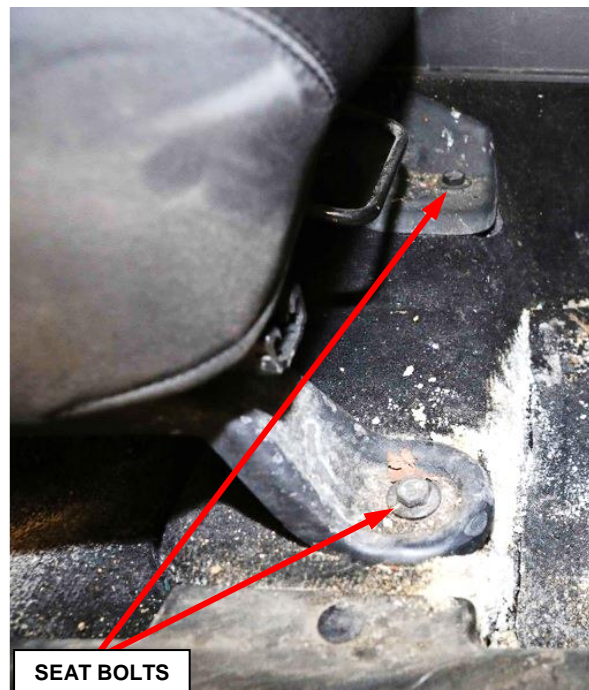
Figure 6 – Driver's Seat Bolts

7. Remove and **DISCARD** the four driver's seat bolts (Figure 6).

23. Position the seat into the vehicle.
24. Connect the electrical connectors (Figure 7).
25. Install the **NEW** bolts securing the seat to the floor (Figure 6).

- a. Adjust the seat rearward.
 - b. Tighten the front inboard bolt to 75 N·m (55 ft. lbs.).
 - c. Tighten the front outboard bolt to 75 N·m (55 ft. lbs.).

- d. Adjust the seat forward.
 - e. Tighten the rear inboard bolt to 75 N·m (55 ft. lbs.).
 - f. Tighten the rear outboard bolt to 75 N·m (55 ft. lbs.).

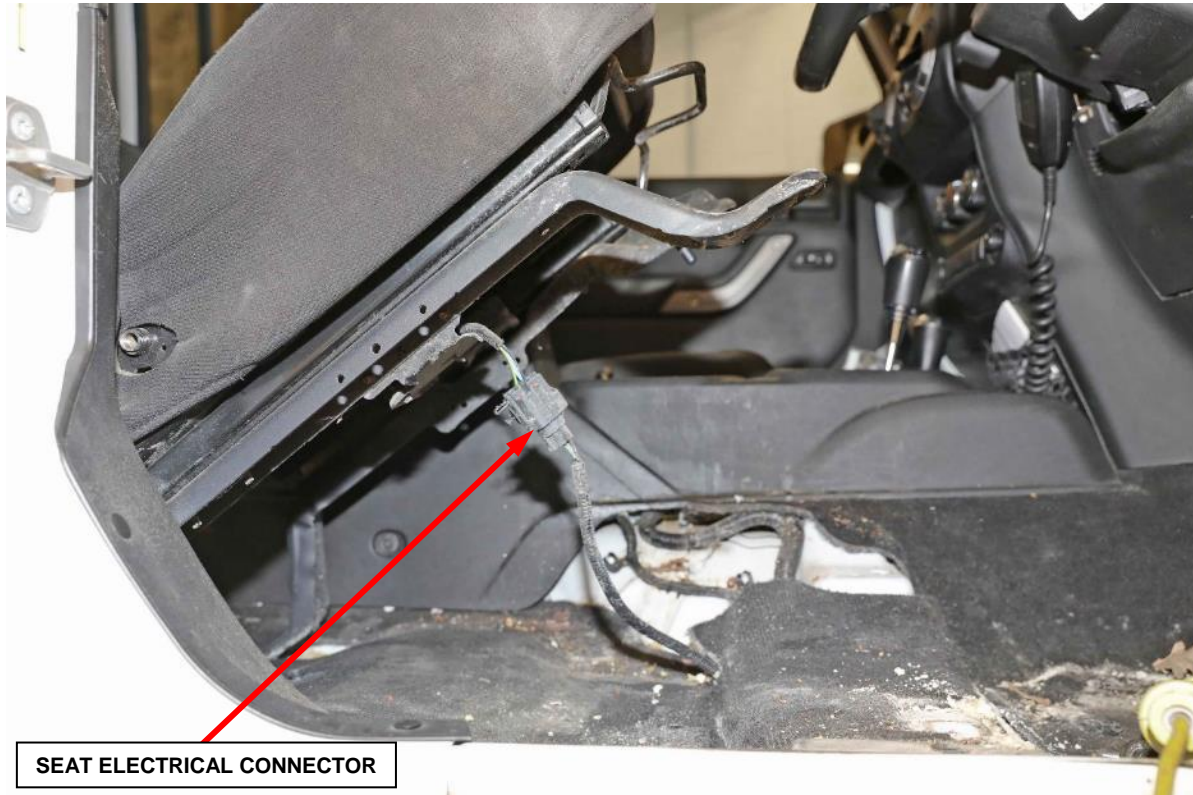
Figure 7 – Driver's Seat Electrical Connector

8. Tip the driver's seat back and disconnect the electrical connectors (Figure 7).

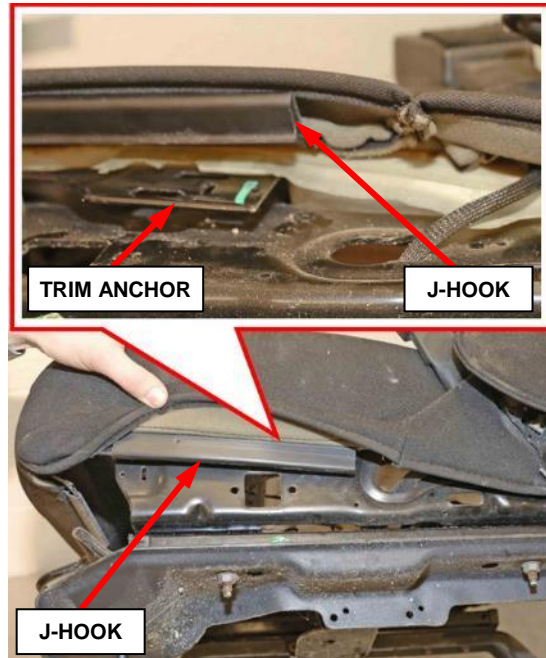
Figure 8 – Trim Cover J-Hook

- 10. Disengage the inboard side of the lower seat cushion trim cover J-hook from the seat cushion trim anchor (Figure 8).
- 11. Pull the inboard side of the lower seat cushion trim cover upward far enough to access the seat belt buckle anchor bolt (Figure 9).
- 12. Reach under the seat cushion frame to access and disconnect the seat belt buckle pigtail wire connector from the seat wire harness (Figure 9).

21. Connect the seat belt buckle pigtail wire connector to the seat wire harness under the seat cushion frame (Figure 9).
22. Install the inboard side seat cushion trim cover J-hook onto the lower seat cushion trim anchor (Figure 8).

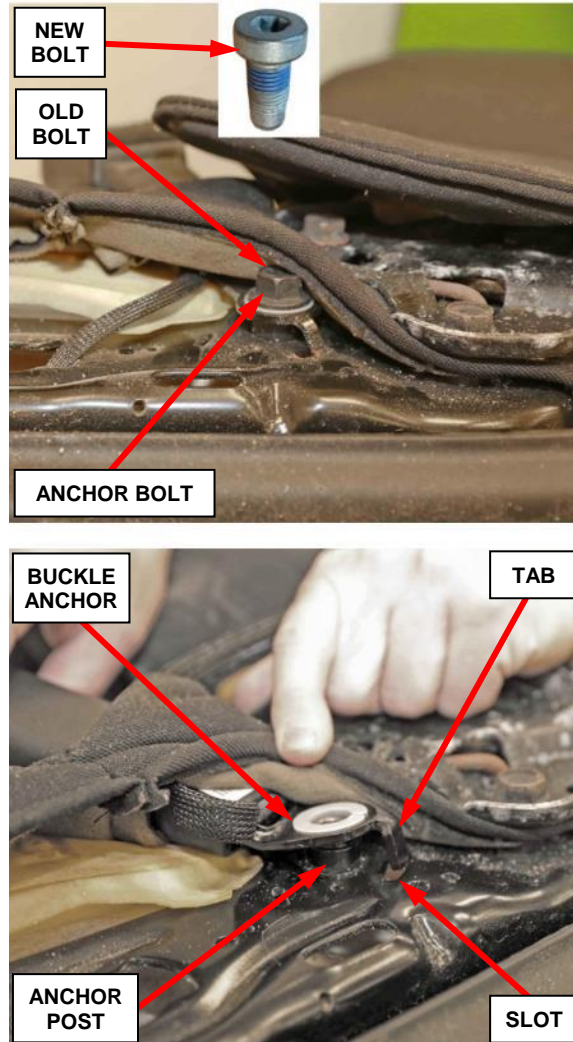
Figure 10 – Seat Belt Buckle Anchor

13. Remove and **DISCARD** the bolt that secures the seat belt buckle anchor to the inboard side of the seat cushion frame (Figure 10).
14. Disengage the seat belt buckle and scabbard from the opening in the inboard side of the seat cushion trim cover (Figure 10).
15. Remove the seat belt buckle assembly from the seat.
16. Render the old seat belt buckle assembly unusable and **DISCARD**.
17. Obtain the **NEW** seat belt buckle assembly and fasteners campaign kit.
18. Insert the **NEW** seat belt buckle scabbard through the opening in the inboard side of the seat cushion trim cover (Figure 10).
19. Position the buckle assembly anchor onto the anchor post on the inboard side of the seat cushion frame and align the tab on the buckle anchor with the slot in the seat cushion frame (Figure 10).

20. Install and tighten the **NEW** bolt that secures the seat belt buckle anchor to the seat cushion frame. Tighten the bolt to 45 N·m (33 ft. lbs.) (Figure 10).
