# Safety Recall

## Code: 66K8

**Subject** Rear Wheel Arch Trim

**Subject: Safety Recall 66K8 – Rear Wheel Arch Trim  
Certain 2018-2019 Model Year Audi SQ5 and 2018-2020 Model Year Audi Q5**

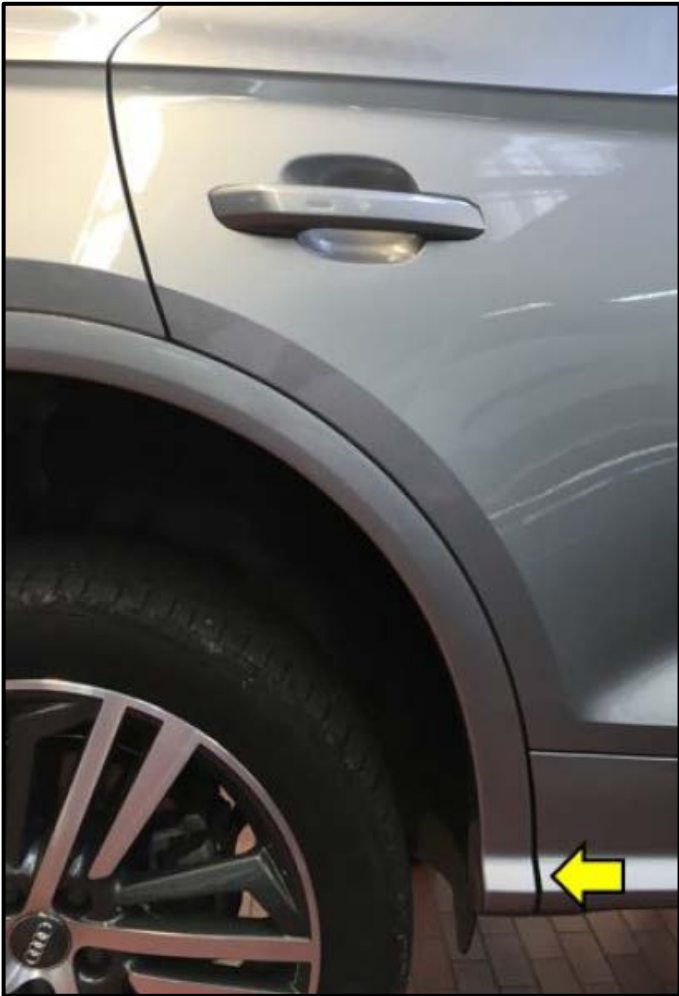
## Repair Overview

- Replace clips for lower wheel arch trim “cap” <arrow> on both left rear and right rear wheel arch trim.

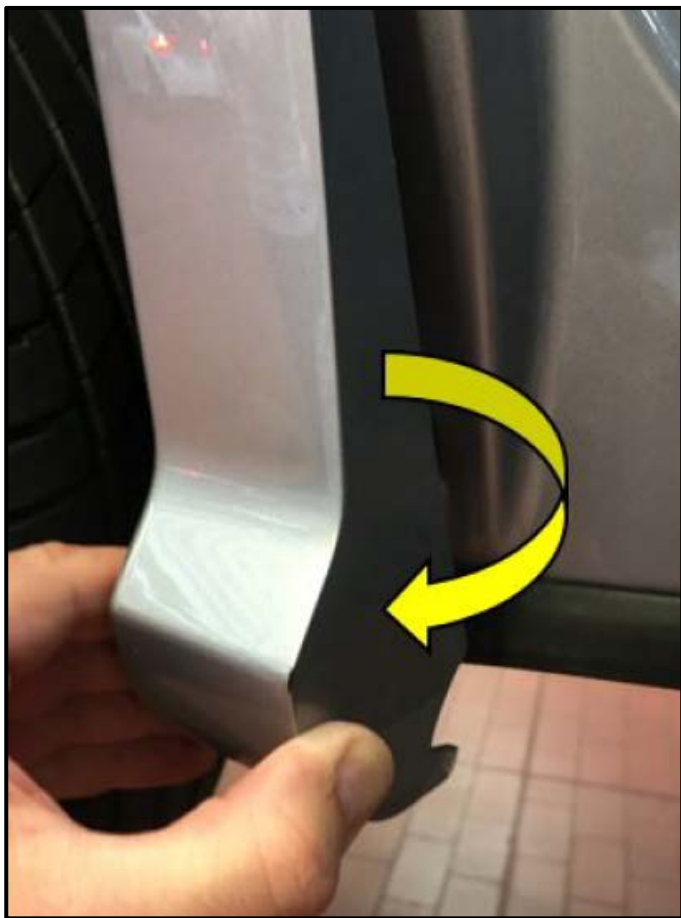
- Unclip wheel arch trim “cap” by turning and pulling simultaneously.

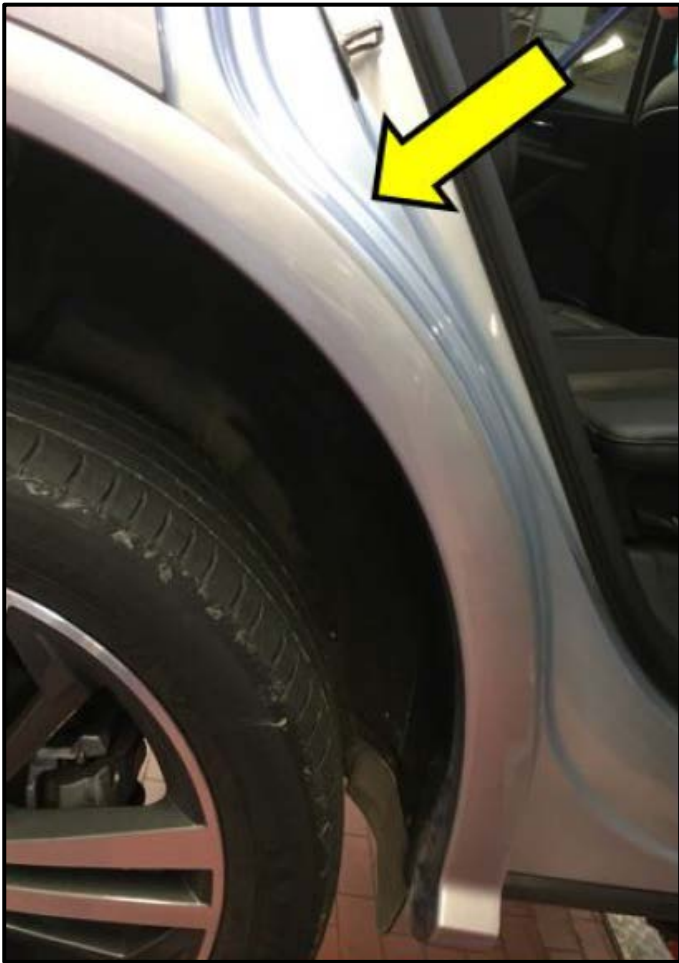
- Only unclip wheel arch trim up about a third of the way to the approximate area of <arrow>.

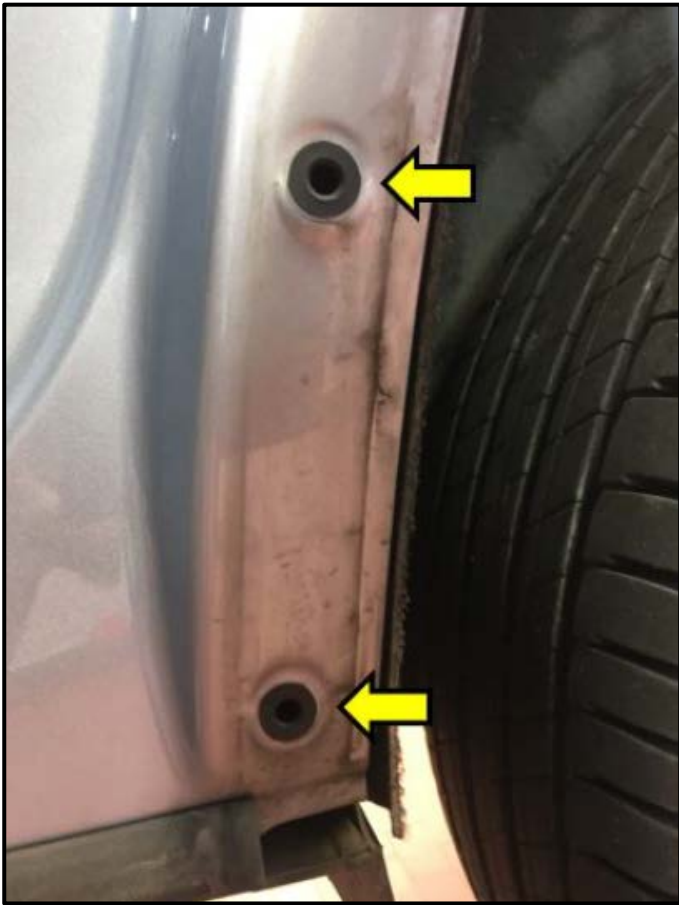
- Install/replace the two lowest grommets <arrows>.

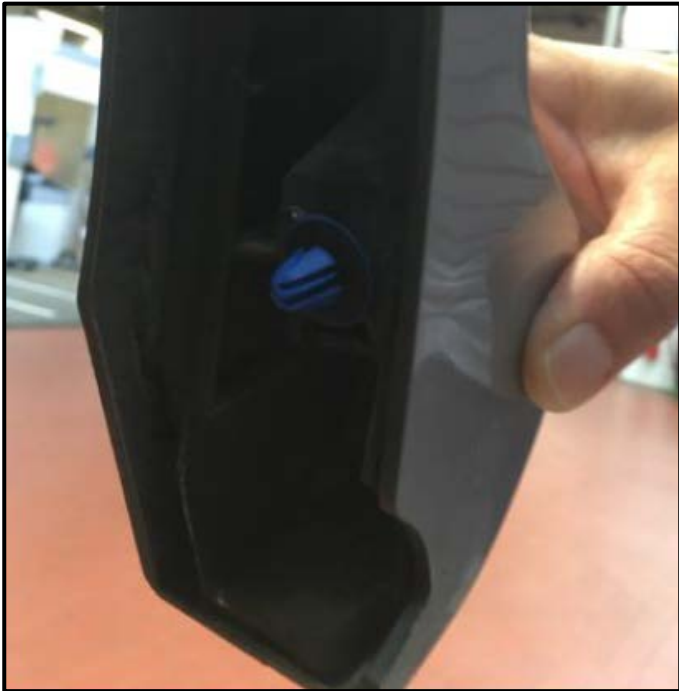
- Carefully hold the wheel arch away from the vehicle.

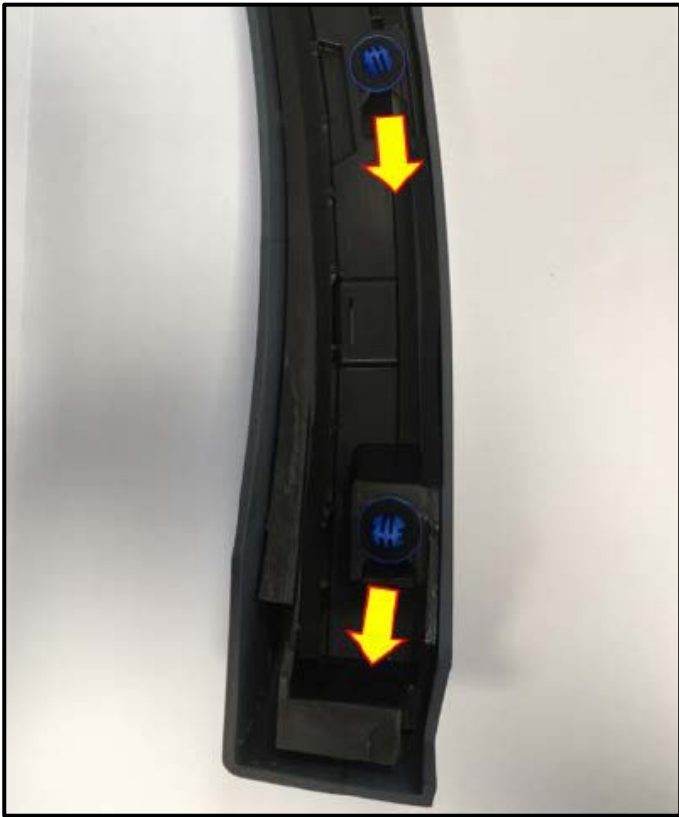
- Remove the old blue clips by sliding them down in direction of <arrows>.

Only the lowest two clips are being replaced.

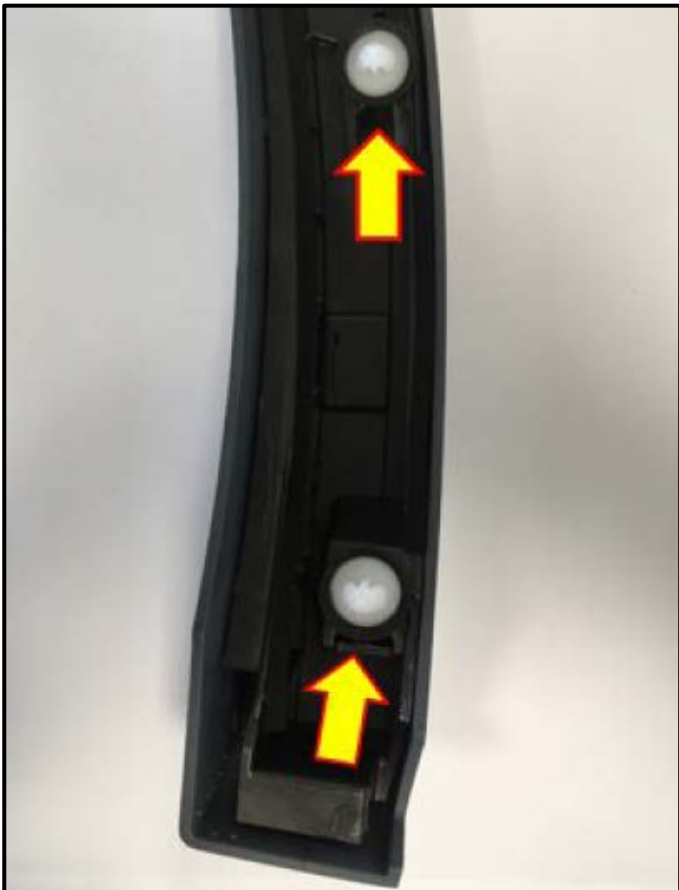
- Install the new white clips in the opposite direction of removal.

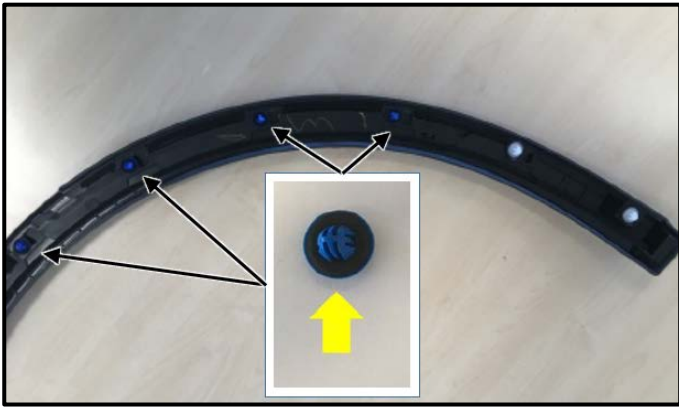
- Verify that the black foam washers <arrow> are still installed on the remaining blue clips.

**NOTE**  
Wheel arch trim shown removed for clarity.

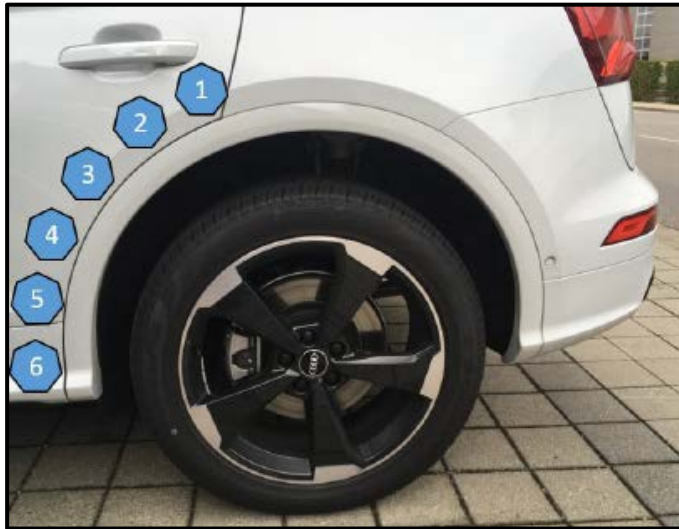
- Reinstall wheel arch trim by pressing on wheel arch trim starting at the top <1> and working down toward the “cap” <6>.
- Repeat for other side.
