TECHNICAL INSTRUCTIONS FOR SAFETY RECALL J0A, J0B, J0C FRONT PASSENGER AIRBAG “MODULE” REPLACEMENT ONLY

CERTAIN 2003 – 2004 MODEL YEAR MATRIX

UPDATE 11-15-2019

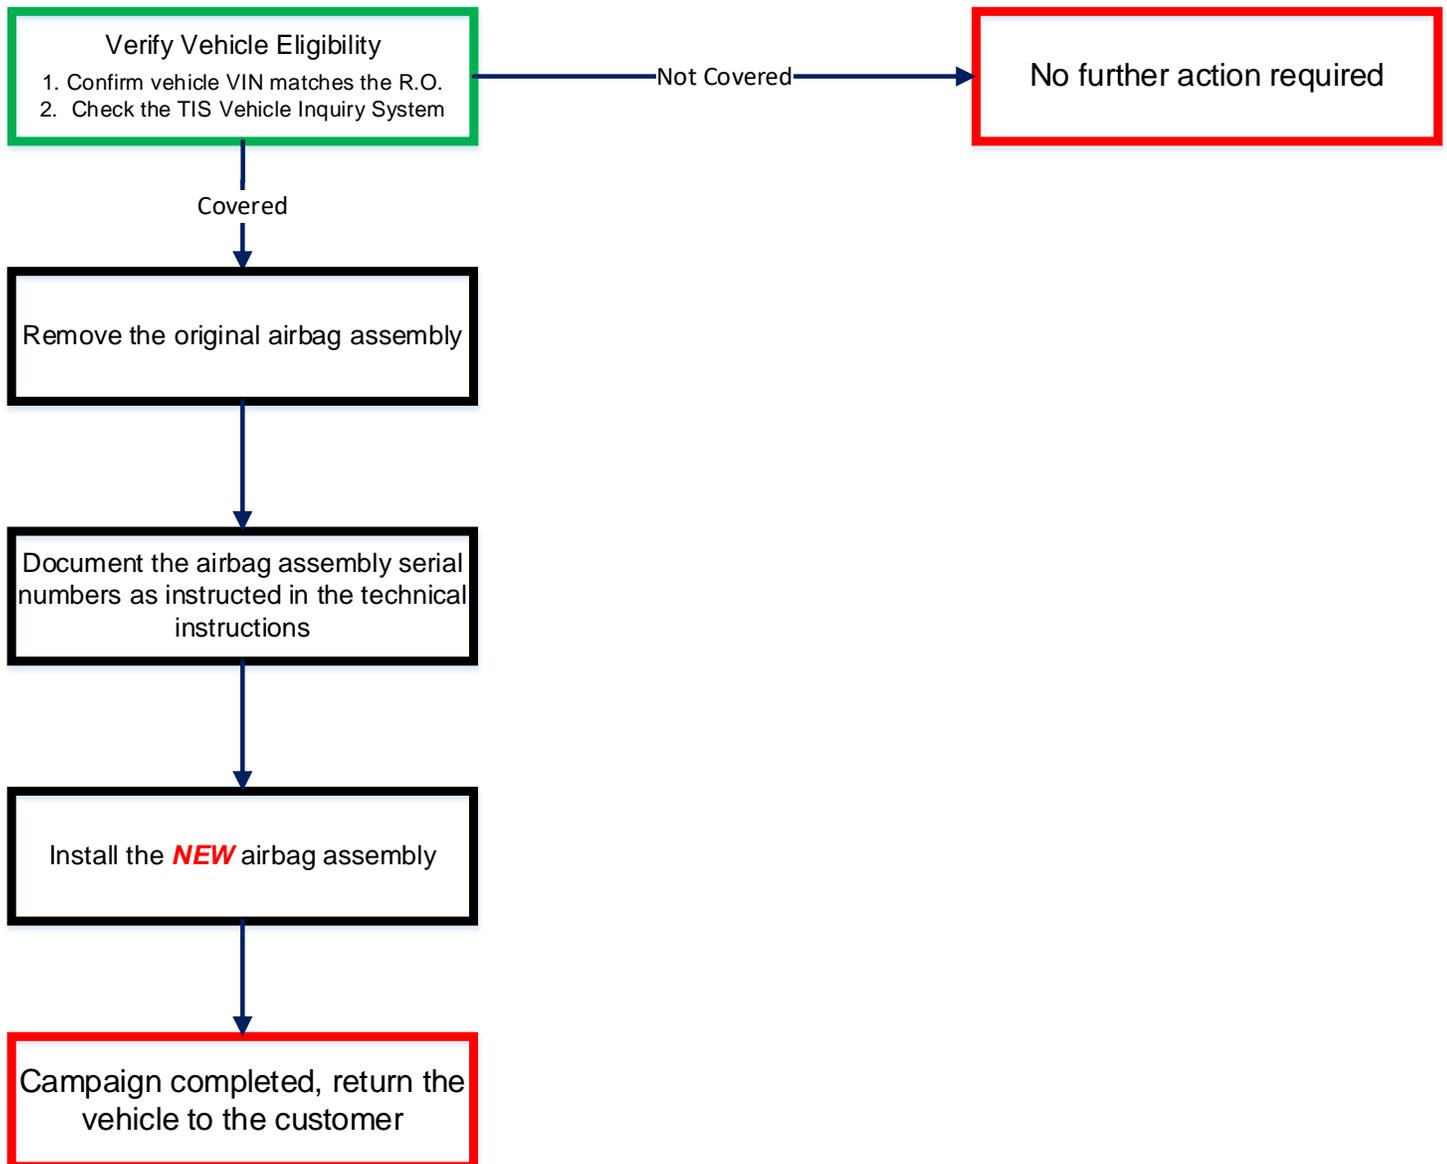
I. OPERATION FLOW CHART

The flow chart is for reference only. **DO NOT** use it in place of the full technical instructions. Follow **ALL** steps as outlined in the full technical instructions to confirm the campaign is completed correctly.

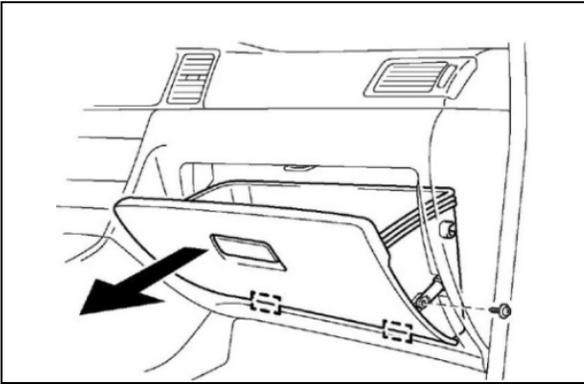
2. REMOVE THE GLOVE BOX

- a) Open the glove box door.
- b) Press in on both sides of the door and swing it down to remove it from the vehicle.

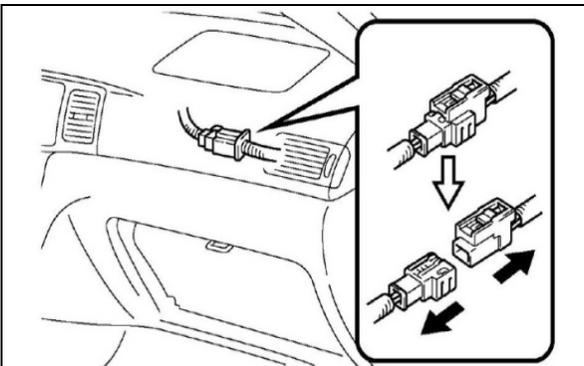
3. REMOVE THE AIRBAG ASSEMBLY

- a) Disconnect the negative battery cable.

- Wait at least 90 seconds after disconnecting the cable from the negative battery terminal to prevent airbag and seat belt pre-tensioner deployment.
- Follow all precautions as outlined on TIS before servicing the SRS system.

- b) Disconnect the airbag connector.

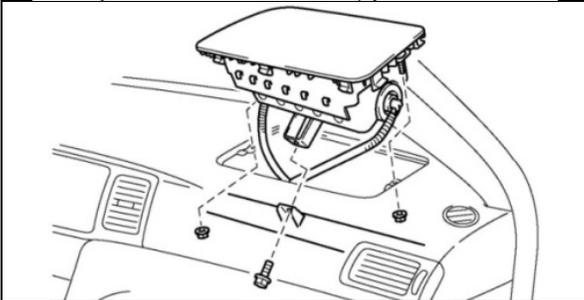
4. REMOVE THE FRONT PASSENGER AIRBAG

- a) Remove the 2 nuts and release the 6 clips.
- b) Remove the airbag assembly.

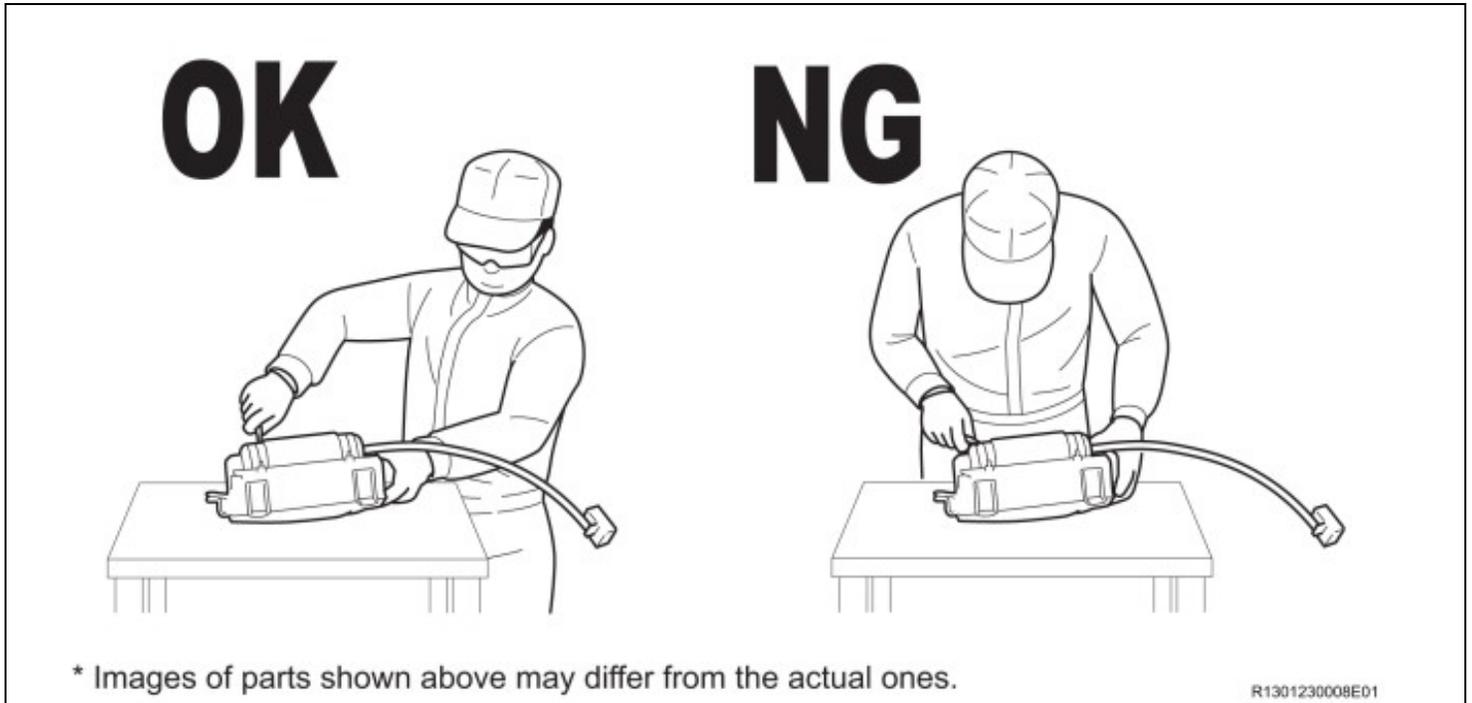
1. WORKING WITH AIRBAG

- Carefully place the airbag on the bench inflator side up.

NOTE: Place clean sheet(s) of paper on the bench to protect the airbag.

- Avoid standing directly over the inflator.

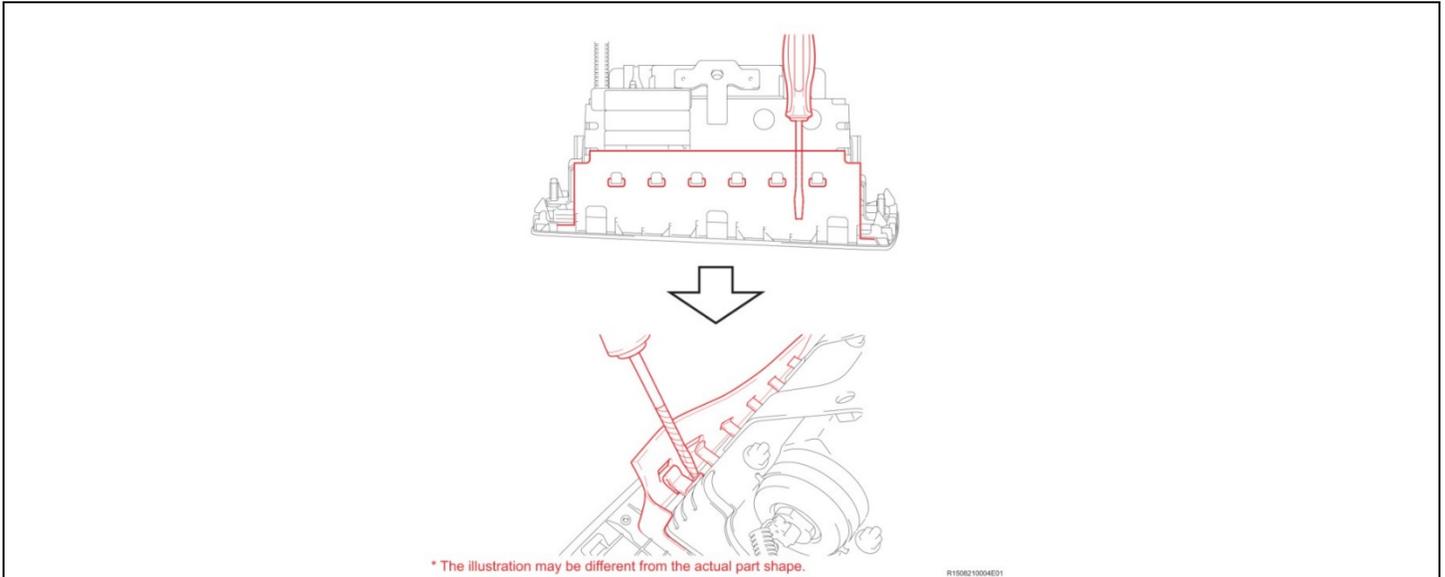
3. REMOVE THE COVER

- a) Gently insert the screwdriver between the airbag door and module and disengage the claws holding the door to the module. Please refer to the video below.

- b) After all the claws have been disengaged separate the module from the door.
- c) Mark the old module so it is not reused.
- d) Inspect the door for damage to the mounting slots.

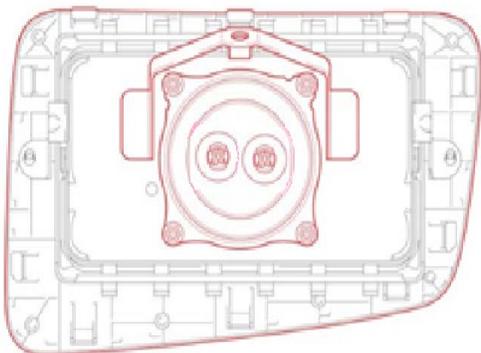
4. INSTALL THE NEW MODULE

Take care not to mistake the mounting direction.

- a) Carefully slide the new module into the airbag door.

NOTE: Mounting direction.

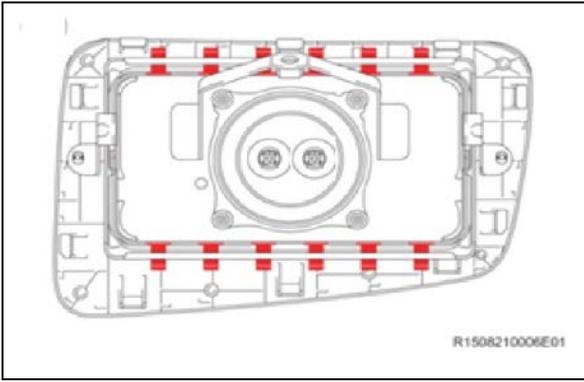
b) Reengage the tangs of the module into the door using the screwdriver with the shaft wrapped in tape.

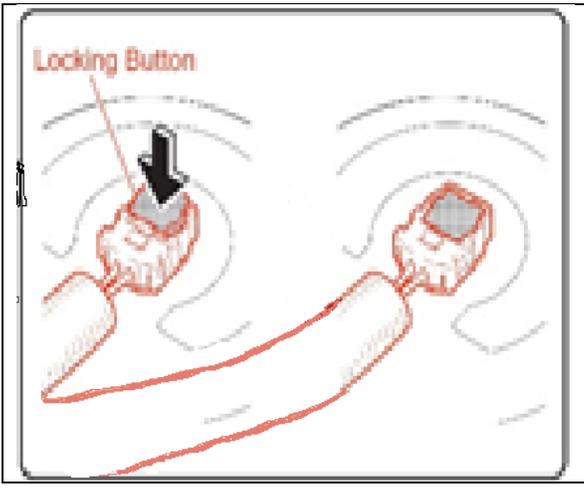
c) Connect the new harness to the new module.
 d) Press the lock tab down.
