**TECHNICAL INSTRUCTIONS**  
**FOR**  
**SAFETY RECALL JLI/JLJ/JLK**  
**FRONT PASSENGER AIRBAG INFLATOR REPLACEMENT**  
**CERTAIN 2010-2015 MY IS 250 CONVERTIBLE**  
**CERTAIN 2010-2011 MY IS 350 CONVERTIBLE**

**Update 02/20/2020**

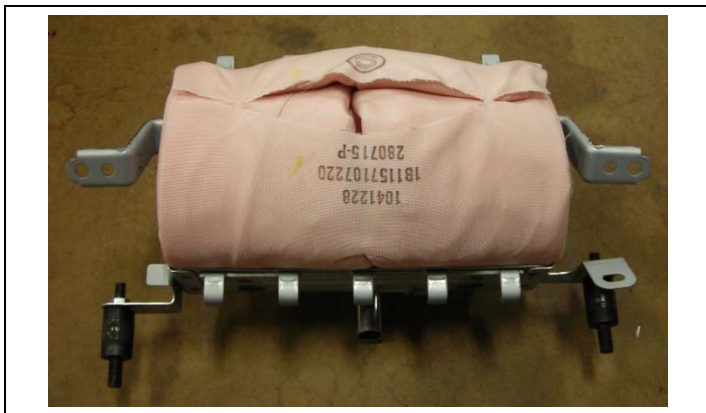
- e) Mount the adaptors (579943-3R3) to the airbag as shown.

**NOTE: The 6mm stud mounts to the airbag.**

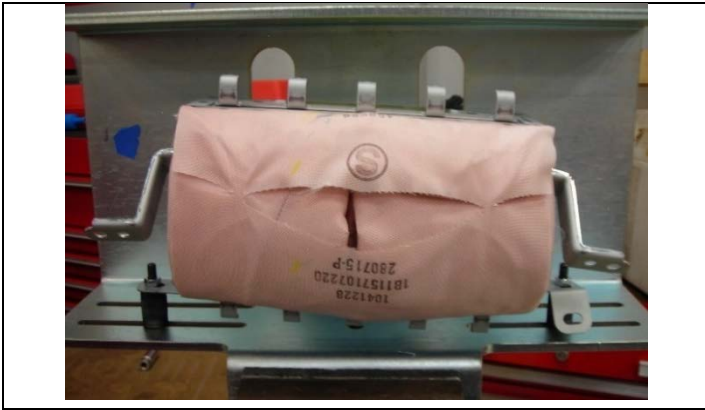
- f) Mount the airbag to the mounting bracket as shown.

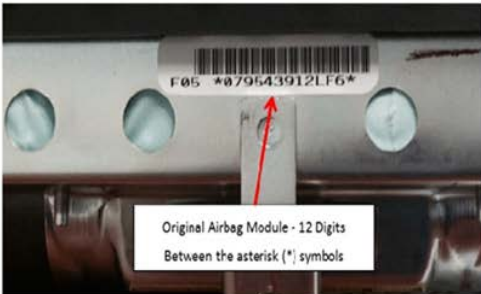
#### Airbag Serial Number Label Example

- The airbag serial number is **ALWAYS** the 12 **DIGITS** located between the asterisks.
- The 3 digits before the asterisk **ARE NOT** part of the serial number, and **SHOULD NOT** be entered or an inaccurate response may be returned.

Original Airbag Module - 12 Digits  
Between the asterisk (\*) symbols

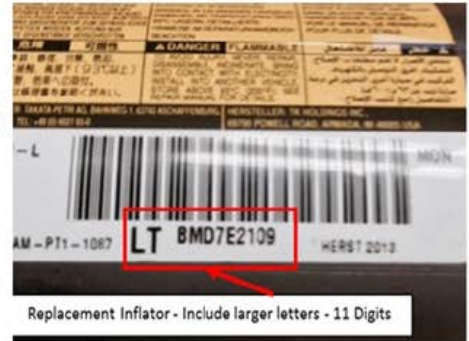
### Replacement Inflator

The first two characters of the Replacement Inflator Serial code will be either 'LT' or 'LR'.

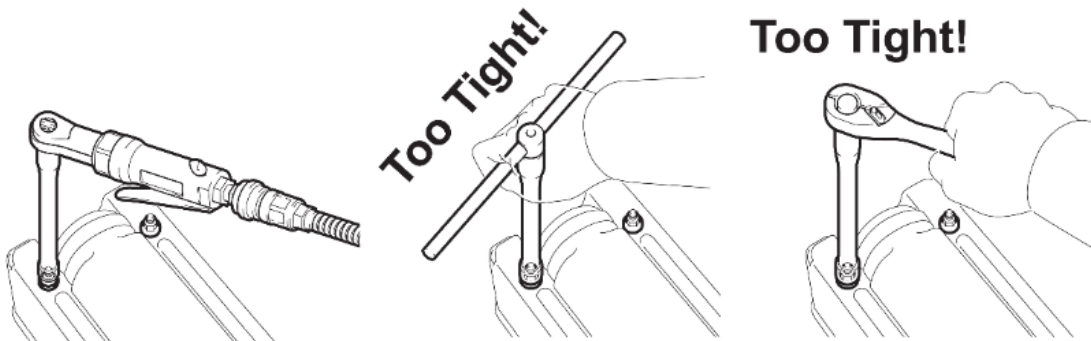
**These tools cause overtightening !**
