TECHNICAL INSTRUCTIONS
FOR
SAFETY RECALL DSF, E04, J0A, J0B, J0C
FRONT PASSENGER AIRBAG INFLATOR MODULE
CERTAIN 2002 –2007 MODEL YEAR SEQUOIA

Update 3/25/22

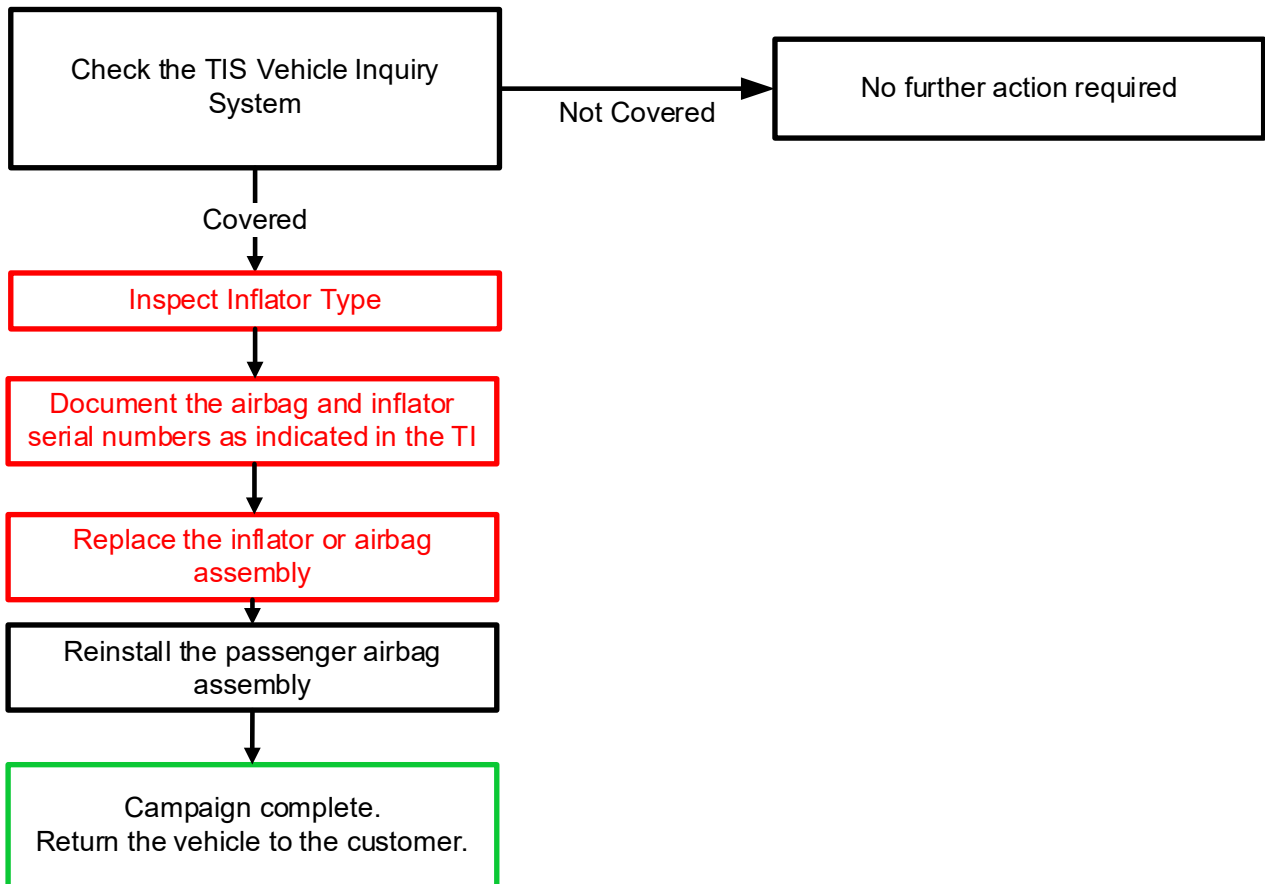
I. OPERATION FLOW CHART

The flow chart is for reference only. **DO NOT** use it in place of the full technical instructions. Follow **ALL** steps as outlined in the full technical instructions to confirm the campaign is completed correctly.

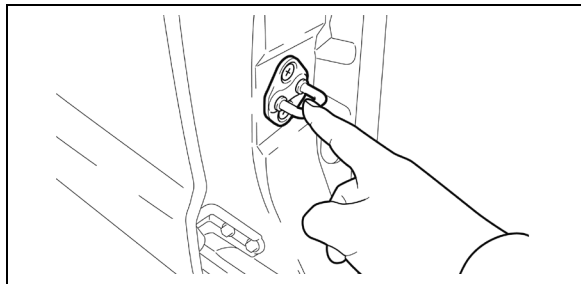
1. ELIMINATE STATIC ELECTRICITY

- a) Before starting work and periodically while working on the vehicle, touch a metallic part of the vehicle to discharge static electricity in the body.

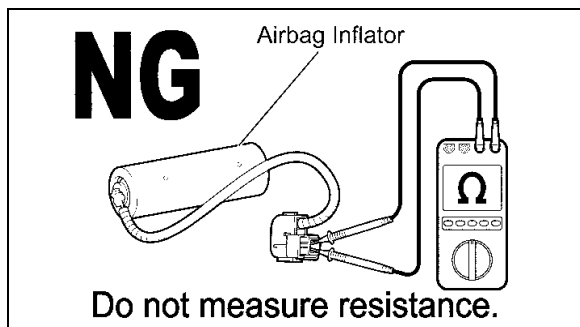
2. DO NOT MEASURE RESISTANCE

- a) **DO NOT** measure resistance of airbag components, this may cause accidental activation.

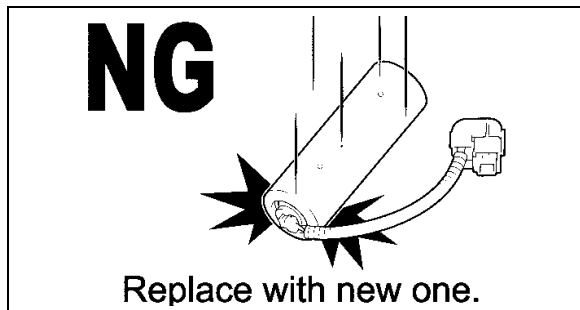
3. HANDLE THE AIRBAG CAREFULLY

- a) If an inflator is dropped, replace it with a **NEW** inflator.

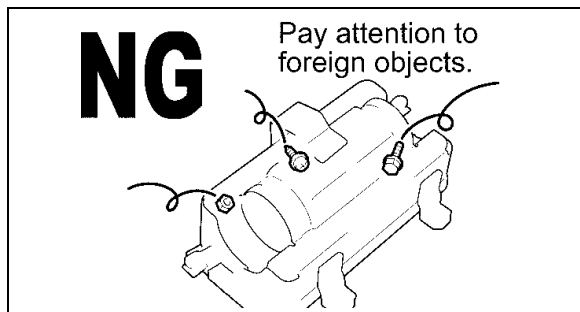
4. DO NOT ALLOW FOREIGN OBJECTS NEAR AIRBAG

- a) Be sure to collect and account for all removed nuts/bolts to prevent them from landing in the airbag assembly.
- b) Any foreign objects in the airbag assembly may cause damage or injury if the airbag is activated.

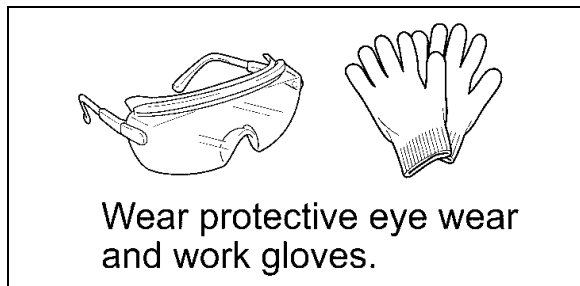
5. WEAR PROTECTIVE EQUIPMENT

- a) Always wear appropriate protective equipment when working on the SRS.

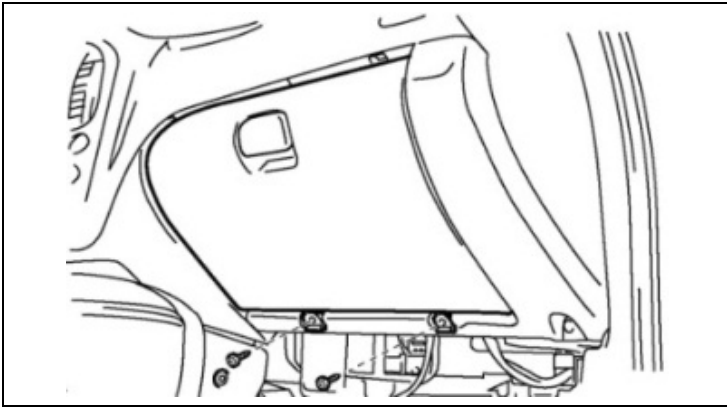
1. **REMOVE THE GLOVE BOX AND FINISH PANEL**
 - a) Remove the 2 screws and the glove box.
 - b) Remove the 3 screws, disconnect the courtesy light connector and remove the lower No.2 finish panel that is behind the glove box.

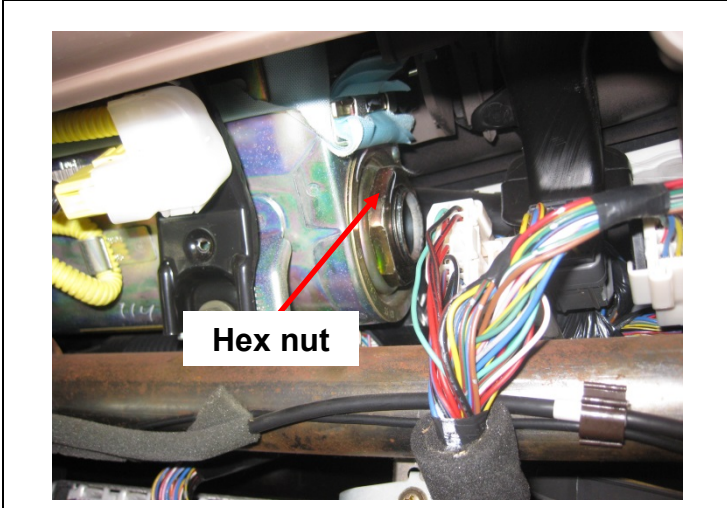
2. **INSPECT INFLATOR TYPE**
 - a) Inspect the inflator to determine if it has a large nut on the right side as shown.
NO: Proceed to section VIII.
YES: The vehicle is **NOT INVOLVED** in the Safety Recall.

Reinstall the glove box and return the vehicle to the customer.

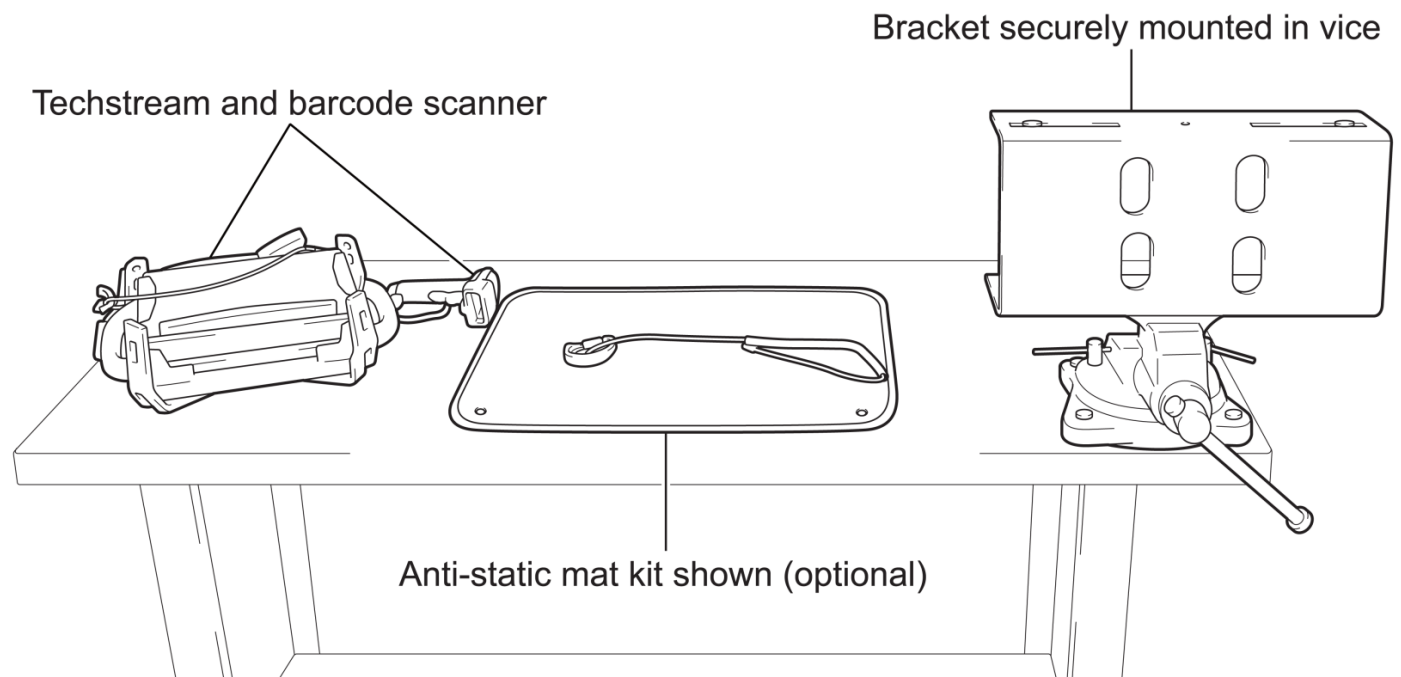
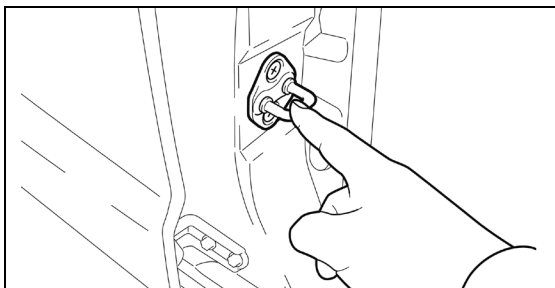
The bracket assembly that was provided at the launch of SSC D0F is a critical added-safety feature that **MUST** be used when replacing the inflator module. Confirm the bracket assembly is installed securely in the vise and confirm the work area being used is appropriate. The anti-static mat set that is an essential SST may be available at your dealership and is optional to use during inflator replacement. If the anti-static kit is not available, before starting work and periodically while working on the vehicle, touch a metallic part of the vehicle to discharge static electricity in the body.

Confirm there are no loose objects or people exposed to the back side of the bracket for safety in the unlikely event of airbag deployment due to improper work procedures (Remember that the inflator **IS NOT** being replaced due to an inadvertent deployment concern).

If the anti-static kit is not available, before starting work and periodically while working on the vehicle, touch a metallic part of the vehicle to discharge static electricity in the body.

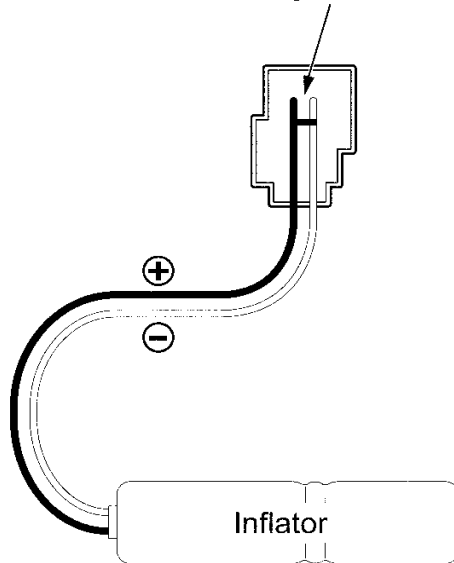
(1)

Short circuiting on both sides.

The connector of the inflator module contains a short circuiting mechanism to eliminate voltage variances when the connector(1) is disconnected. To allow for the replacement of the inflator module, a new short circuit(2) *MUST* be created before cutting the wires(3) and removing the inflator. The following steps *MUST* be followed exactly as described to ensure the work is completed correctly and safely.

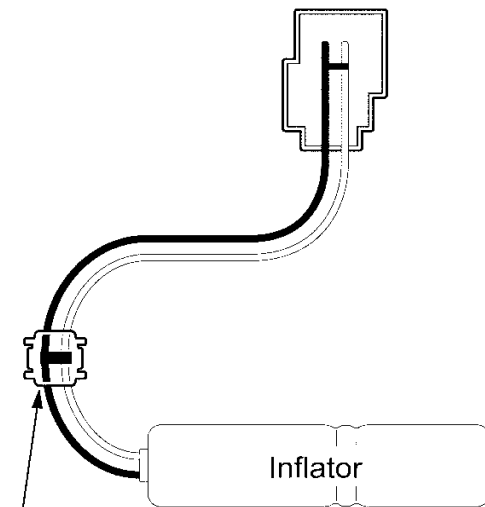
(2)

Create new short circuit using electro tap.

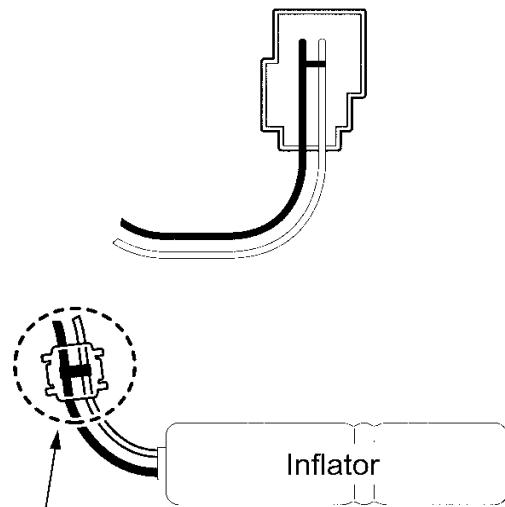
(3)

Short circuiting is maintained even after cutting harness.

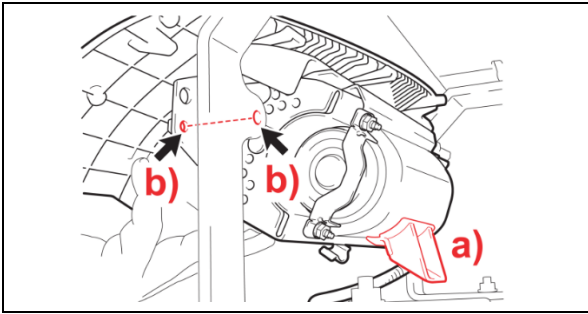
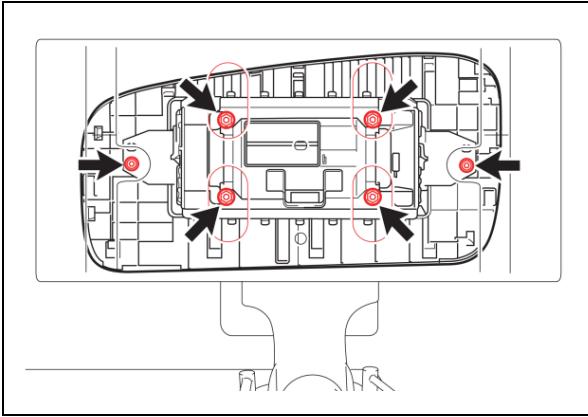
1. MOUNT THE AIRBAG IN THE MOUNTING BRACKET

- a) Position the airbag assembly so that the center mounting bracket is facing towards the ground.
- b) Install the airbag to the support bars with the bolts supplied in the bracket kit.

- c) Position the airbag so that all four stopper plate nuts can be removed through the access holes.
- d) Tighten the bolts holding the support bars to the mounting bracket.
- e) Confirm the following:
 - Mounting bracket is secure in the vise.
 - Airbag is secure in the support bars.
 - The center mounting bracket on the airbag assembly is facing downward.
 - Support bars are secure on the mounting bracket using 1 bolt/nut at the top of each support bar and 2 nuts/bolts at the bottom of each support bar.

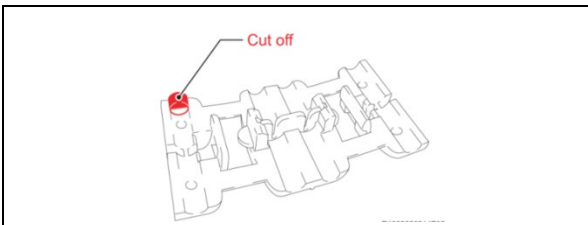
- a) Cut the yellow corrugated tube on the harness approximately 4 inches (10 cm) using nippers.

- **DO NOT** damage the wires in the tube.
- **DO NOT** use a knife or razor blade to cut the tube to avoid damaging the wires.
- This may be performed on either end of the inflator.

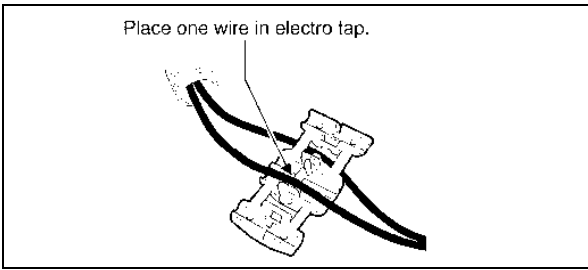
- b) Cut off the tab of the electro tap shown in the illustration.

NOTE: The electro tap is included in the inflator parts kit.

This tab *MUST* be removed to ensure a good short.

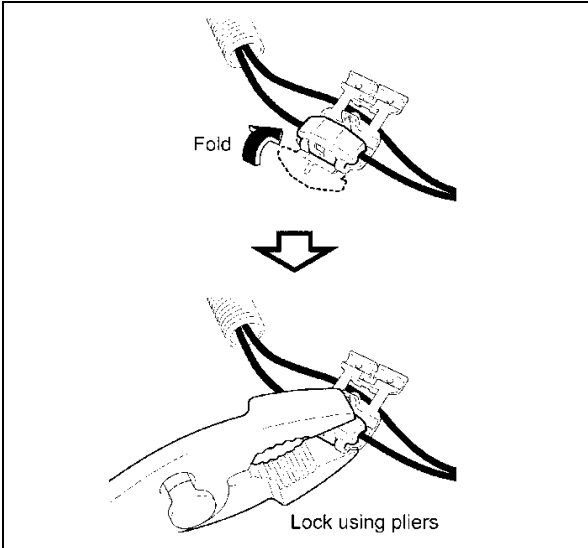
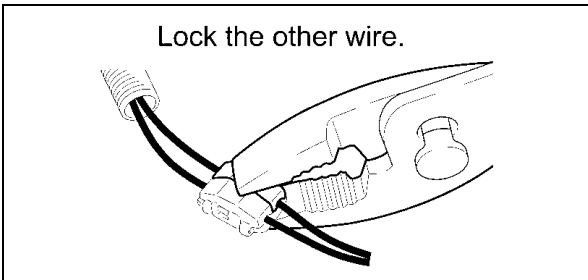
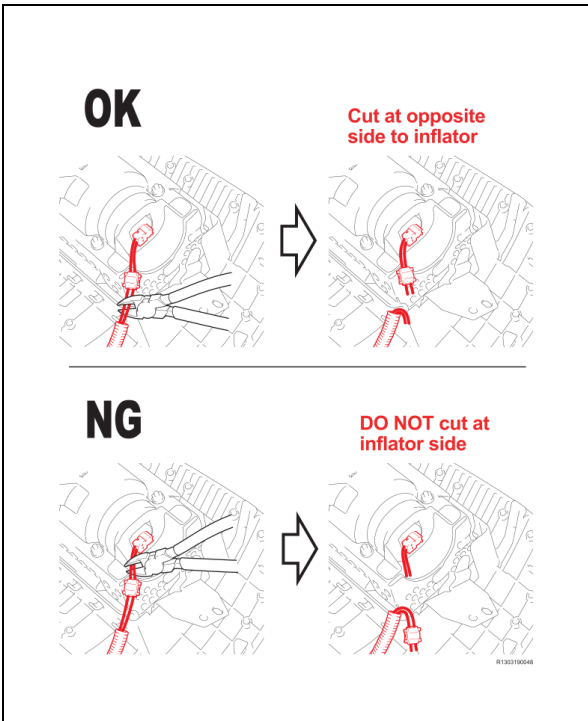
- a) Place one wire in the electro tap as shown in the illustration.
- b) Fold and pinch the half of the electro tap with the wire and use pliers to lock the electro tap.

- **DO NOT** work on both wires at the same time to avoid errors.
- Pliers **MUST** be used to confirm the electro tap is firmly locked in place.

- c) Set the other wire in the electro tap and lock it in place using pliers.

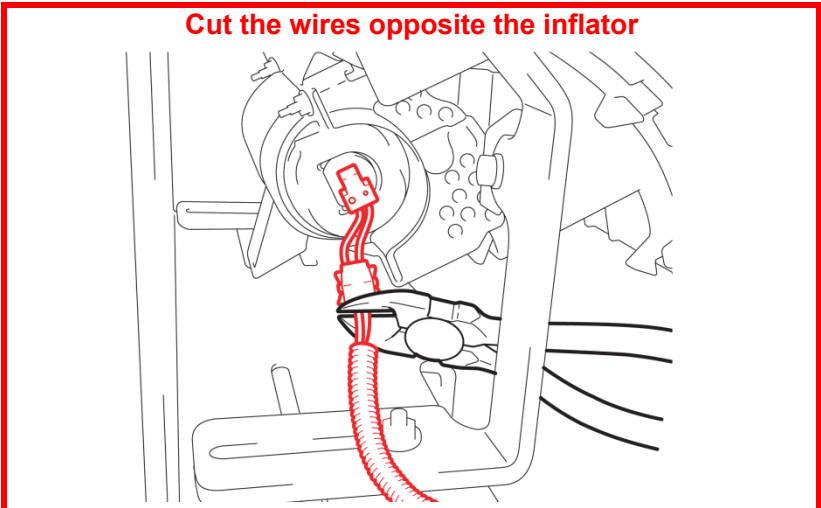
- a) Cut the 2 wires at the side of the electro tap that is farthest away from the inflator.

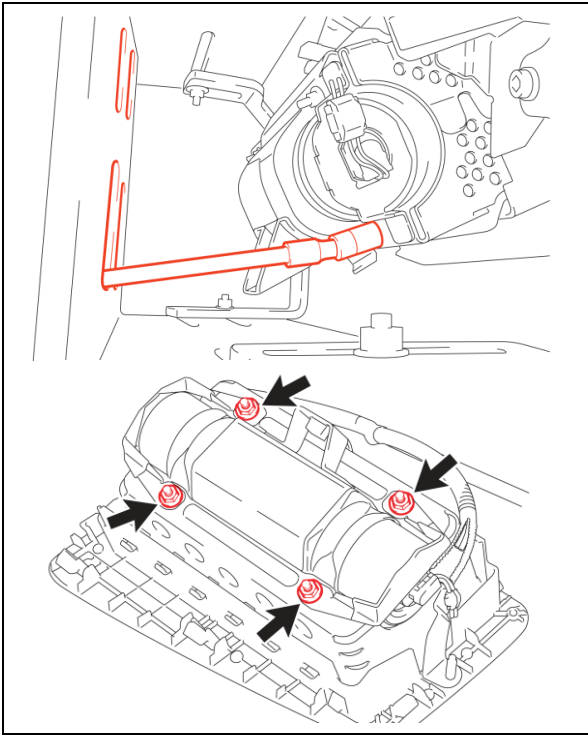
5. REMOVE THE SELF LOCKING NUTS

a) Use the access holes in the bracket to remove the 4 nuts.

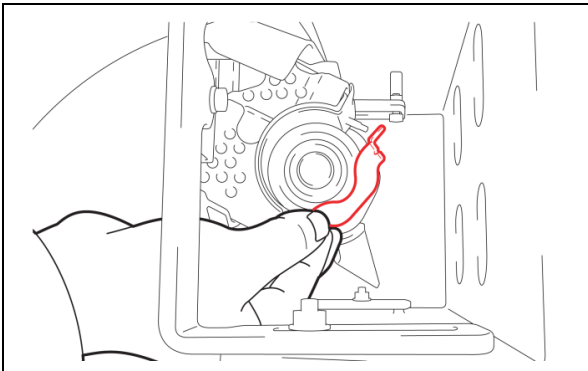
- **DO NOT** use power tools.
- The bracket support bars may need to be repositioned to remove the nuts through the access holes.

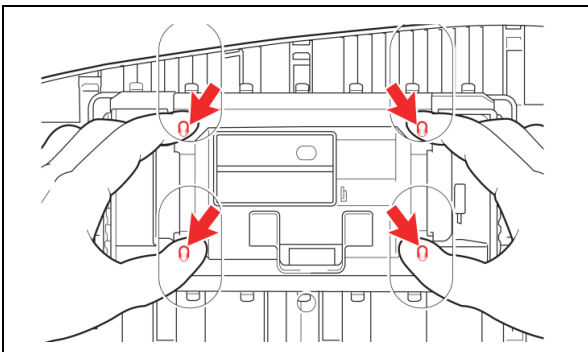
b) Remove the stopper plate and place in a secure location because it will be reused.

c) Discard the 4 nuts as they are not to be reused.

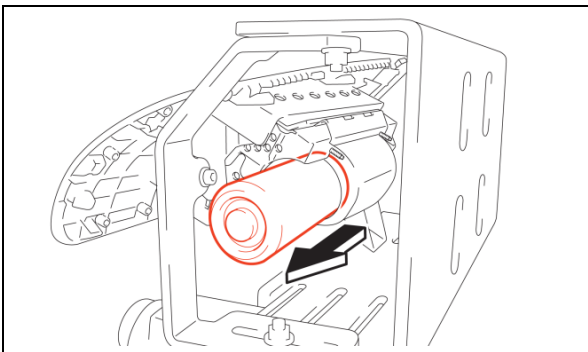
a) Gently push in the 4 studs to loosen the inflator for removal.

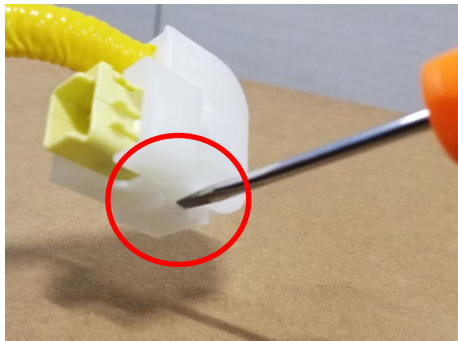
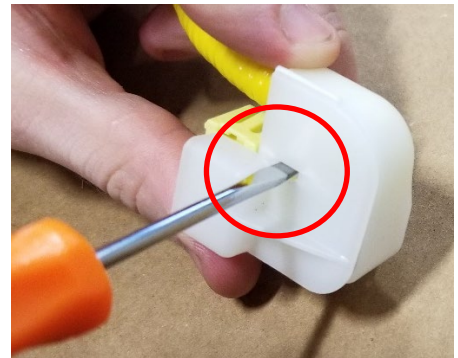
8. REMOVE NEW INFLATOR CONNECTOR COVER

- a) Carefully use a pocket screwdriver to disengage the first release tab as shown in the image
- b) Carefully use a pocket screwdriver to disengage the second release tab as shown in the image

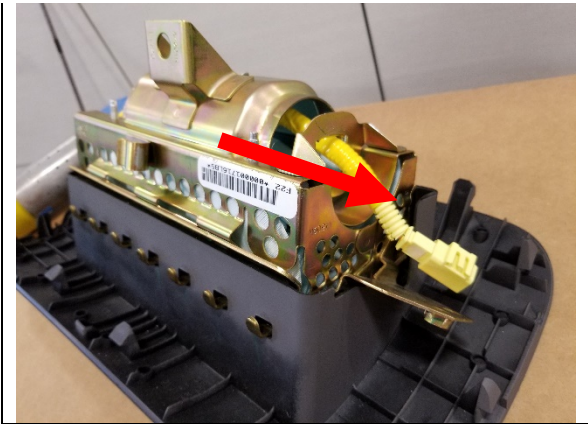
- c) Open the connector cover. Once open carefully use a pocket screwdriver to disengage the release tab and remove the connector cover from the connector

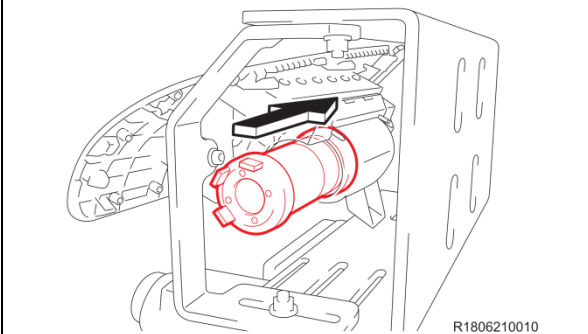
- a) Route the inflator wire harness through the stopper plate

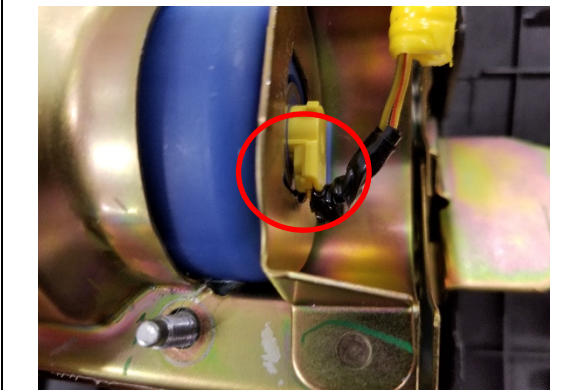
- b) Carefully slide the new inflator into the airbag assembly.

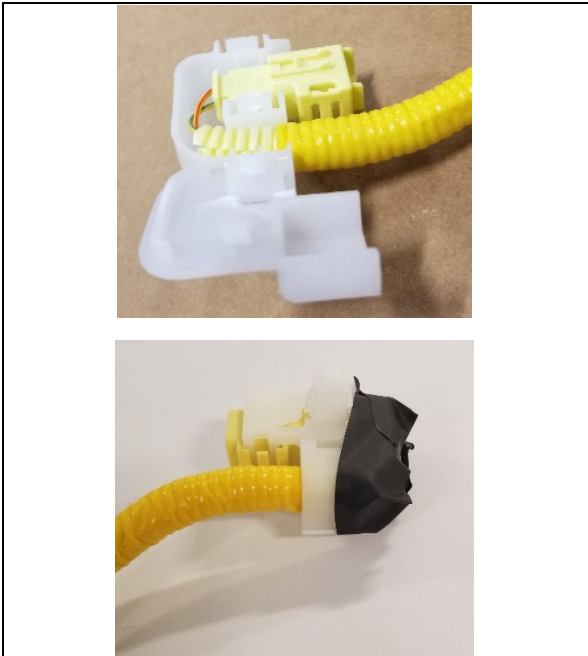
- c) Confirm the harness is not pinched by the stopper plate

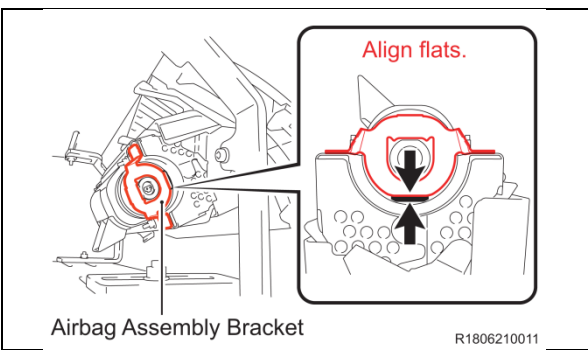
- d) Install the connector into the connector cover. Ensure the release tab on the connector is engaged into the connector cover.
- e) Once the connector is installed into the connector cover, close the connector cover over the connector.
- f) Wrap electrical tape around the connector to prevent the connector from opening.

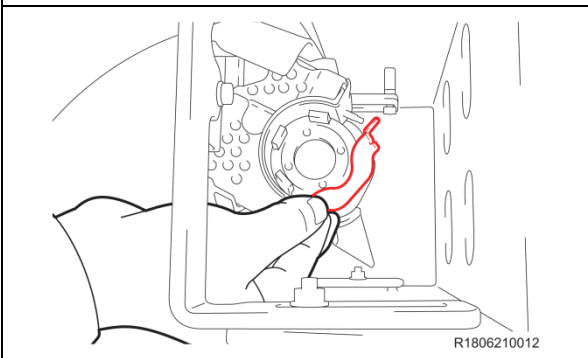
- a) Align the flat on the inflator with the flat on the airbag assembly bracket.

STOP Confirm the flats on the airbag assembly and inflator are aligned.

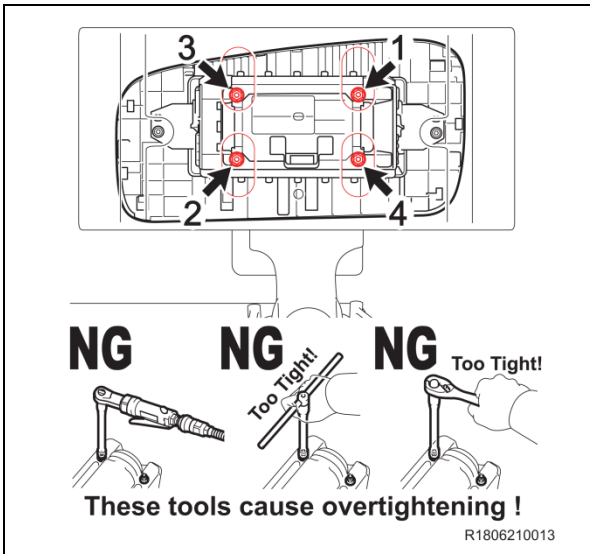
- g) Place the stopper plate on the airbag assembly.

- h) Install stopper plate nuts (**NEW**) by hand. They will be torqued on a later step.
- i) Install the **NEW** nuts on the airbag assembly bracket by hand. They will be torqued on a later step.

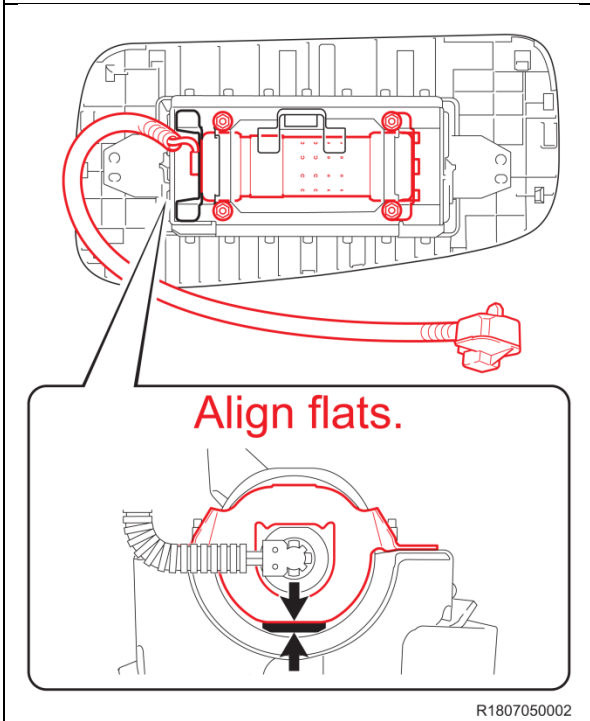
- a) Tighten the nuts evenly in two increments following the sequence shown in the illustration. Use a socket driver or torque wrench to tighten the nuts.

- There will be some resistance when tightening the nuts because they are self-locking, confirm the nuts are tightened correctly.
- DO NOT** use a power tool, T-handle, or ratchet when tightening the nuts to avoid over torquing.

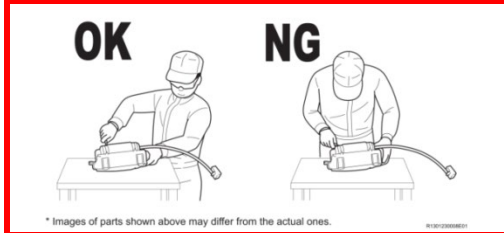
Avoid standing directly in front of the parts.

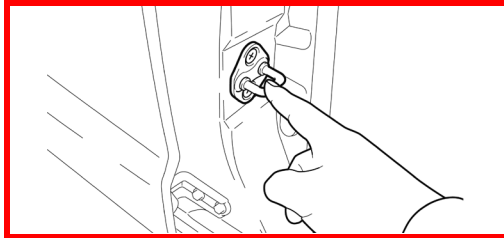
Before starting work and periodically while working on the vehicle, touch a metallic part of the vehicle to discharge static electricity in the body.

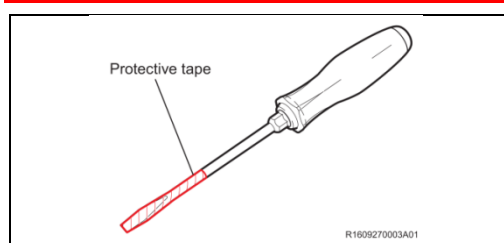
1. Wrap protective tape around a flathead screwdriver.

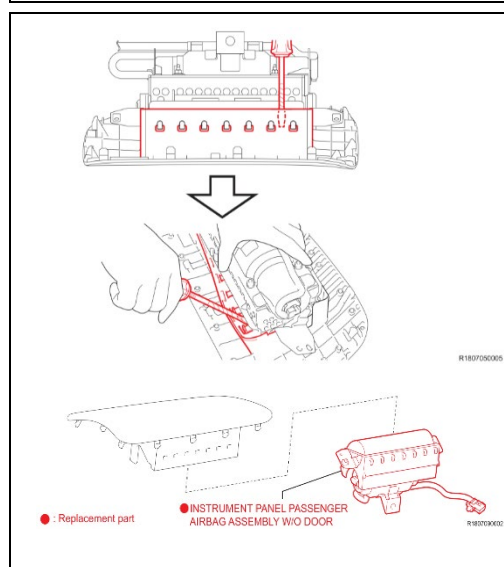
2. Disengage the claws from the vehicle rear side using the flathead screwdriver to remove the airbag assembly from the cover.

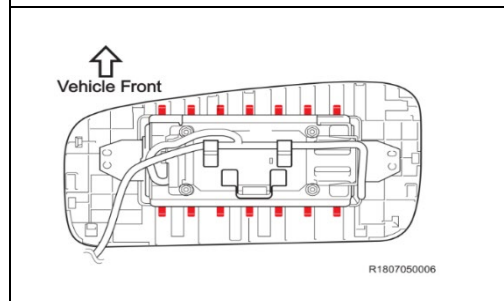
4. Install the *NEW* airbag assembly in the correct mounting direction

5. Confirm that the 14 claws have engaged correctly
